VESSEL: M.V MORANDI

DATE: 2ND JAN 2024

UNDERWATER SERVICE REPORT

Report Number	NSPL – 01- 24- 1835	U/W	STILL PHOTO INSPECTION. BOROSCOPE X3 SCRUBBER. CCTV WITNESS BY PAINT INSPECTOR
Attendance Date	2 ND JAN 2024	Services	
Location	AEBC	Performed

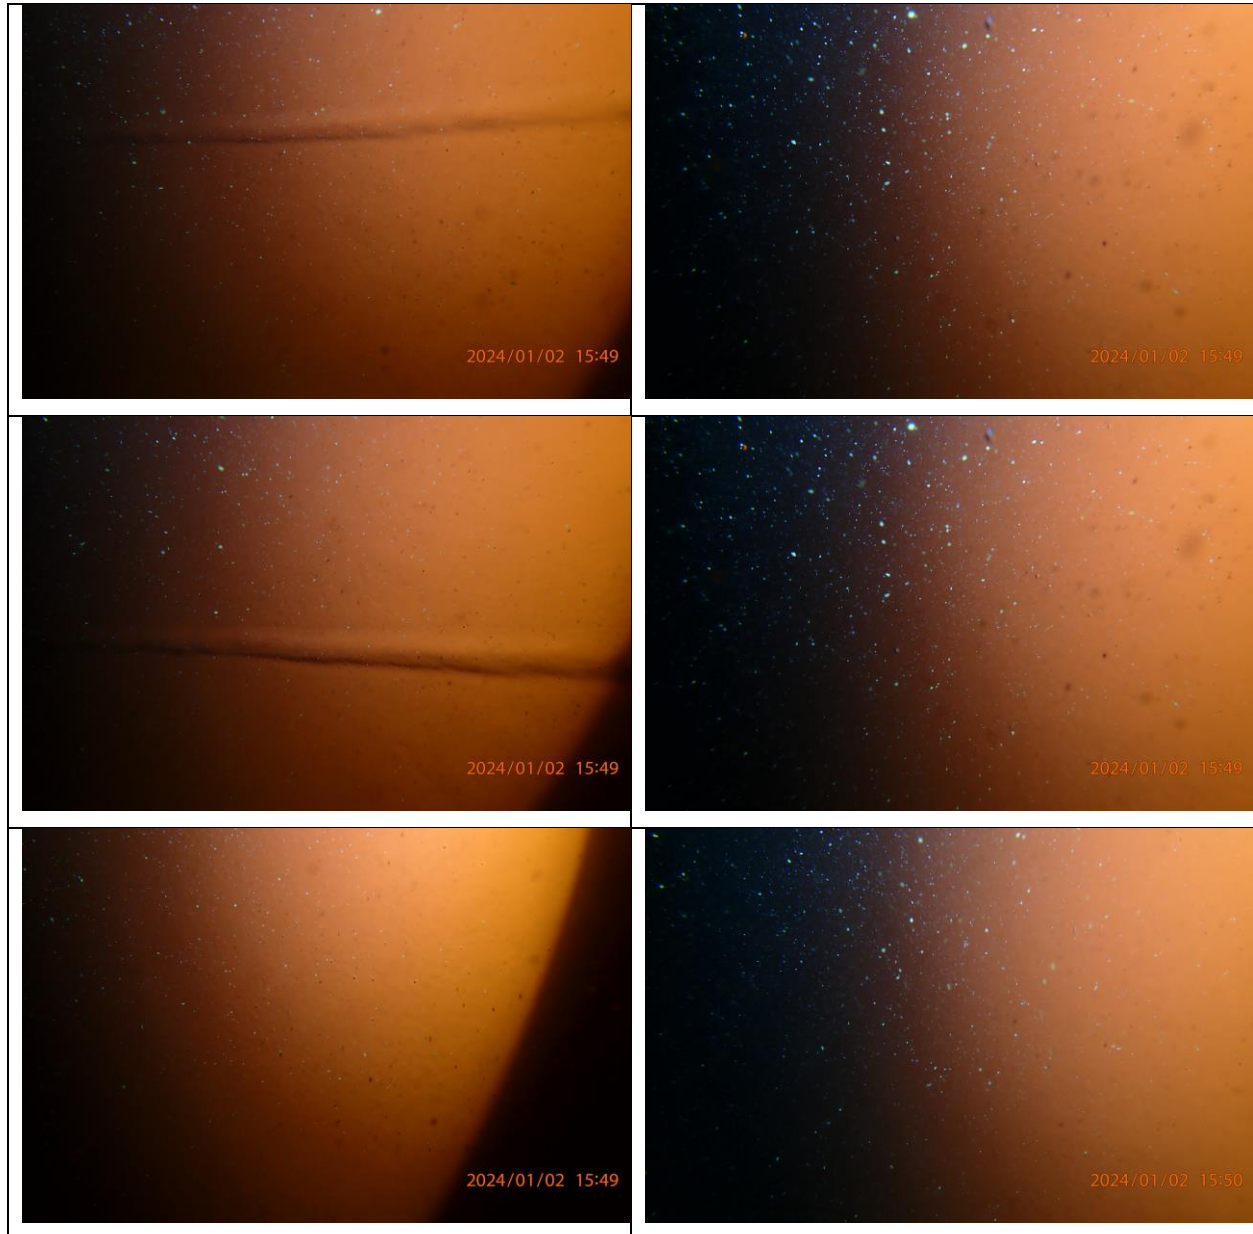
FORWARD AREA (STARBOARD) – VERTICAL SIDE

1. Bulbous bow on port and observed to clean.
2. Vertical sides on both Port and Starboard were clean.
3. The Flat Bottom was observed to clean.

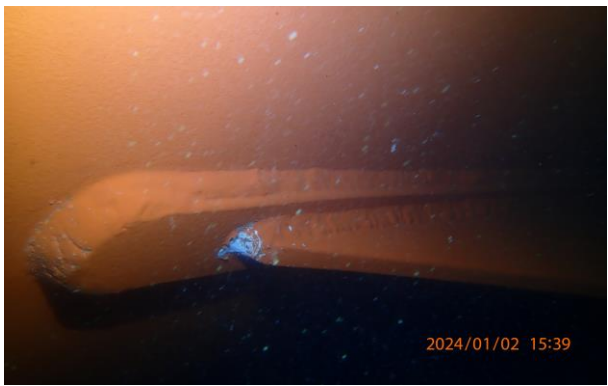
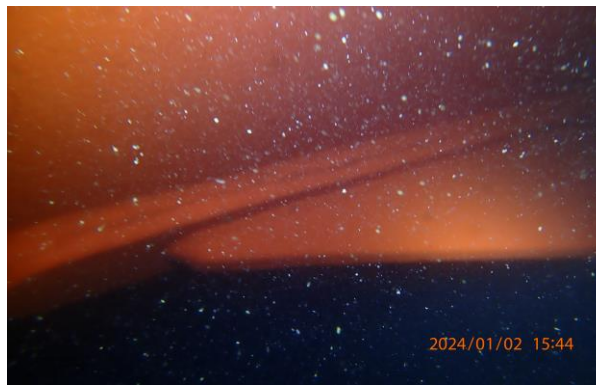
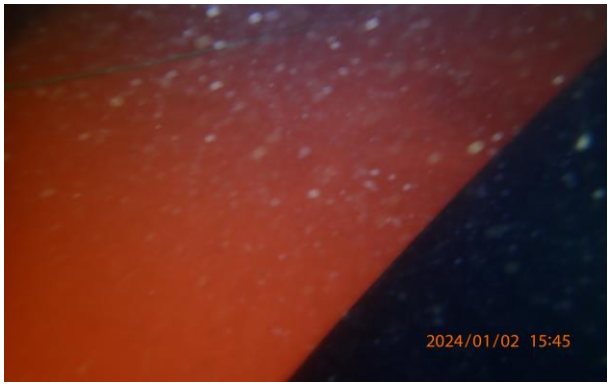
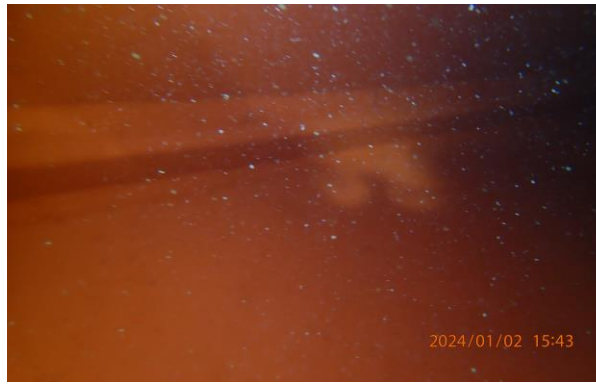
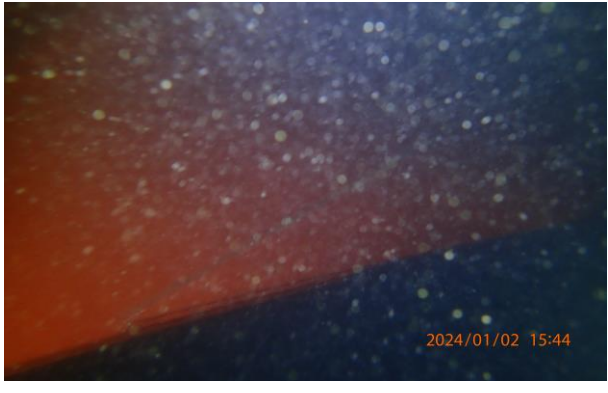
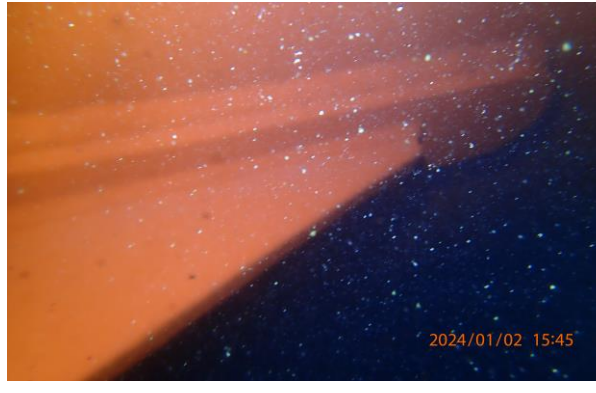
BILGE KEEL (STARBOARD)

1. 07 series type on each side.
2. No damage or cracks observed on weld joints.
3. Bilge Keels on both port and starboard were observed to be clean.

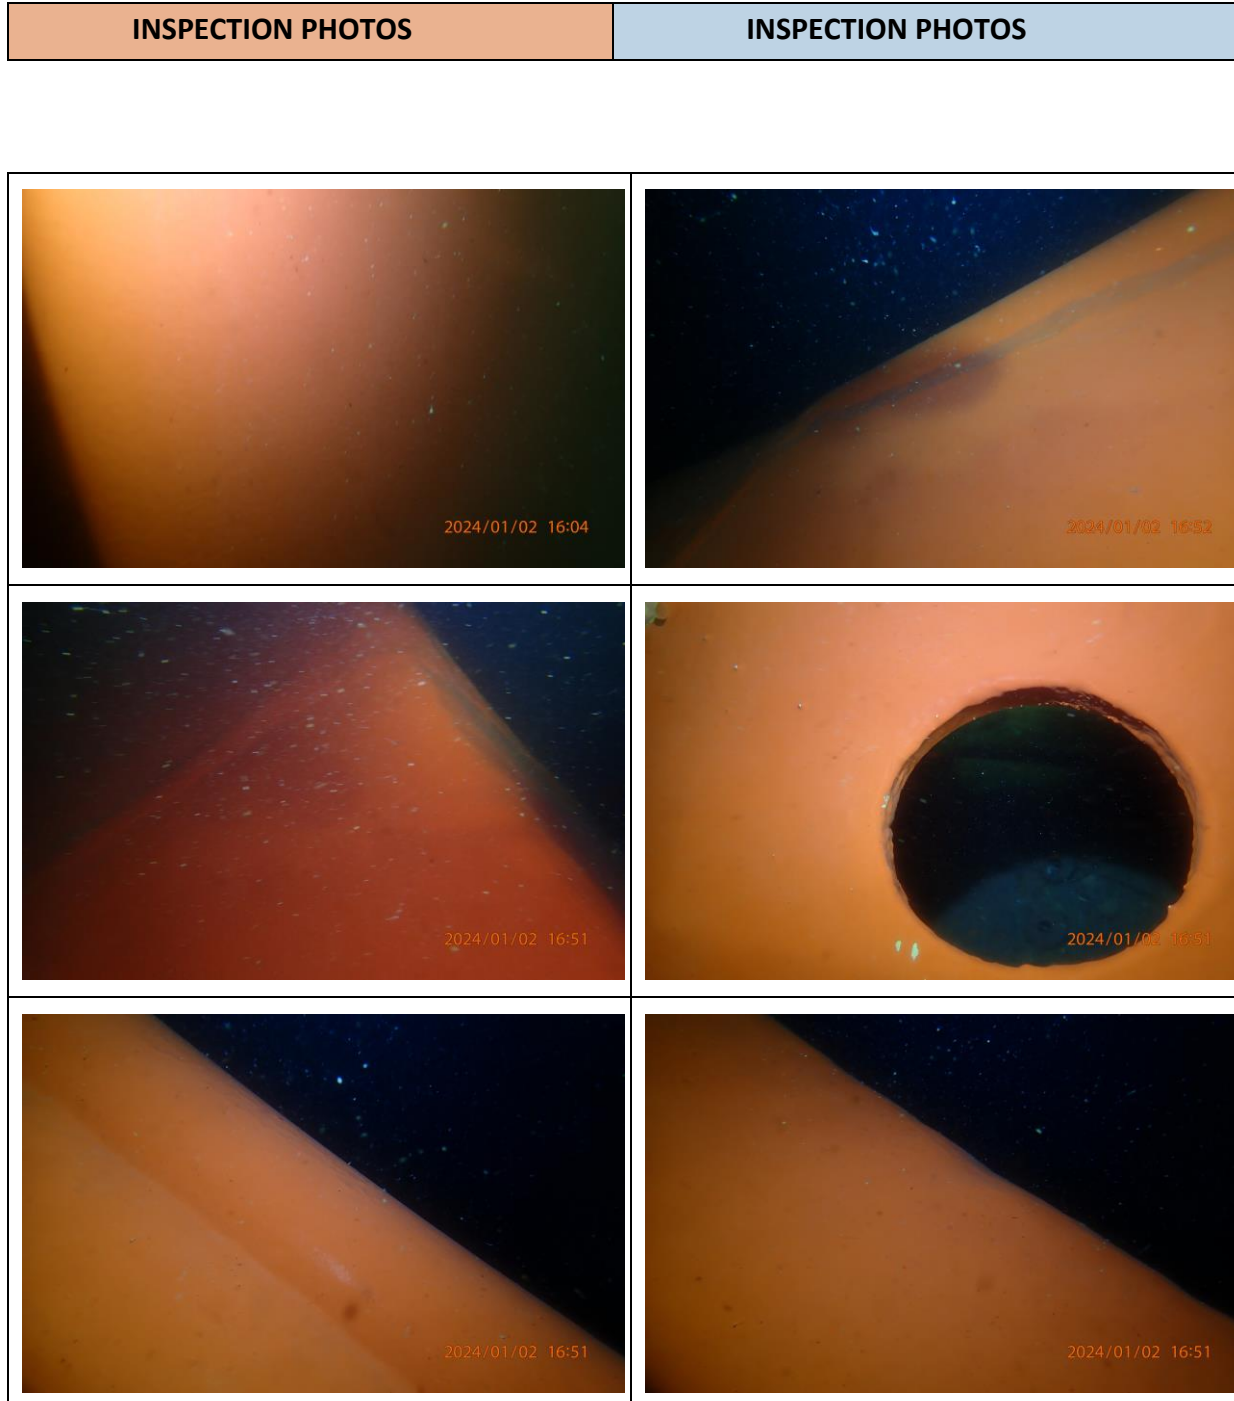
STERN FRAME/STERN TUBE

Remarks: NO VISIBLE DAMAGE OBSERVED. NO SKEG OBSERVED

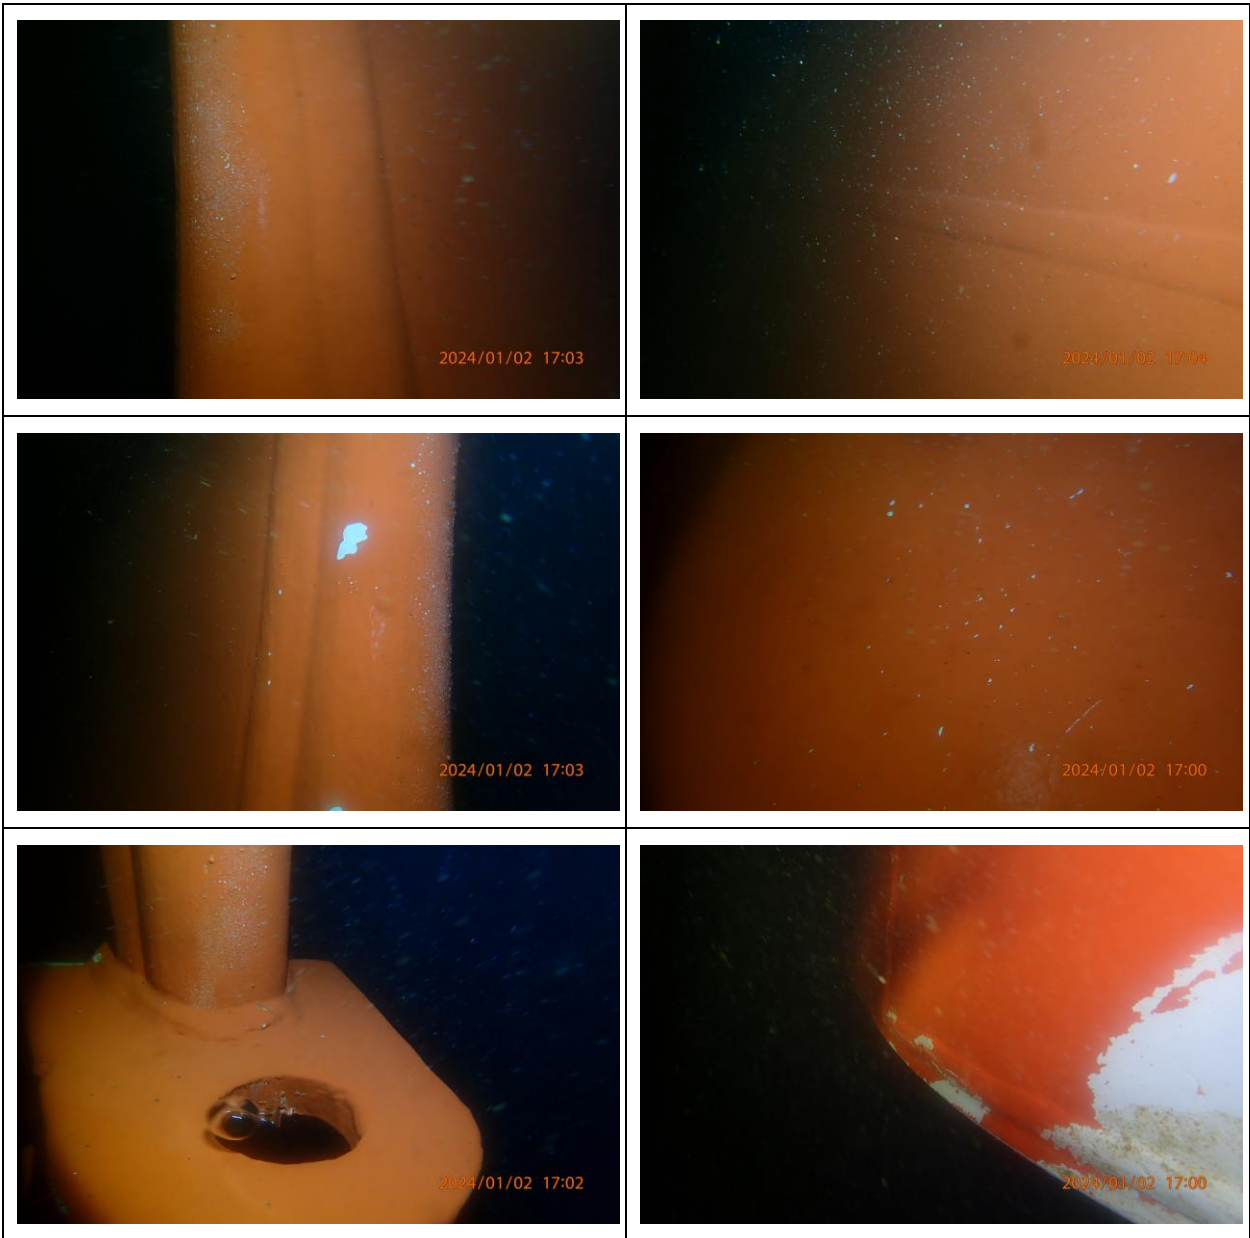
RUDDER

1. Rudder Horn observed in good condition with no damage or crack sighted.
2. Rudder Stock observed in good condition with no damage or crack sighted.
3. Rudder plate observed in good condition with no damage sighted.
4. 01 Rudder plugs are sighted and intact.
5. Rudder was observed to be clean with about 10% barnacle.

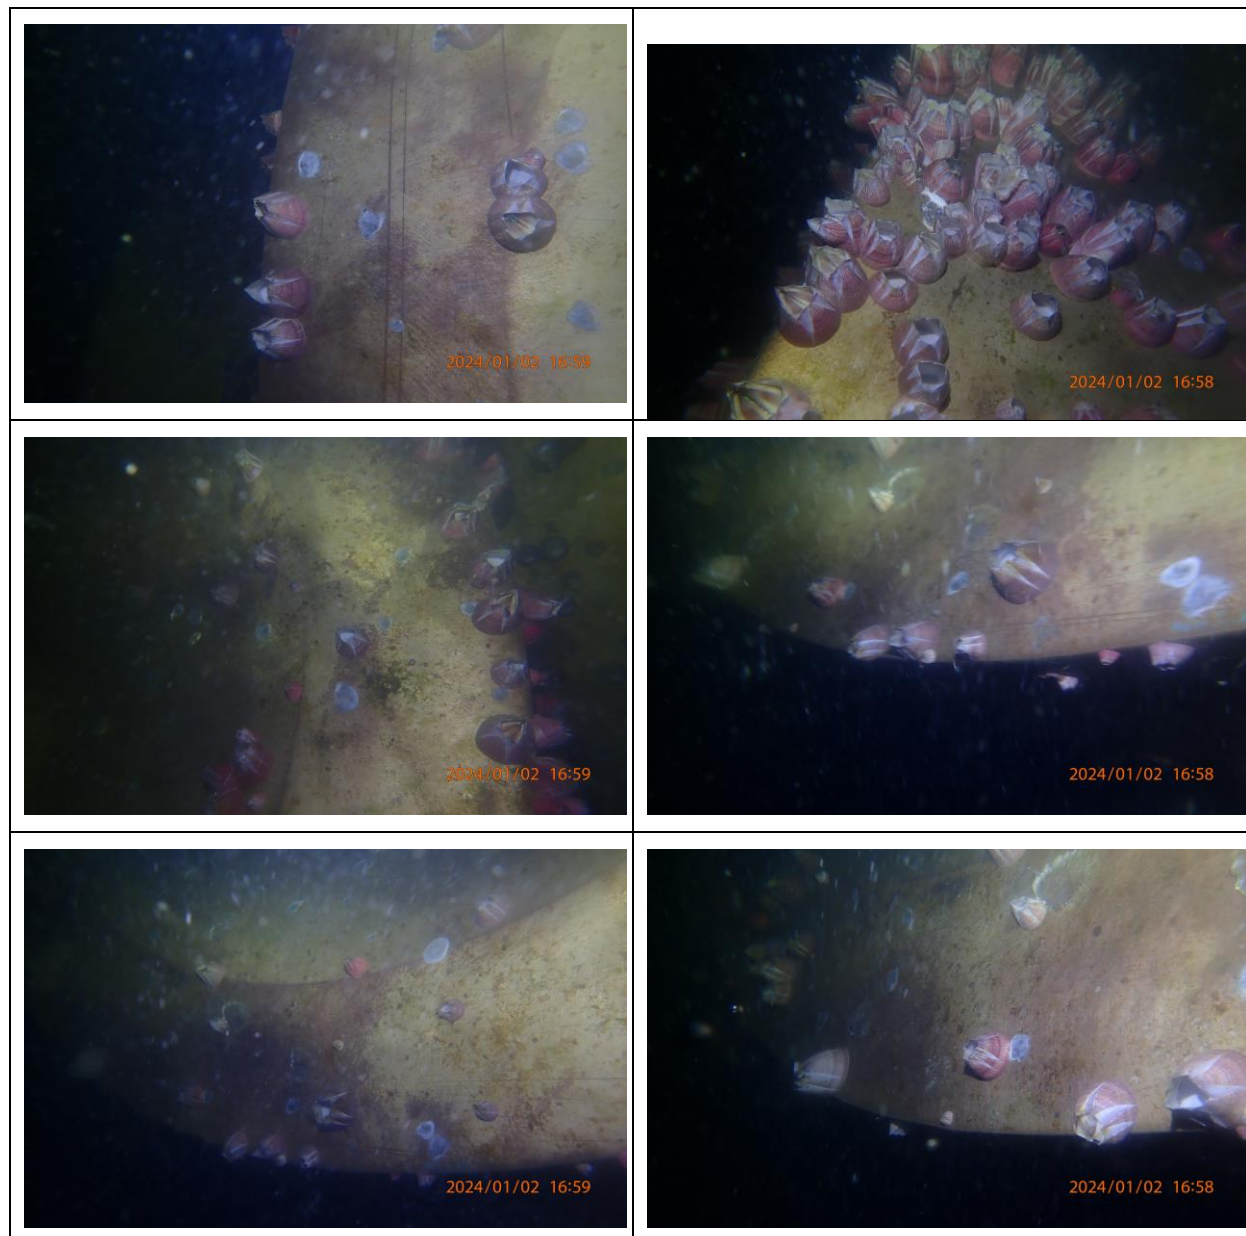
PROPELLER BLADES

1. Of 04 blades single type.
2. Blades observed in good condition.

3. Boss cone observed in good with cement covers intact and bolting assembly covered.
4. No oil leak from the shaft was observed.
5. No damage was sighted to the tail shaft assembly.
6. Propeller found to be heavily covered with about 80% barnacle, 40% Algae, 40% Slime, and 70% Calcareous

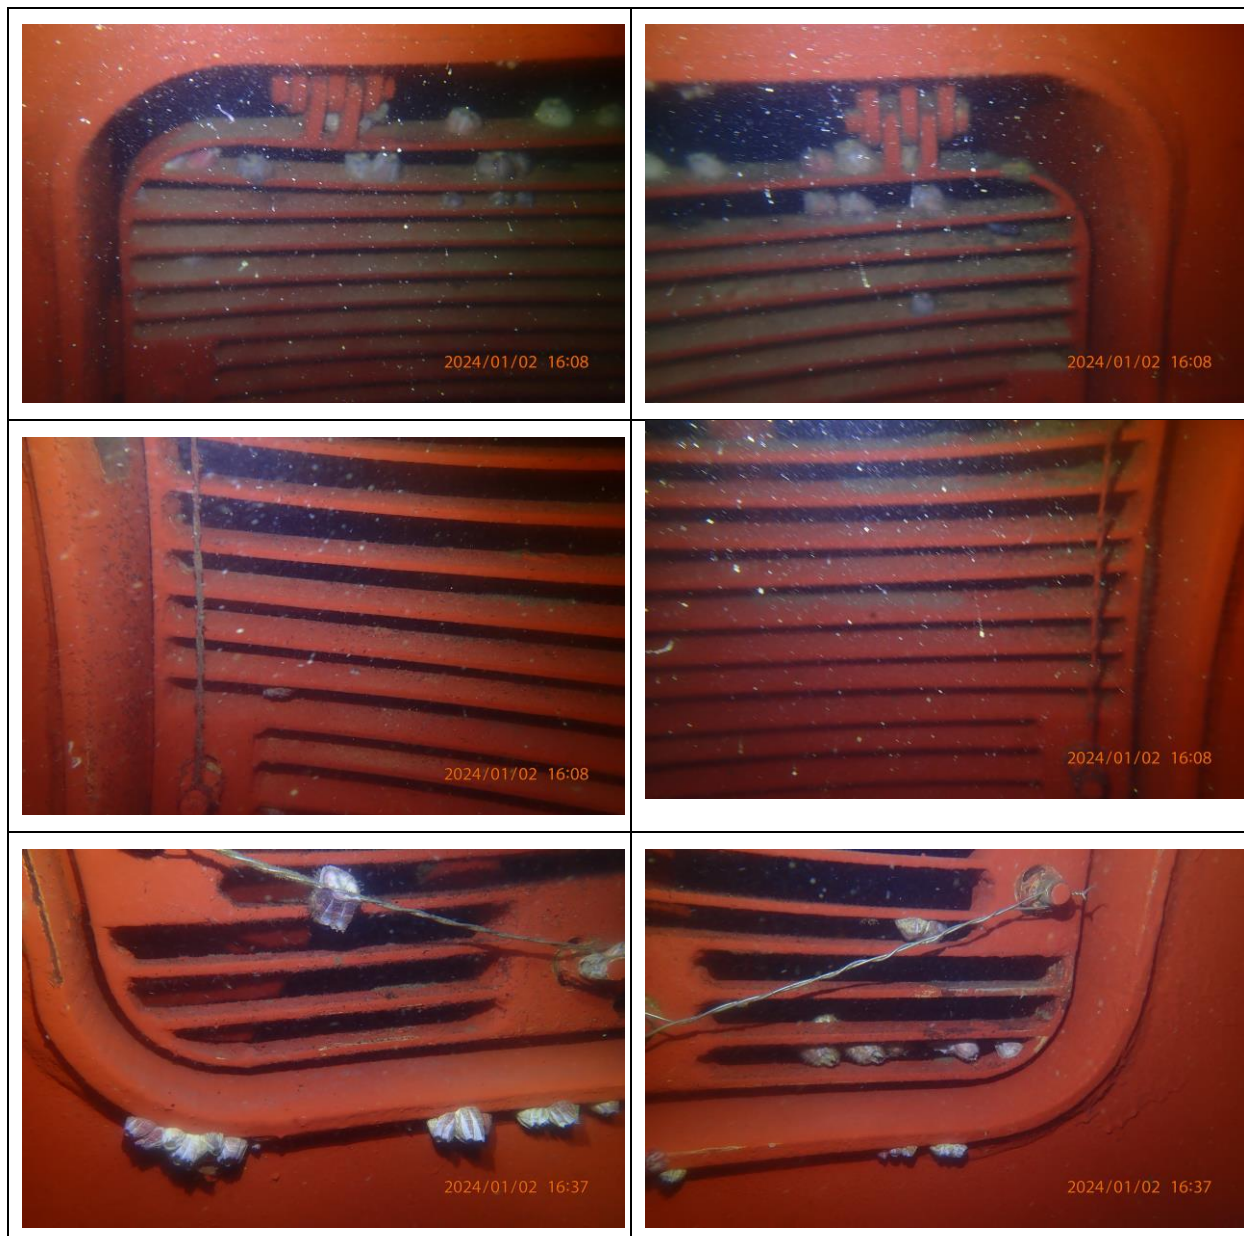
SEACHEST (STARBOARD) - GRATINGS

1. Gratings are bolted type.
2. Gratings on both port and starboard were observed to be lightly covered with about 05% barnacle, 10% algae, and 10% slime.
3. Gratings sighted intact and in good condition with seizing wires intact.
4. (02 no Port side) (02 no Starboard side) (01 no Fire Pump port aft)

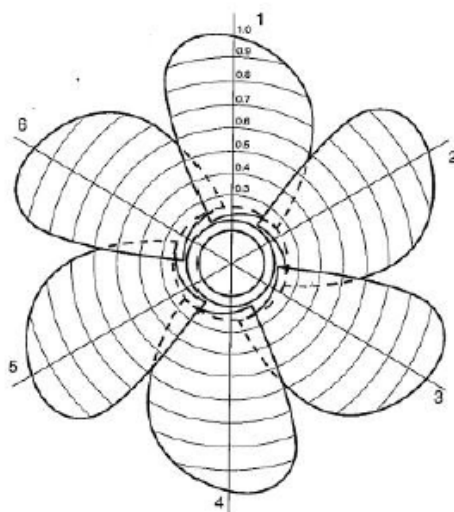
PROPELLER SKETCH REMARKS SHEET

Remarks: NO VISIBLE DAMAGE OBSERVED.

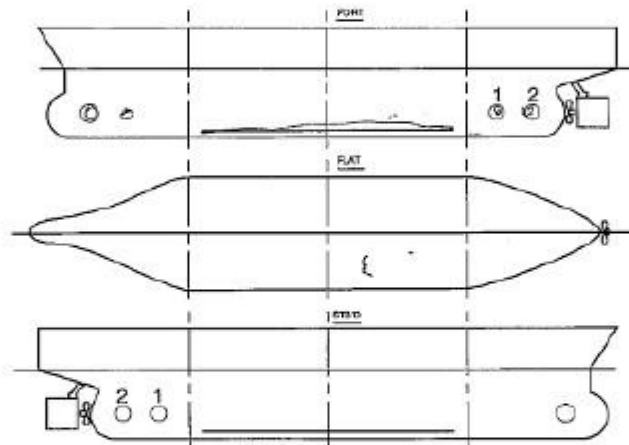
Hull Plating Below Waterline Damage Remarks Page

Remarks: NO VISIBLE DAMAGE OBSERVED.
