Nitrate Stress Corrosion Cracking of a Furnace Shell

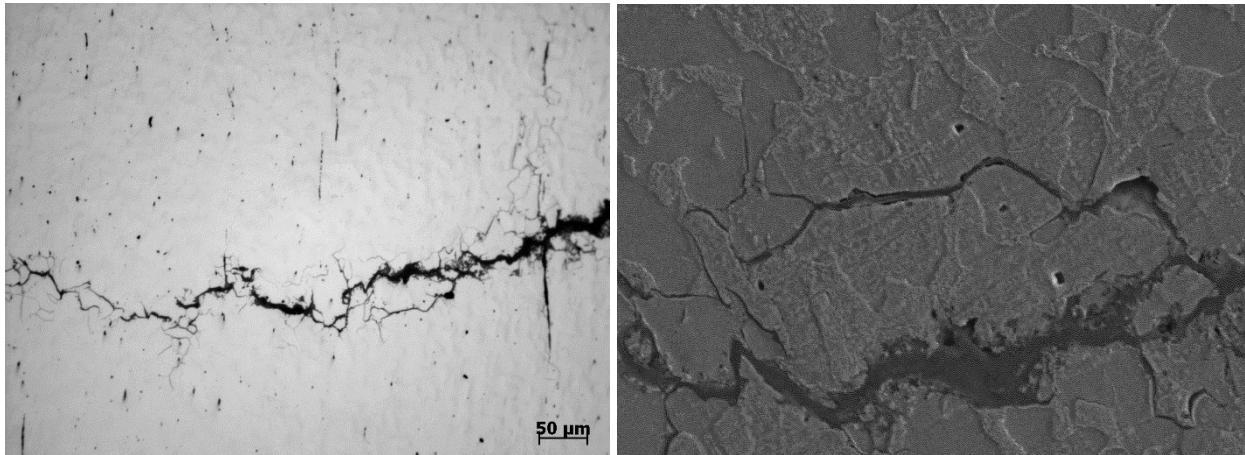
Figure 1: Optical Micrograph (Left) and SEM Micrograph (Right) of Intergranular Cracking and Corrosion in a Polished Cross Section of the Furnace Shell

Summary: The failure of the furnace shell was caused by nitrate stress corrosion cracking, and not by thermal fatigue. The presence of stress corrosion is clear from the crack branching (left image in Figure 1) and the intergranular nature of the cracking (right image in Figure 1). There are relatively few mechanisms that result in intergranular failure of low strength plain carbon steel, and of those mechanisms, the only one likely to take place in a furnace shell is nitrate SCC. However, for nitrate SCC to occur there has to be a source of nitrates, and that is where the lack of NO_x control measures is important.

The NO_x that was produced by the burners for the first 30 years of operation had partially condensed on the I.D. of the furnace shell and reacted with the insulation to form magnesium and sodium nitrate salts. Then, when the furnace was cycled and cooled to below the dew point, the surface of the metal was wetted and the nitrate salts entered into solution, resulting in the formation of a stress corrosive environment. Upon startup, the areas of maximum stress were the areas where thermal stress was at a maximum, and so the stress corrosion cracking occurred most prominently in these areas.
