Deepwater Horizon Accident

Gulf of Mexico on Tuesday, April 20, 2010

Mahmoud Farag Radwan

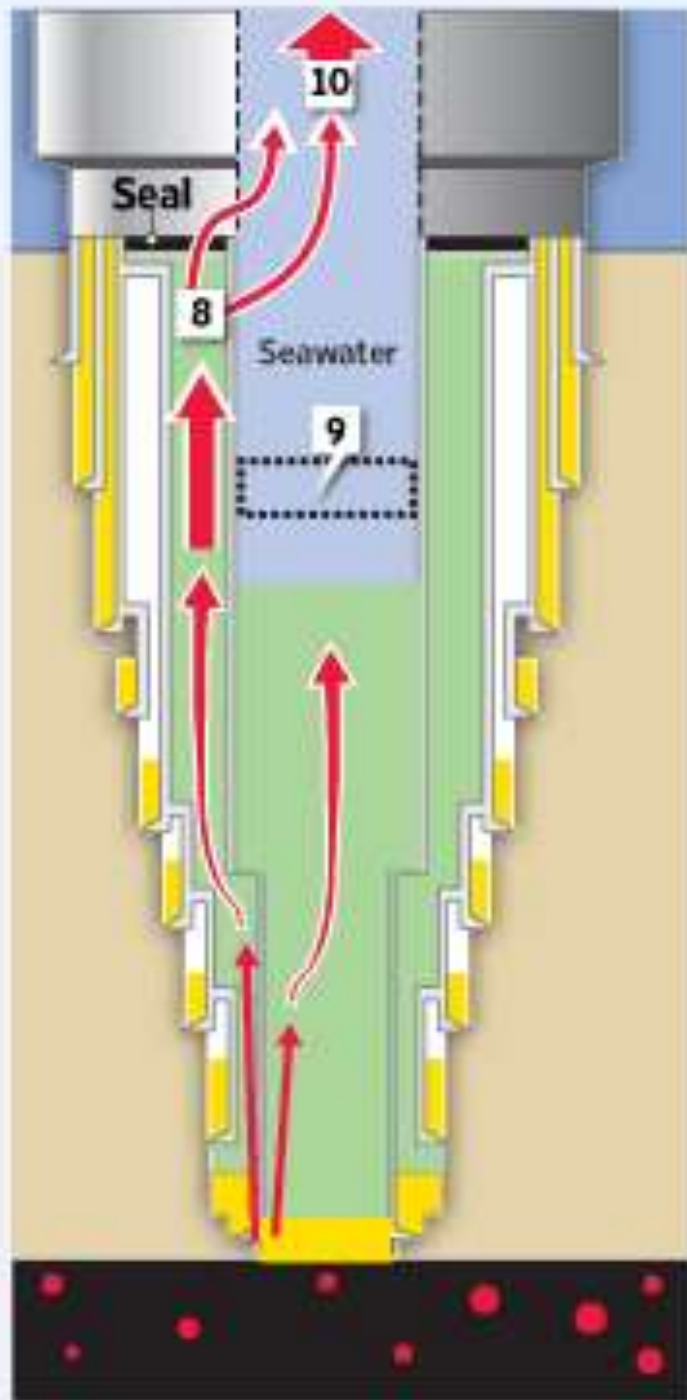
As one of the final steps to prep the pipe, the heavy mud was removed and replaced with much lighter seawater.

The gas easily moved through the seawater and up the pipe to the surface where it caught fire.

This is commonly known as a “blowout.”

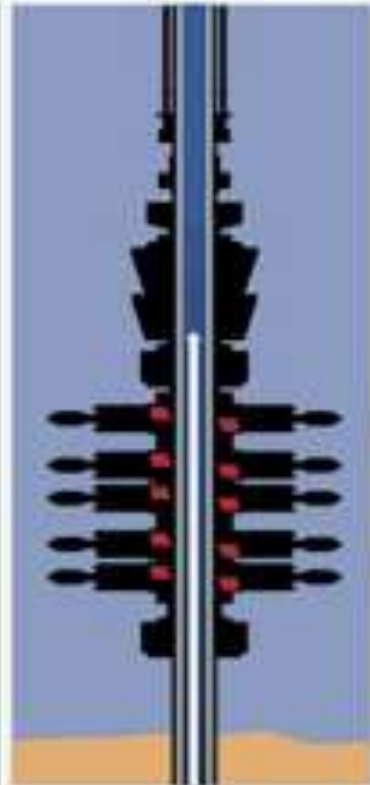
The emergency device called the blowout preventer (BOP) sits at the top of the well.

The blowout preventer failed.

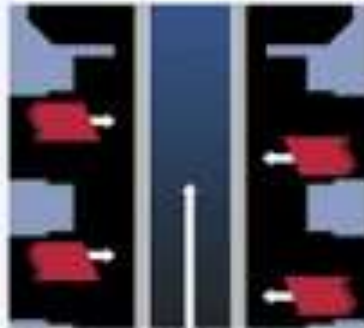
Oil, gas and mud flowing upward within the BOP.

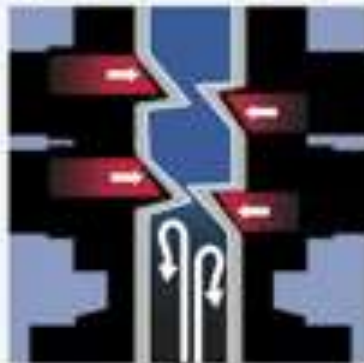
The BOP contains hydraulic devices called shear rams that are supposed to cut through the pipe to stop the flow.

Engineers don't know why the shear rams failed.

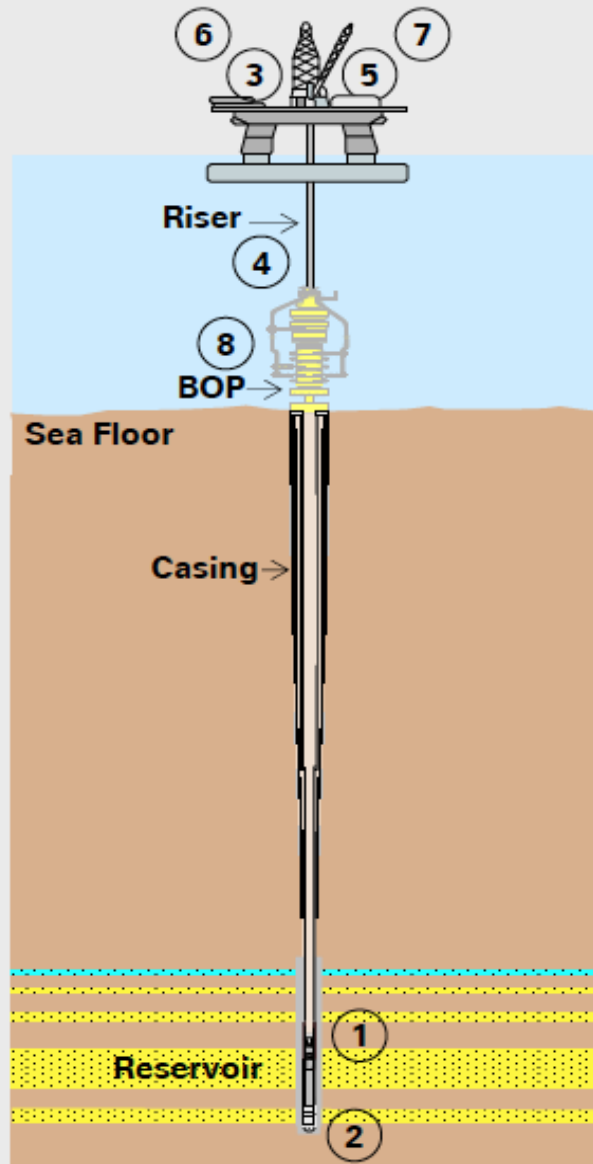
Eight Barriers Were Breached

Well integrity was not established or failed

- ① Annulus cement barrier did not isolate hydrocarbons
- ② Shoe track barriers did not isolate hydrocarbons

Hydrocarbons entered the well undetected and well control was lost

- ③ Negative pressure test was accepted although well integrity had not been established
- ④ Influx was not recognized until hydrocarbons were in riser
- ⑤ Well control response actions failed to regain control of well

Hydrocarbons ignited on the *Deepwater Horizon*

- ⑥ Diversion to mud gas separator resulted in gas venting onto rig
- ⑦ Fire and gas system did not prevent hydrocarbon ignition

Blowout preventer did not seal the well

- ⑧ Blowout preventer (BOP) emergency mode did not seal well
