## Chapter 4.6 | Negative Pressure Test

The negative pressure test performed at Macondo showed repeatedly over a three-hour period that the well lacked integrity and that the cement had failed to seal off the hydrocarbons in the pay zone. BP well site leaders, in consultation with Transocean rig personnel, nevertheless mistakenly concluded that the test had demonstrated well integrity and then proceeded to the next phase of temporary abandonment.

The Chief Counsel's team finds that the failure to properly conduct and interpret the negative pressure test was a major contributing factor to the blowout.

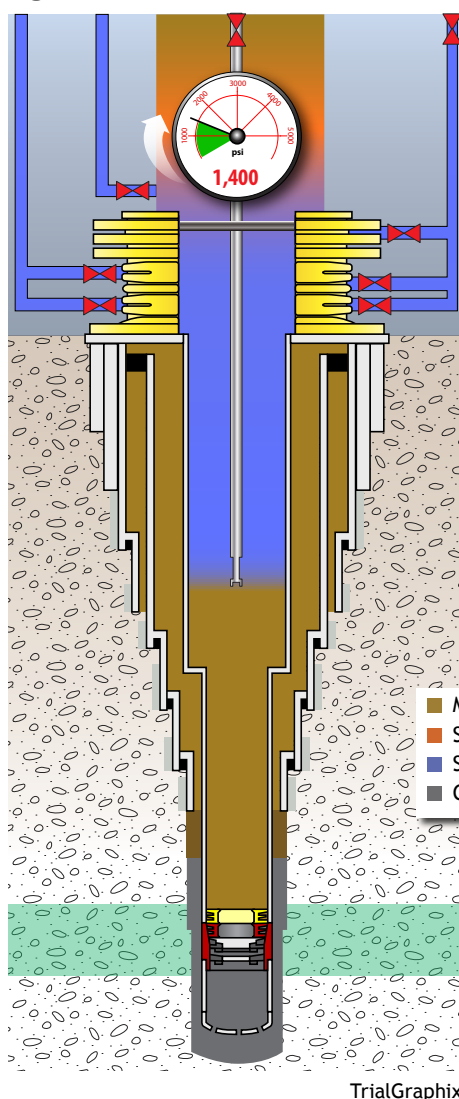
**Figure 4.6.7. First test failure.**

All parties now agree that this 1,400 psi pressure reading indicated that the well had failed the negative pressure test and that the cement job would not prevent hydrocarbons in the pay zones from entering the well.<sup>7</sup> The 1,400 psi pressure was the pressure of the hydrocarbon-bearing pay zone that was not properly sealed off by the primary cement.

During the first negative pressure test, the crew repeatedly bled the drill pipe pressure down to 0 psi. However, more fluids bled than expected, and the drill pipe pressure repeatedly increased. After the last bleed, the drill pipe pressure rose from 0 to 1,400 psi, a clear failure.

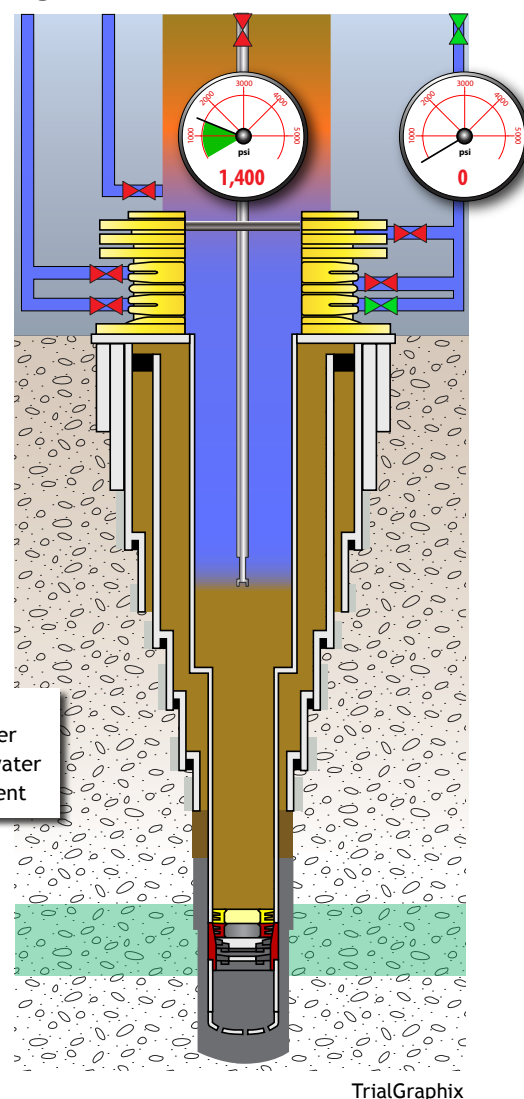
**Figure 4.6.8. Second test failure.**

During the second negative pressure test, the crew bled off the pressure in the kill line, rather than the drill pipe. The crew observed no excessive flow or pressure buildup on the kill line. The well site leaders and rig crew decided this was a successful test. But they had never accounted for the pressure on the drill pipe, which remained at 1,400 psi throughout the second test.

*The well site leaders and rig crew never adequately accounted for that elevated pressure in the drill pipe.*

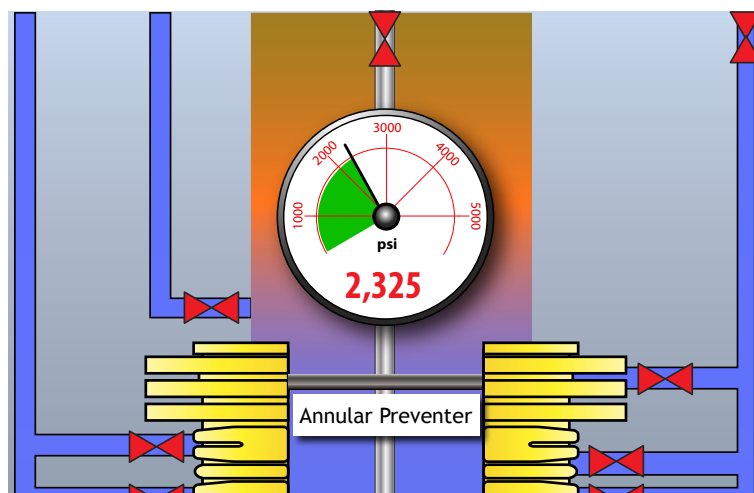
**Figure 4.6.11. 4:53 p.m.**

The crew closed the annular preventer around the drill pipe. The drill pipe pressure was approximately 700 psi higher than should have been expected, a sign that some spacer may have remained beneath the BOP.

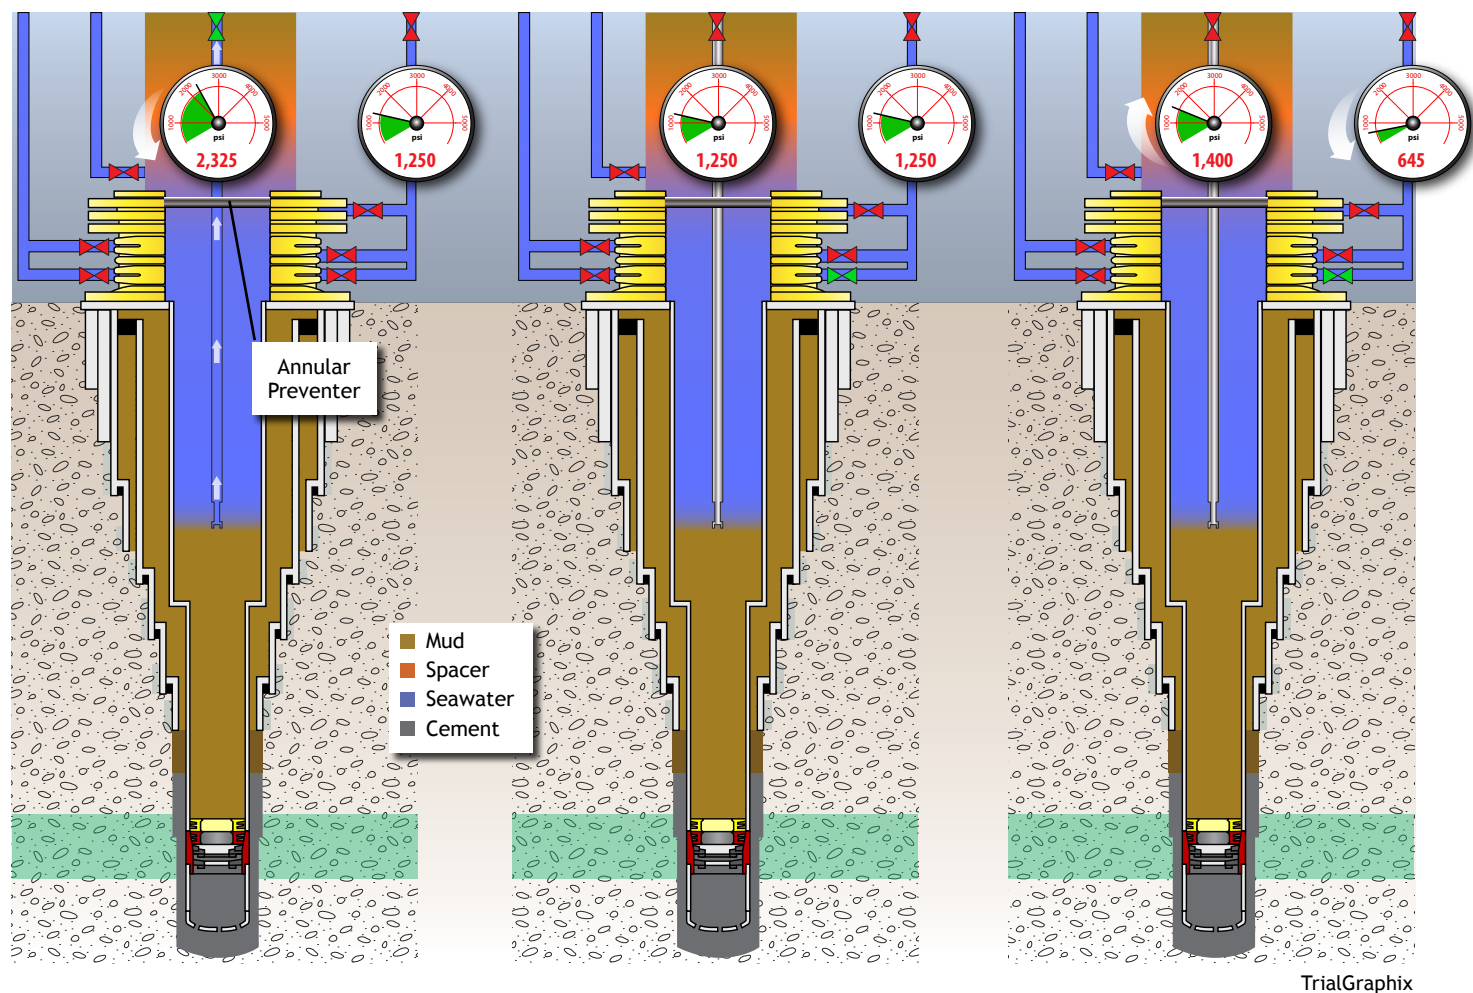
**Figure 4.6.12. 4:55 p.m.**

After the annular preventer was closed (left) the crew bled down the pressure in the drill pipe to equalize its pressure with the pressure in the kill line. Because both the drill pipe and the kill line go to the same vessel, when the valve connecting the kill line to the BOP is opened, the pressures should remain equal (middle). Instead, when the valve was opened, the pressures diverged (right).

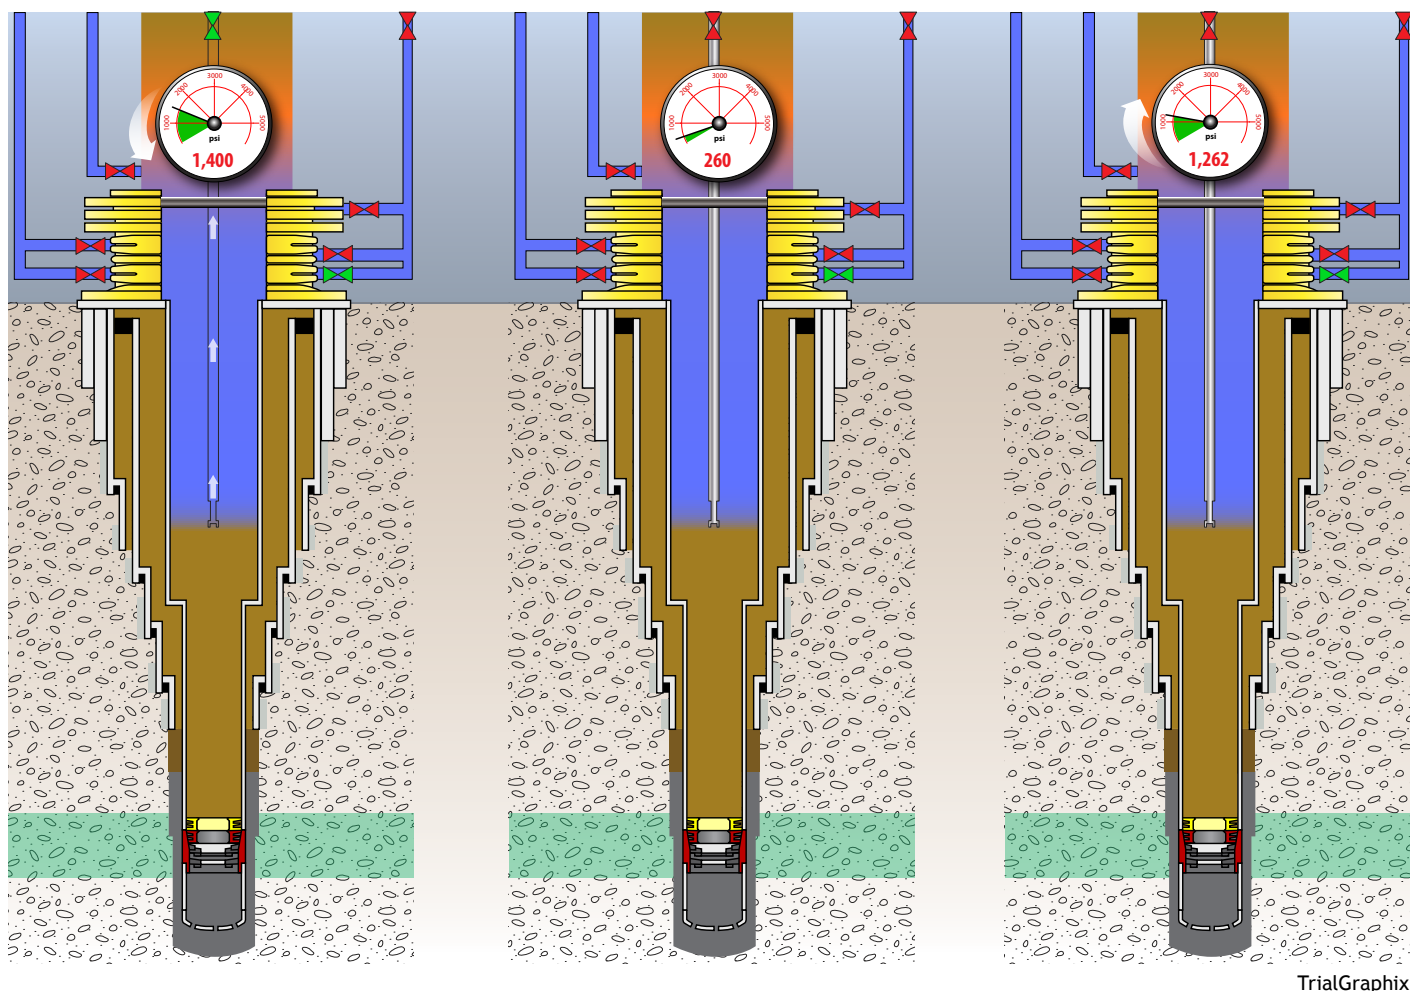
**Figure 4.6.13. 4:58 p.m.**

The crew began the negative pressure test by attempting to bleed the drill pipe pressure to 0 psi (left). However, the crew was unable to reduce pressure to below 260 psi (middle). This bleed returned an unknown amount of water to the rig. The crew shut in the drill pipe, and the pressure built up to 1,262 psi (right). In a successful negative pressure test, pressure does not build up.

As one independent expert has pointed out, this series of events actually constituted a failed negative pressure test, although the crew did not recognize that fact.<sup>40</sup>

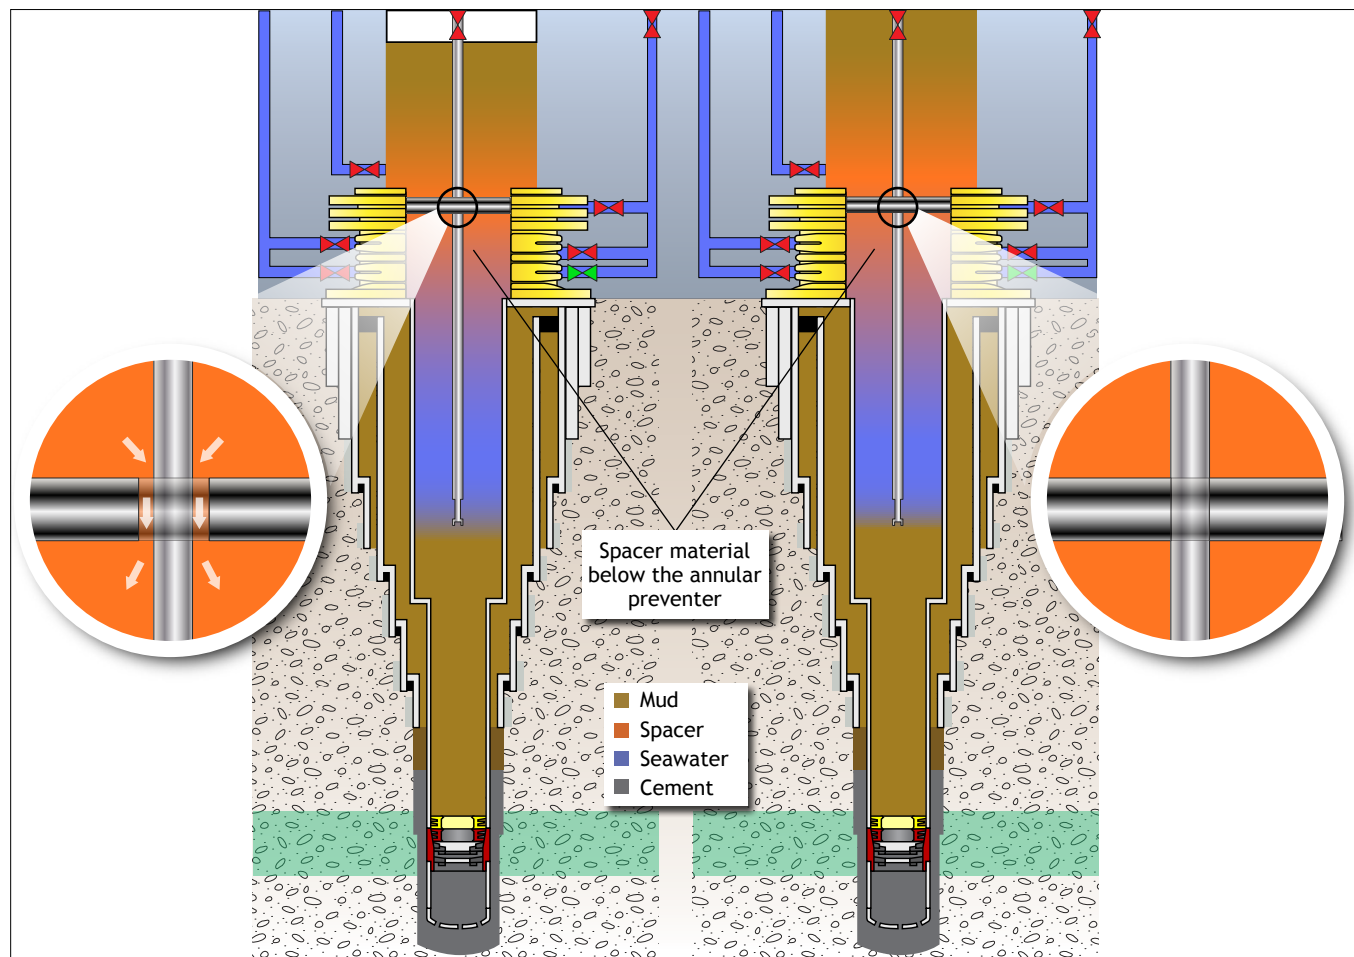
**Figure 4.6.14. 5:10 p.m.**

The rig crew noticed that the fluid level in the riser was falling. Because the annular preventer was not sufficiently tight around the drill pipe, spacer fell beneath the BOP (left). In response, the rig crew tightened the seal of the annular preventer and refilled the riser (right), but did not circulate the spacer back above the BOP.

At 5:10 p.m., the rig crew apparently noticed that the level of fluid in the riser was falling.<sup>41</sup> Spacer in the riser was leaking down through the annular preventer and into the well below the BOP.<sup>42</sup> Unlike many other indications, the crew could observe the fluid levels in the riser with their own eyes. When one rig crew member arrived on the rig floor, he saw others standing around the rotary table and using a flashlight to peer down into the riser to see how much fluid was missing.<sup>43</sup>

In response to the dropping levels of fluid in the riser, Harrell instructed the rig crew to tighten the seal of the annular preventer against the drill pipe as shown in Figure 4.6.14. Wyman Wheeler, the Transocean toolpusher on duty at the time, then topped off the riser with 20 to 25 barrels of mud, and the fluid level in the riser stayed steady.<sup>46</sup> The crew had thus identified and eliminated a leak in the well system that could have explained the anomalous pressure readings they had seen and their inability to bleed the drill pipe pressure to 0 psi.<sup>47</sup> By this time Kaluza returned to the rig floor.<sup>48</sup>

Despite clear evidence that spacer had probably leaked below the BOP, rig personnel again did nothing to ensure that they had fully displaced the spacer above the BOP and instead proceeded with the test.<sup>49</sup>

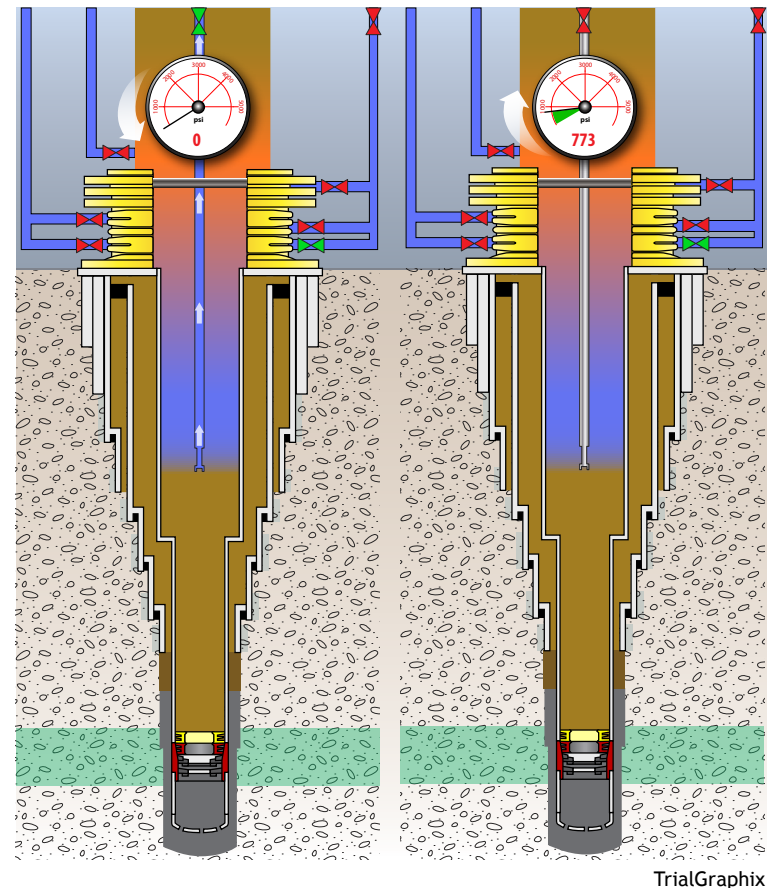
**Figure 4.6.15. 5:26 p.m.**

This second series of bleed-offs, excessive flows, and pressure buildups constituted another failed “negative pressure test” that the crew again did not recognize as such. With the annular preventer fully closed and sealed, the only explanation for the excessive returns and pressure increase would be that the primary cement job had failed to seal off the pay zone. Hydrocarbons were leaking from the formation into the well. Individuals involved in the test at this point should have recognized that the well lacked integrity.

The rig crew attempted again, this time successfully, to bleed the drill pipe pressure down to 0 psi. Fifteen barrels of seawater were returned during this bleed (left). The drill pipe was shut in, but the drill pipe pressure rose to 773 psi. Fifteen barrels is a higher return than should have been expected, and the drill pipe pressure should not have built back up.

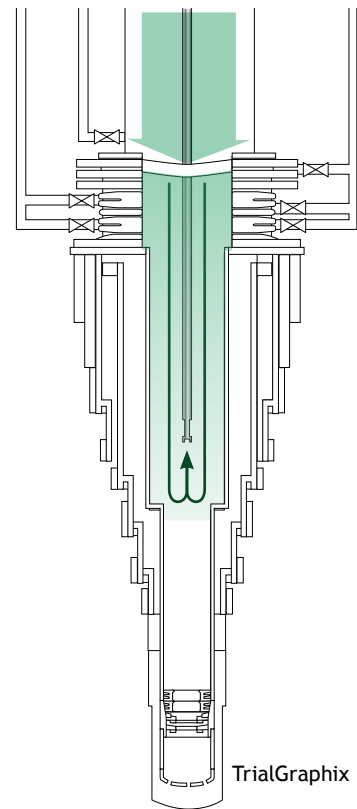
**Figure 4.6.17**

According to notes from BP's post-incident interviews of Kaluza and Vidrine, as well as testimony from Lambert, Anderson explained that the 1,400 psi pressure on the drill pipe was being caused by a "bladder effect" or "annular compressibility."<sup>65</sup> According to Lambert, Anderson explained that "heavier mud in the riser would push against the annular and transmit pressure into the wellbore, which in turn you would expect to see up the drill pipe," as illustrated in Figure 4.6.17.<sup>66</sup>

The Chief Counsel's team found no evidence to support this theory. Indeed, every industry expert that the Chief Counsel's team spoke with agreed that no such phenomenon exists. Even if it did exist, any pressure caused by this "bladder effect" would have disappeared after the rig crew bled off the drill pipe and kill line.<sup>67</sup>

**Bladder Effect.** This figure represents the Chief Counsel's team's understanding of the "bladder effect" theory that supposedly explained the elevated pressure on the drill pipe. The "bladder effect" explanation contends that heavy fluids (mud and spacer) displaced to the riser were exerting force on the annular preventer from above, which in turn communicated pressure into the well. The Chief Counsel's team found no evidence to support this theory.

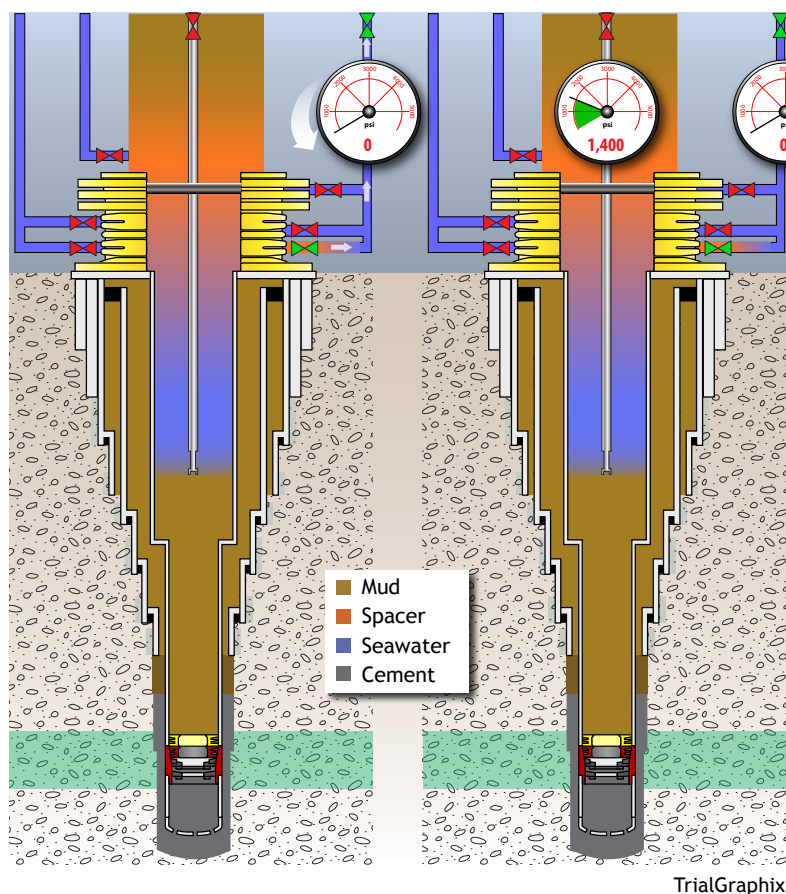
**Figure 4.6.18. 6:40 p.m.**

The rig crew conducted a negative pressure test on the kill line. The rig crew reduced the pressure on the kill line to 0 psi, bleeding an insignificant amount of water (left). No flow or pressure buildup was observed on the kill line, which on its own would have been a successful negative pressure test. However, the 1,400 psi on the drill pipe remained and was never properly accounted for (right).

The second negative pressure test showed again that the well lacked integrity. The 1,400 psi reading from the drill pipe indicated that hydrocarbons were leaking into the well. The fact that the kill line pressure was 0 psi at this time suggests that something may have been blocking fluids from flowing through the kill line and transmitting pressure to the gauges on the rig. One possibility, alluded to earlier, is that the spacer below the BOP had migrated into the 3 $\frac{1}{16}$ -inch

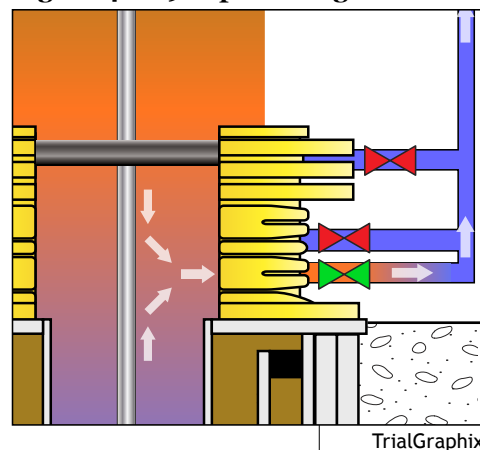
**Figure 4.6.19. Spacer migration.**

Leftover lost circulation material used as spacer for the negative pressure test could have migrated into the kill line during bleeds.

diameter kill line and clogged it.<sup>90</sup> It is also possible that rig crews accidentally closed a valve that should have been open. The kill line could also have been clogged by undisplaced mud in the kill line or by gas hydrates that solidified during the test (the same type of hydrates that complicated containment operations).<sup>91</sup> The exact reason may never be known.
