Project Quality Audit

Project: Tengah garden walk (TGW)

Audit Date: 30-Aug-2023

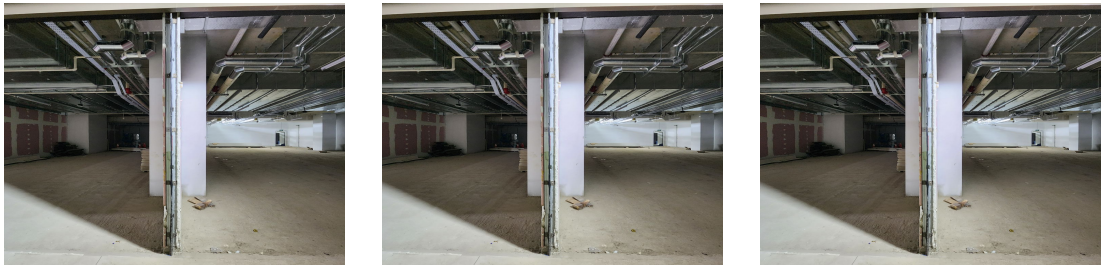
4	<p>B2 - Gap between door frame and dyntek stiffener were filled up with AAC block to make up the big gap. Door frame brackets were observed to be secured to the AAC blocks, which is a concern as AAC blocks are non-load bearing, potentially posing as a safety concern.</p>

<p>Severity: 3 Frequency: 1 Points: 30</p>

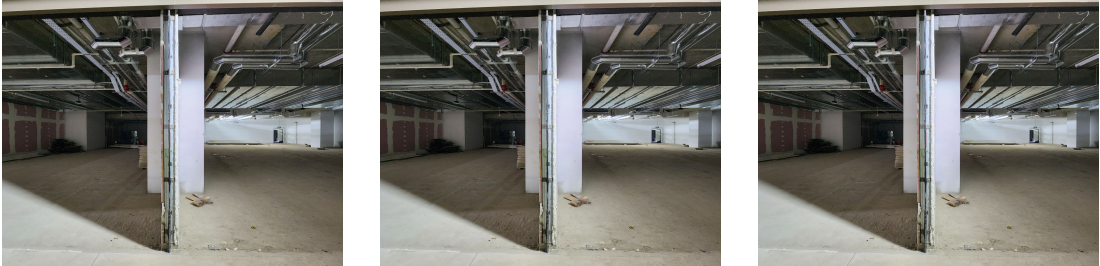
S/N	Findings	
5	<p>B2 - Additional aluminium plate attached to drywall frame, which differs from original detail where a hollow section support is present. May cause a compromise on the integrity of the drywall frame, as it may not be designed for additional load. To verify suitability and obtain approval.</p>

<p>Severity: 2 Frequency: 3 Points: 10</p>
6	<p>B2 - Rubbish and debris found within the cistern compartment. To clear the debris and call for inspection clearance prior to closure.</p>

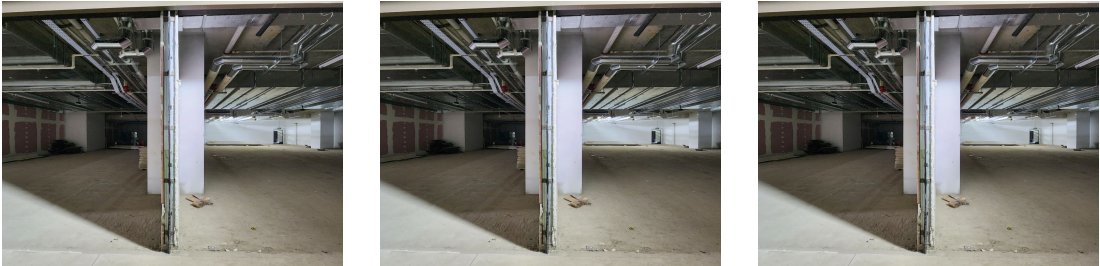
<p>Severity: 1 Frequency: 1 Points: 45</p>
7	<p>B1 Zone A - Absence of mesh observed at upper half height of ALC panel, which may lead to formation of cracks on the finishes eventually. Recommended for mesh to be completed in one operation after the installation of the panels, to avoid missing out.</p>

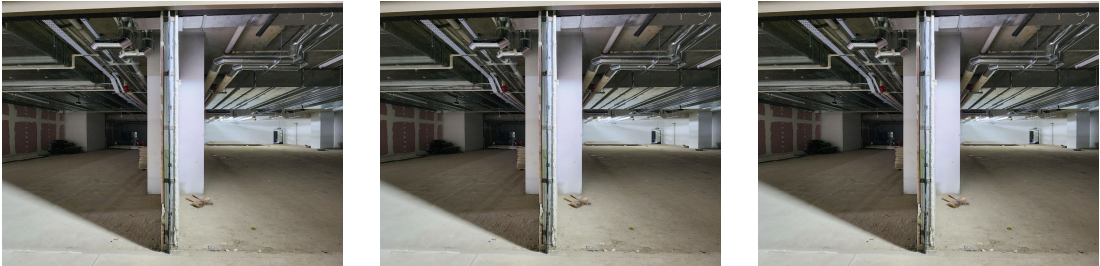
<p>Severity: 1 Frequency: 2 Points: 40</p>
8	<p>B1 Zone A - Absence of mesh observed at upper half height of ALC panel, which may lead to formation of cracks on the finishes eventually. Recommended for mesh to be completed in one operation after the installation of the panels, to avoid missing out.</p>

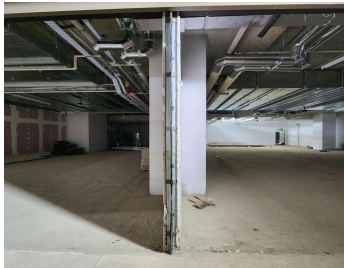
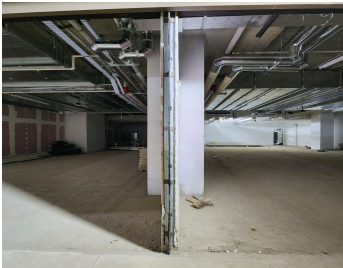
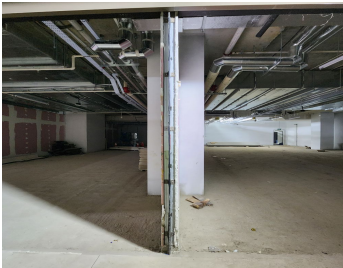
S/N	Findings	
9	<p>B1 Zone A - Absence of mesh observed at upper half height of ALC panel, which may lead to formation of cracks on the finishes eventually. Recommended for mesh to completed in one operation after the installation of the panels, to avoid missing out.</p> <div>

</div>	<p>Severity: 1 Frequency: 2 Points: 40</p>
10	<p>B1 Zone A - Absence of mesh observed at upper half height of ALC panel, which may lead to formation of cracks on the finishes eventually. Recommended for mesh to completed in one operation after the installation of the panels, to avoid missing out.</p> <div>
