Detailed Diagnosis Re

July 24, 2023

Flat No-8/63, Yamuna CHS,
Kamdhenu, Hari Om
Nagar,Mulund East, Mumbai-
400081

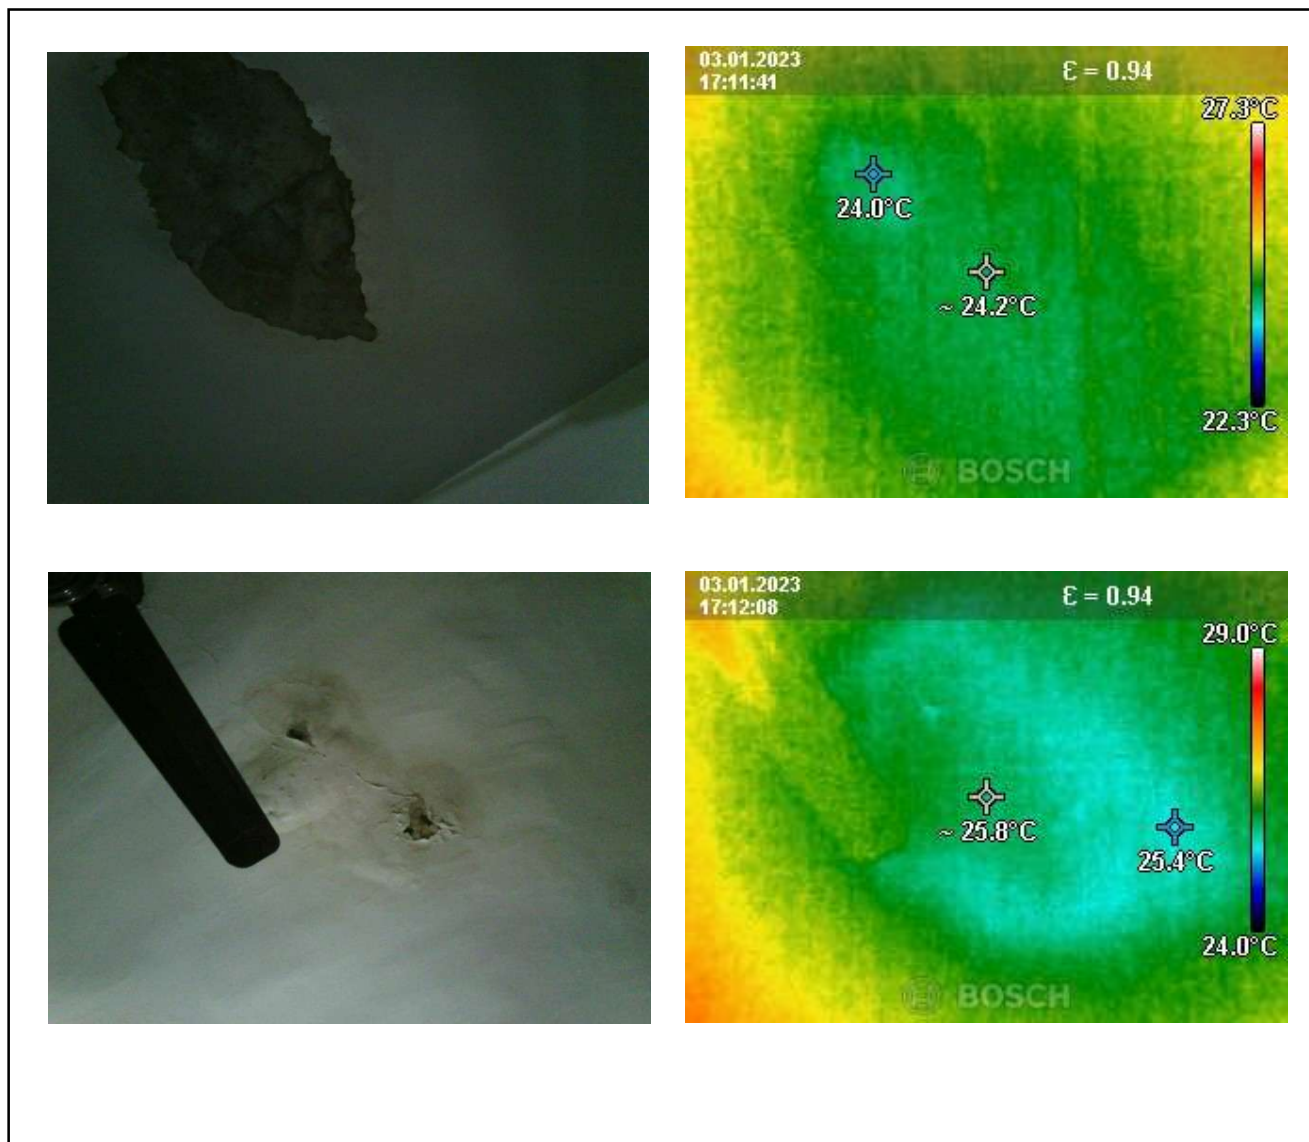
4.4.1 CEILING (HALL)

| Point No | Impacted area (-ve side) | Point No | Exposed area (+ve side) |
|---|---|---|--|
| 4.4.1 | Observed dampness, efflorescence and spalling of paint at the ceiling of Hall (Ground Floor). | 4.5.1 | Observed hollowness & gaps between the tile joints of Master Bedroom Bathroom of 1 st Floor. |

IMAGE 1: DAMPNESS, EFFLORESCENCE & SPALLING OF PAINT AT THE CEILING OF HALL (GROUND FLOOR)

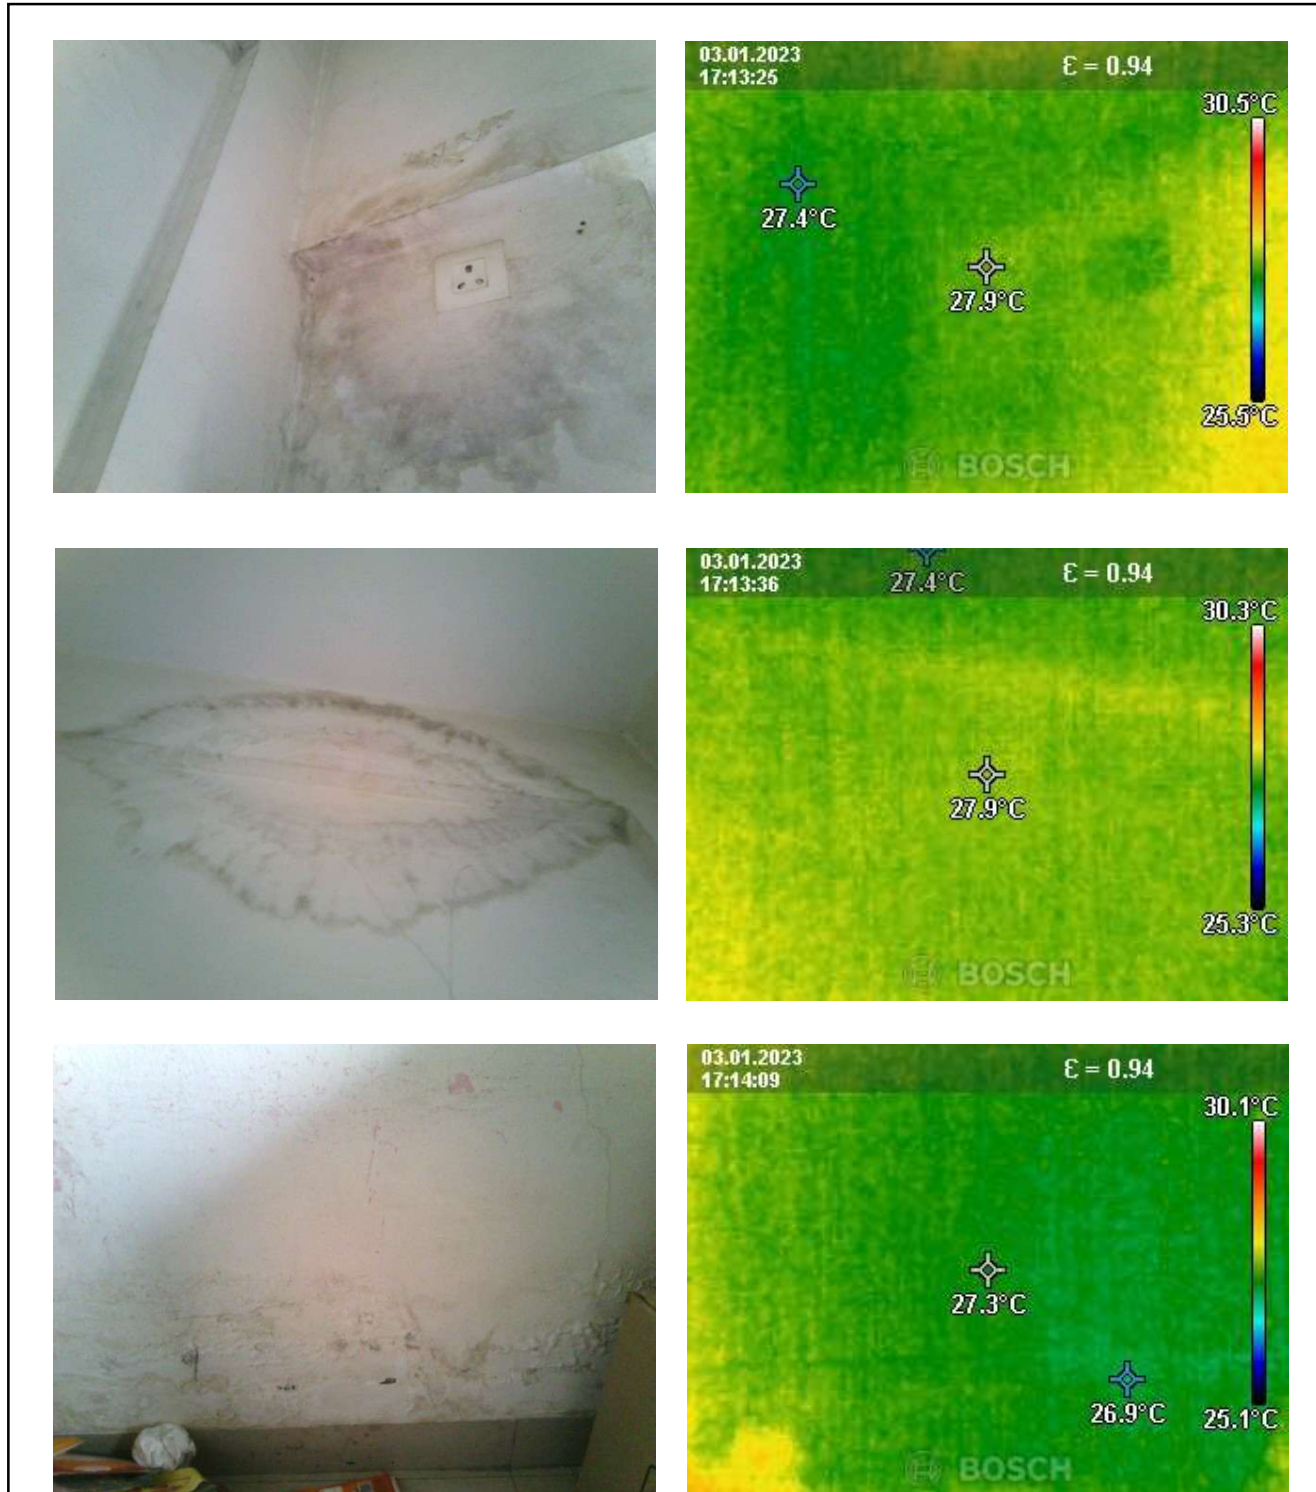
4.4.2 SKIRTING AND CEILING-WALL CORNER (BEDROOM)

| Point No | Impacted area (-ve side) | Point No | Exposed area (+ve side) |
|---|---|---|--|
| 4.4.2 | Observed dampness at the skirting level & wall corner of Bedroom (Ground Floor). | 4.5.2 | Observed cracks on the External wall of the Bedroom. |

IMAGE 2: DAMPNESS AT THE SKIRTING LEVEL & WALL CORNER OF BEDROOM (GROUND FLOOR).

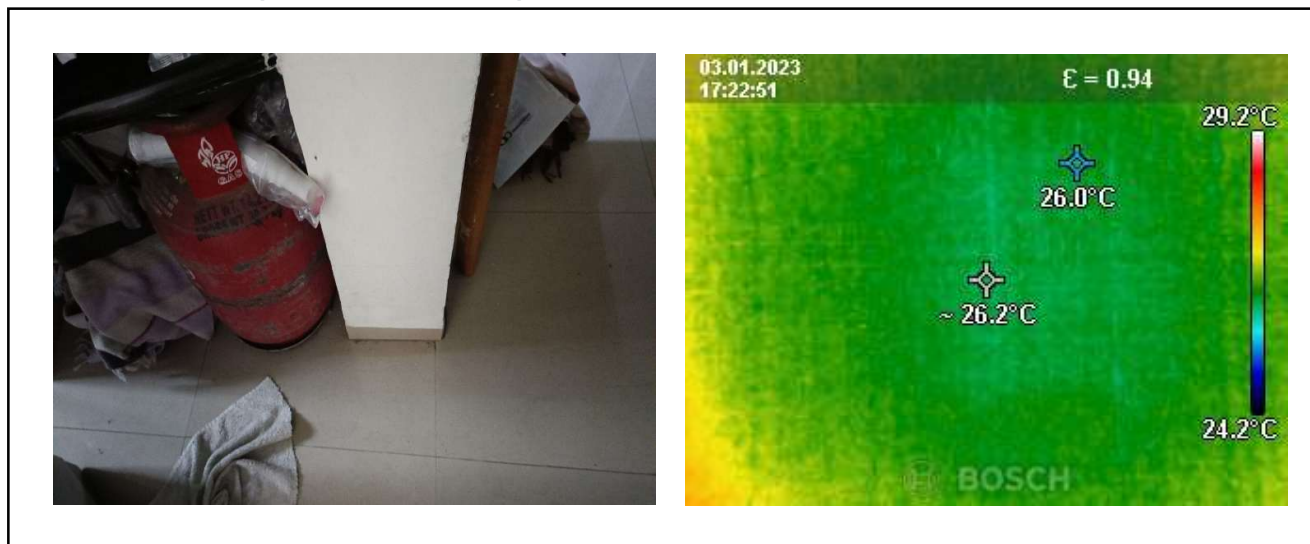
4.4.3 SKIRTING LEVEL (PASSAGE AREA)

| Point No | Impacted area (-ve side) | Point No | Exposed area (+ve side) |
|---|---|---|--|
| 4.4.3 | Observed mild seepage at the skirting level of Common Bathroom Passage Area (Ground Floor) | 4.5.3 | Observed gaps between the tile joints of the Common Bathroom (Ground Floor) |

IMAGE 3: MILD SEEPAGE AT THE SKIRTING LEVEL OF COMMON BATHROOM PASSAGE AREA (GROUND FLOOR)

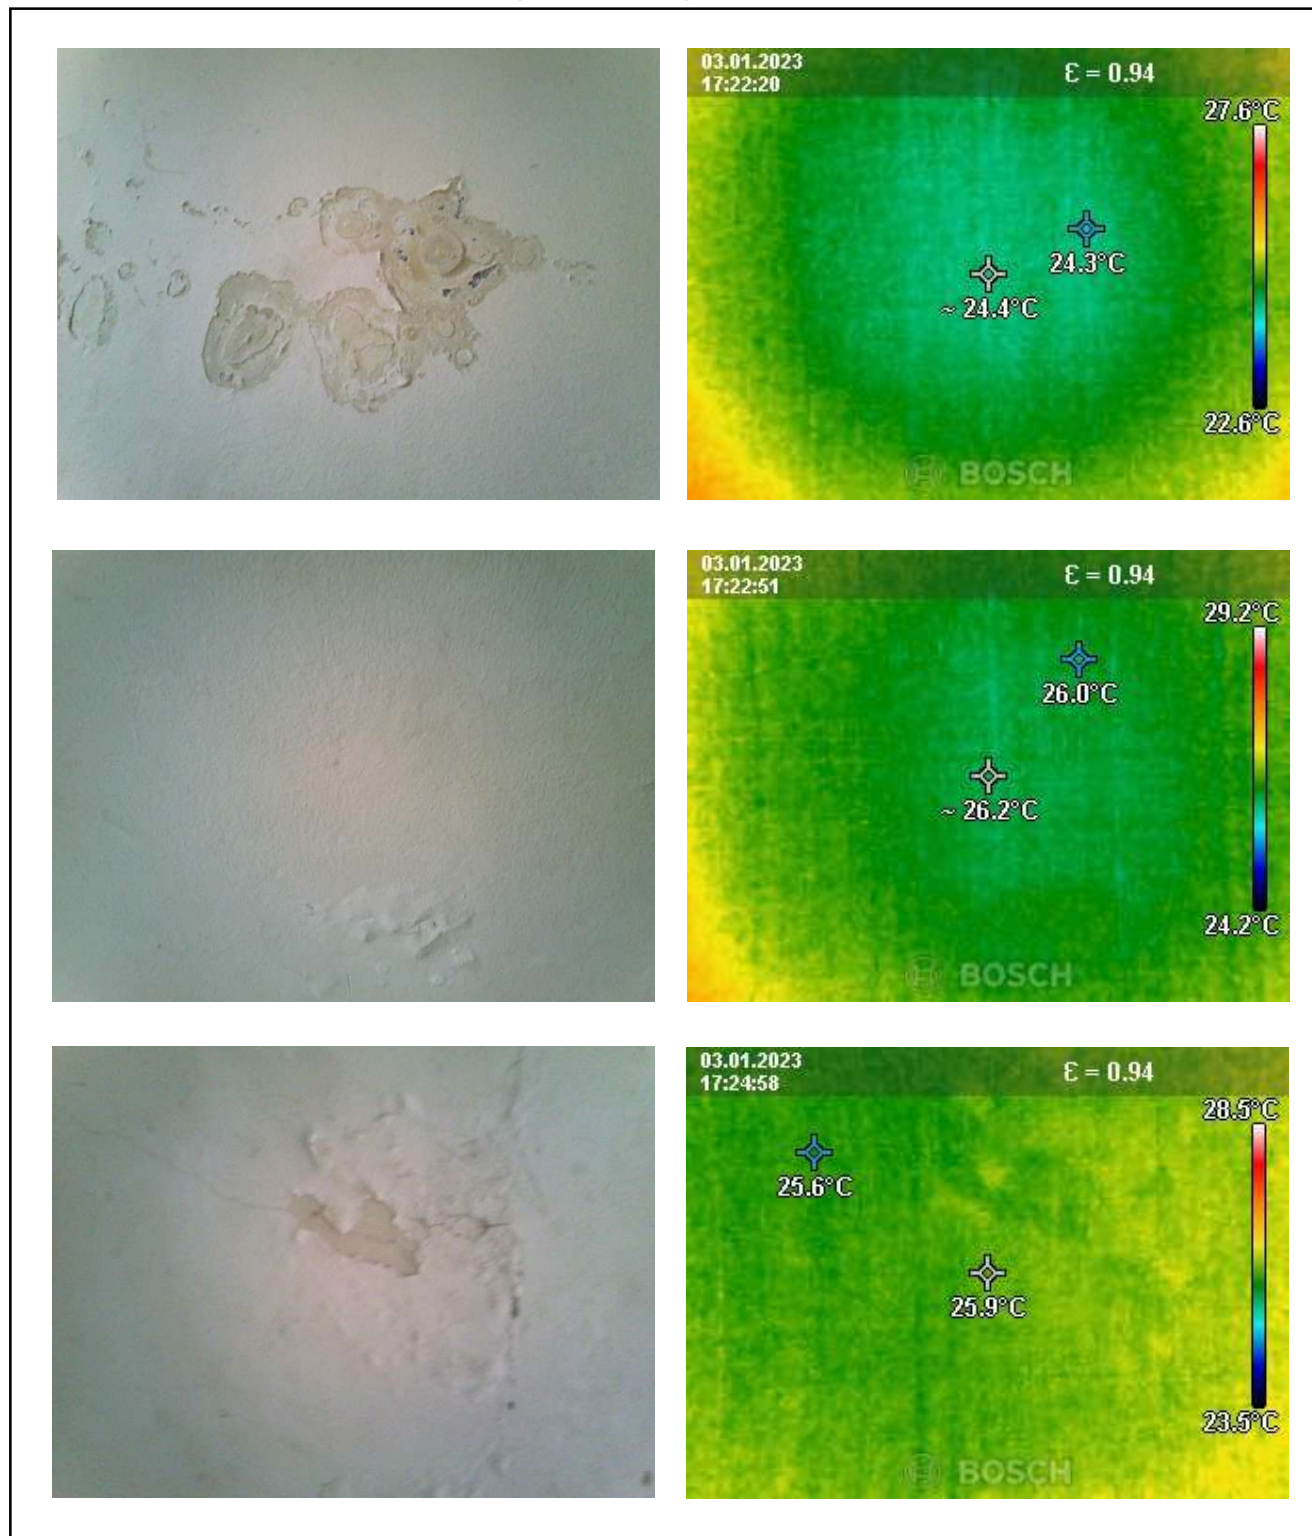
4.4.4 STAIRCASE AREA

| Point No | Impacted area (-ve side) | Point No | Exposed area (+ve side) |
|---|---|---|--|
| 4.4.4 | Observed dampness at the wall surface of Staircase Area. | 4.5.4 | Observed hollowness & gaps between the tile joints of Open Balcony. Cracks have been observed on External wall of Balcony. |

IMAGE 4: DAMPNESS & PAINT SPALLING AT SKIRTING LEVEL & AREA NEAR THE WINDOW IN MASTER BEDROOM (1ST FLOOR).

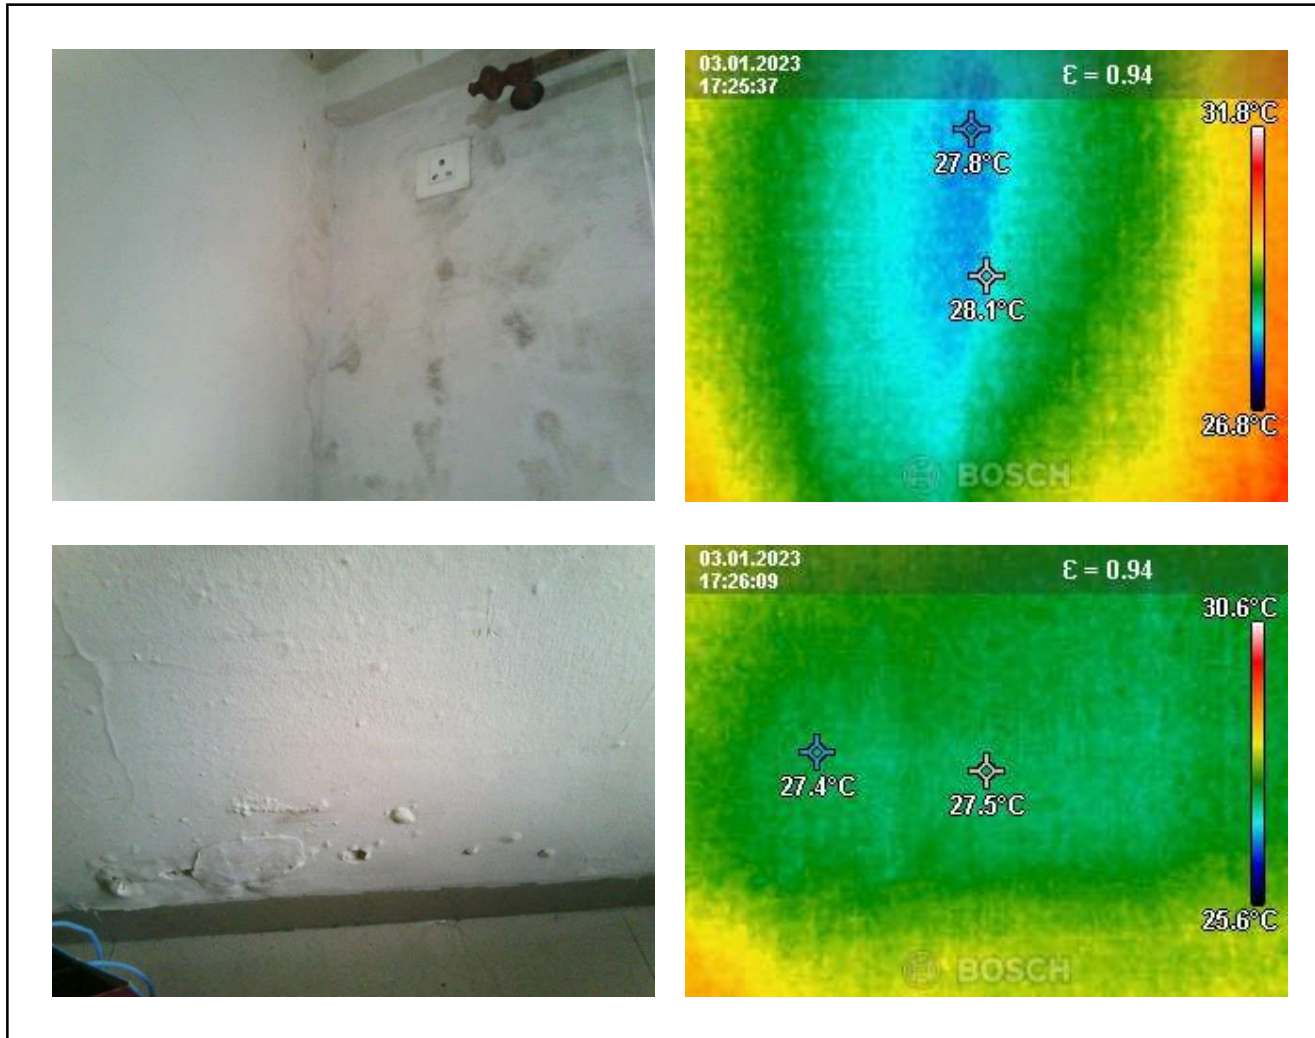
4.4.5 SKIRTING LEVEL (MASTER BEDROOM)

| Point No | Impacted area (-ve side) | Point No | Exposed area (+ve side) |
|---|---|---|--|
| 4.4.5 | Observed dampness & paint spalling at skirting level & area near window in Master Bedroom (1 st Floor) | 4.5.5 | Observed cracks on External wall of Master Bedroom Wall & gaps between the tile joints of Master Bedroom Bathroom. |

IMAGE 5: DAMPNESS & PAINT SPALLING AT SKIRTING LEVEL & AREA NEAR WINDOW IN MASTER BEDROOM (1ST FLOOR).

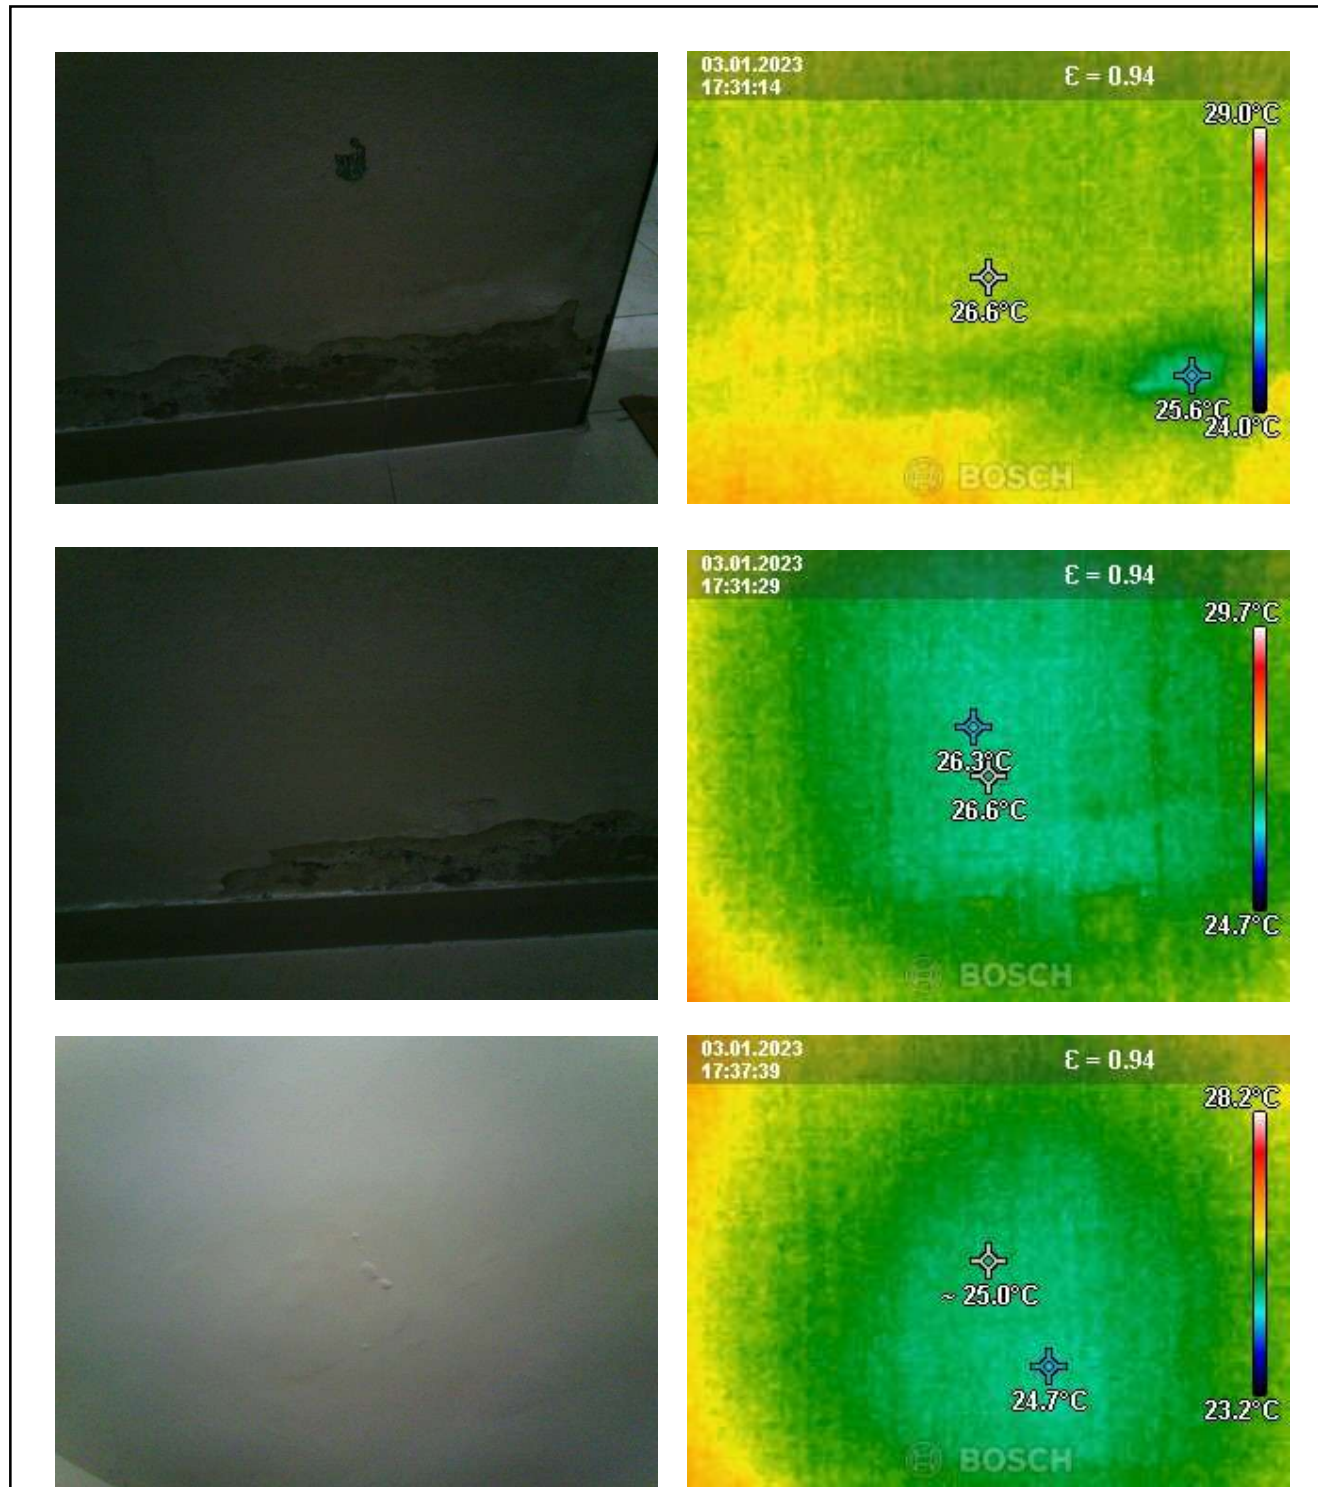
4.4.6 SKIRTING LEVEL AND CEILING OF MASTER BEDROOM -2(1ST FLOOR)

| Point No | Impacted area (-ve side) | Point No | Exposed area (+ve side) |
|---|---|---|--|
| 4.4.6 | Observed dampness & paint spalling at skirting level & ceiling in Master Bedroom – 2 (1 st Floor) | 4.5.6 | Observed gaps between the tile joints of Master Bedroom – 2 Bathroom & Vegetation Growth on Terrace Surface + Hollowness on Terrace Surface. |

IMAGE 6: DAMPNESS & PAINT SPALLING AT SKIRTING LEVEL & CEILING IN MASTER BEDROOM - 2 (1ST FLOOR)

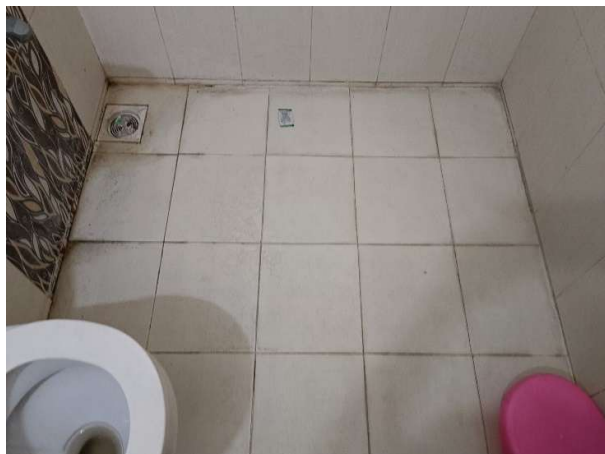
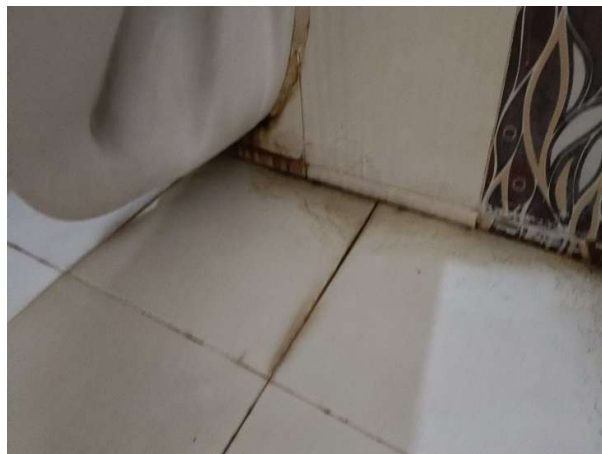
4.5.1 MASTER BEDROOM BATHROOM (1ST FLOOR)

Gaps were observed between the tile joints of the Master bedroom Bathroom of first floor. Unless these gaps are repaired immediately a similar leakage will happen at the ceiling and skirting level near Master Bedroom Bathroom and ground floor ceiling.

IMAGE 7: GAPS IN TILE JOINTS OF MASTER BEDROOM BATHROOM (1ST FLOOR)

Clean the surface. Cut the joints into v shape with electric cutter, fill the joints using liquid polymer modified mortar made up of Dr. Fixit URP so that it will reach to the cracks developed below the tiles. After the initial set of grouts, clean the surface with a clean cloth. Further fill the RTM grout into the tile joints and patch the joints. Outlets and corners to be patched with PMM made of Dr. Fixit URP. Let the entire system air cure for 24-48 hours.

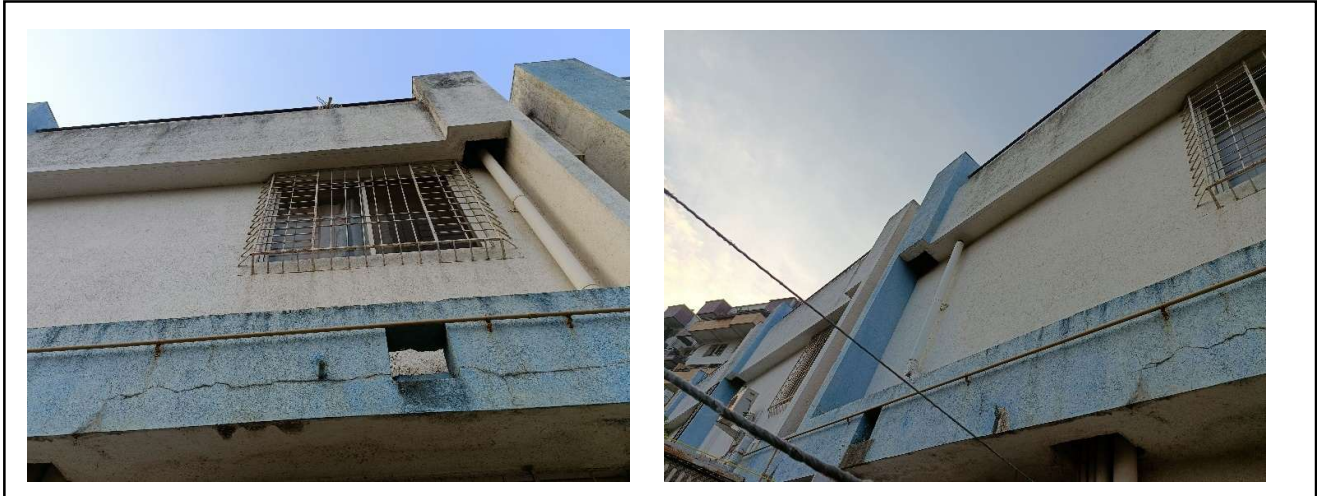
4.5.2 EXTERNAL WALL

Cracks observed on the external wall of bedroom. Through which water is ingressing inside the wall causing dampness at the skirting level and wall corner of bedroom.

IMAGE 8: CRACKS ON EXTERNAL WALL

Cracks to be opened in V shape groove, filling with heavy duty polymer mortars. Any spalling of concrete is treated using heavy duty mortar such as Dr Fixit HB. Any exposed-corroded re-enforced steel to be treated using jacketing & support by following standardized strengthening of RCC members.

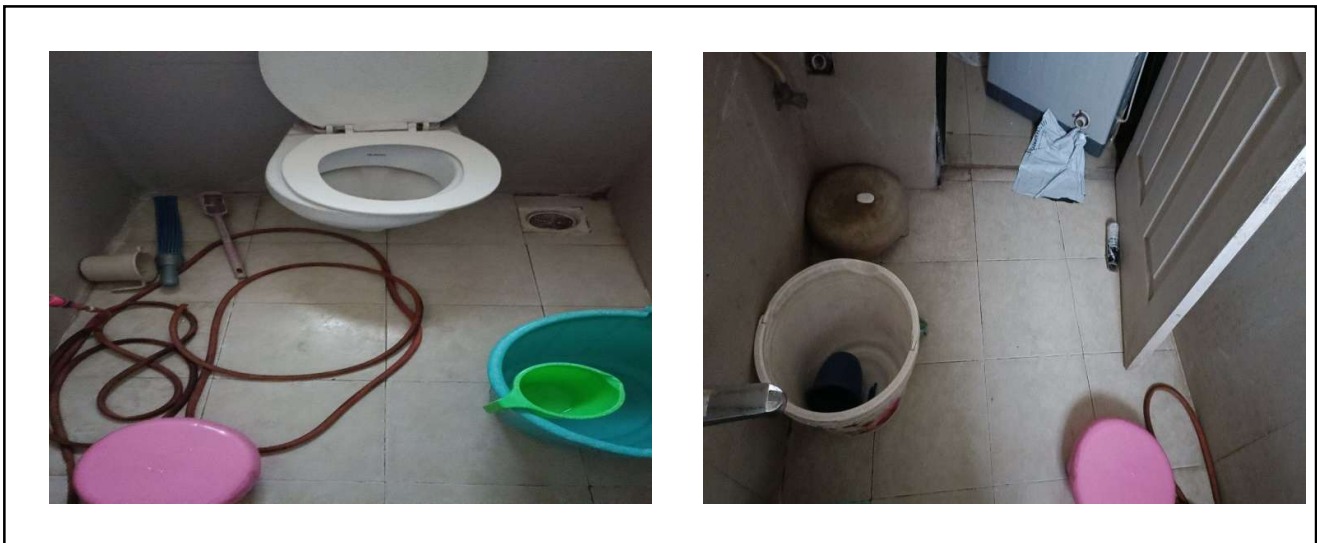
4.5.3 COMMON BATHROOM

IMAGE 9: GAPS BETWEEN TILE JOINTS OF COMMON BATHROOM

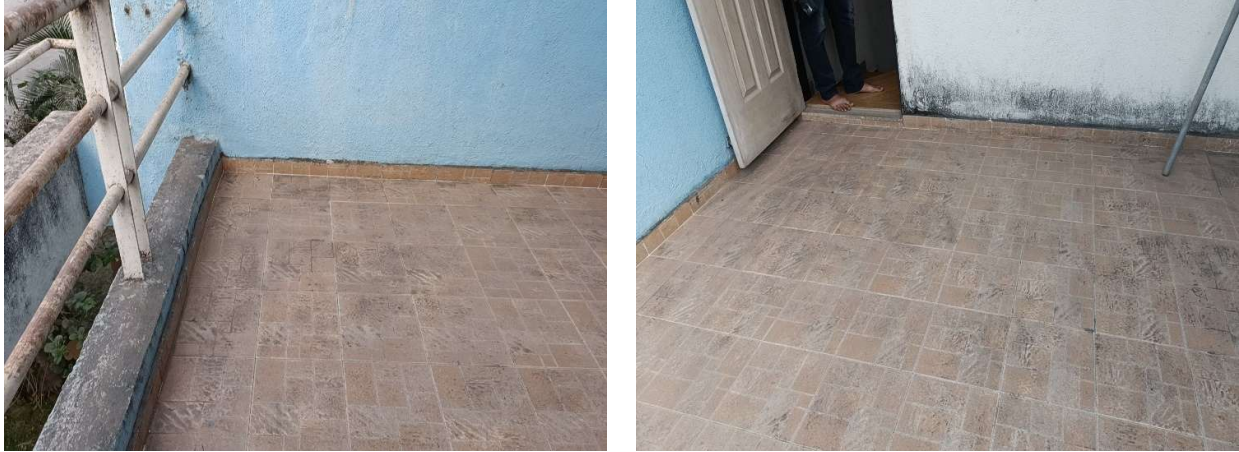
4.5.4 OPEN BALCONY

IMAGE 10: GAPS BETWEEN TILE JOINTS OF BALCONY

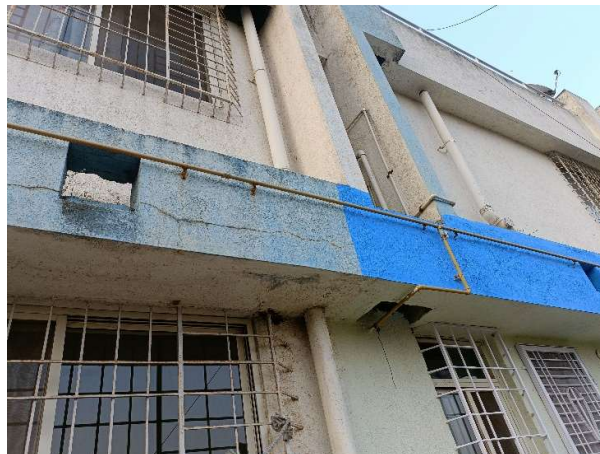
4.5.5 EXTERNAL WALL

IMAGE 11: CRACKS ON EXTERNAL WALL OF MASTERBEROOM

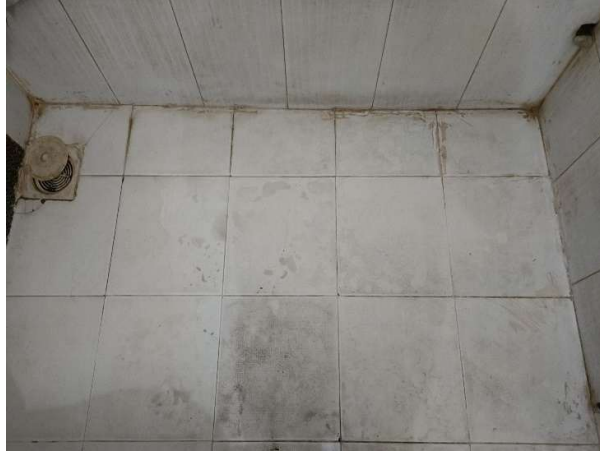
4.5.6 TERRACE AND MASTER BEDROOM-2 BATHROOM

| 11 | Hollow surface condition identified & checked by Nylon hammer | | ✓ | | Soundness of the surface was checked on terrace surface by tapping a lightweight hammer. Hollow sound was observed at many locations on the roof terrace. |
| 15 | Growth of Vegetation | | ✓ | | Observed vegetation growth at many locations. |

IMAGE 12: HOLLOWNESS AND VEGETATION GROWTH OBSERVED ON TERRACE SURFACE, GAPS OBSERVED BETWEEN TILE JOINTS OF BATHROOM IN MASTERBEDROOM-2
