Power Quality Disturbance Analysis Report

Parameter	Value
Location	Main LT Panel (Incoming Feeder)
Sampling Frequency	10 kHz
Nominal Voltage	230 V
Event Type	Voltage Swell
Event Time	2025-06-21 14:27:55
Event Duration	140 ms
Amplitude Increase	230 V → 335 V
Recovery Time	160 ms

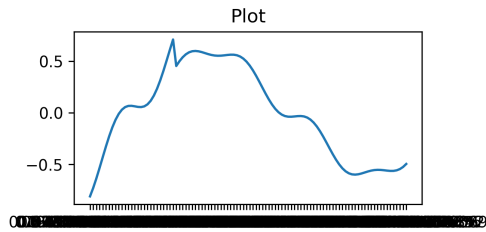
Graphical Snapshot

At 14:27:55 on June 21, 2025, a voltage swell was detected on the Main LT Panel (Incoming Feeder). The voltage increased from 230 V to 335 V, lasting for 140 milliseconds, and recovered within 160 milliseconds.

- **Swell Severity:** Moderate
- **Voltage Deviation:** Approximately 45.7% increase
- **Likely Causes:**
 - Sudden load reduction
 - Capacitor bank switching
 - Downstream fault clearing
- **System Impact:**
 - Potential damage to sensitive equipment due to overvoltage stress
 - Possible insulation breakdown in electrical components
- **Standards Compliance:**
 - Evaluate against IEEE Std 1159 recommended limits for swell duration and magnitude.

- Monitor the feeder for recurrence.
- Investigate any sudden load reductions or capacitor bank operations.
- Check for any recent fault clearing events in the downstream network.

- Consider installing surge protection devices (SPDs) or a voltage regulator.
- Evaluate capacitor bank switching practices.
- Ensure proper grounding and bonding throughout the electrical system.
