# ISEC2076

Assignment 1 - CPTED Physical Security Assessment

The subject of this security assessment is the property located at 3611 Commission St, Halifax, NS B3K 5P6. It is currently occupied by Kerr Controls Ltd, a wholesale distributor of heating, ventilation, air-conditioning, and refrigeration materials for residential and commercial markets. <https://kerrcontrols.ca/>

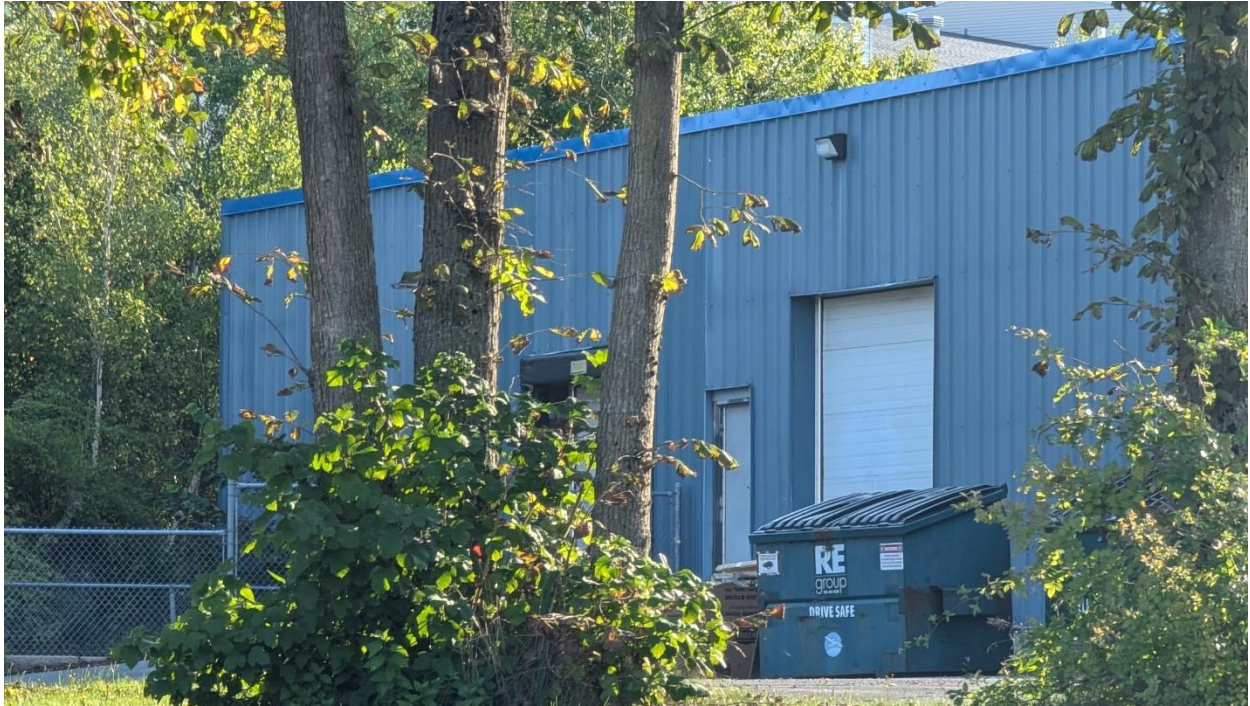
West side of building showing loading bays

- 8.2. There are a limited number of windows on that side of the building, allowing for some natural surveillance.
- 9. The West side of the building has a parking area and has access to the warehouse portion of the building, including three man-doors and two loading bays.
  - 9.1. The neighbouring property belongs to Wolseley Plumbing/HVAC and Happy Hounds Doggy Daycare.
  - 9.2. There are three lights on this side of the building that illuminate the parking lot.
- 10. A substantial number of windows near the front of this side of the building allows for good natural surveillance but the lack of windows near the back creates poor natural surveillance in that area.

7. The warehouse area should be divided into separate shipping and receiving areas, preferably with a dedicated cargo bay for each.
  - 7.1. If the warehouse is bonded, and secure area must be provided for bonded goods.

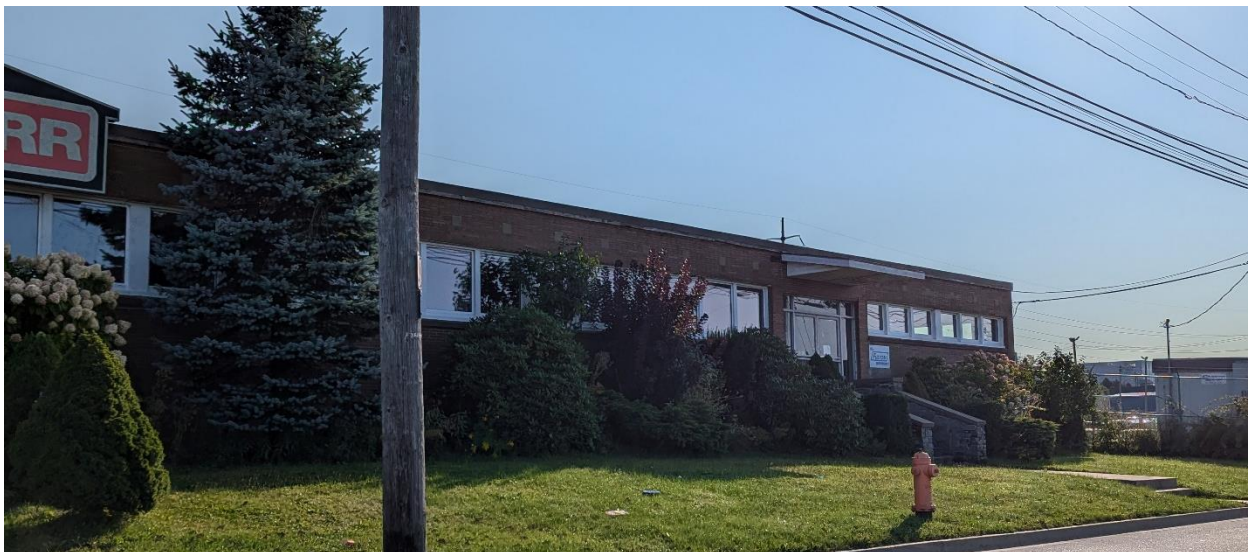
South side of building showing the office section

6. The south side of the building fronts on Commission St.
  - 6.1. The windows provide good natural surveillance.
  - 6.2. Barred gates inside the glass door provides good after-hours access control.

- 6.3. The front lawn is poorly distinguished from adjoining roadsides.
  - 6.4. Poorly groomed bushes create an eyesore and limit natural surveillance.

- 5.2. This, combined with appropriate door locks and alarms will create multiple layers of security.
6. On the South side, street-facing area, the bushes next to the building should be eliminated to increase natural surveillance.

- 6.1. A low hedge or planters should be planted next to the edge of the property to separate public from semi-public spaces.
  - 6.2. Windows should be treated with a reflective coating so that people can see out but not in. This will improve the perception of active surveillance.

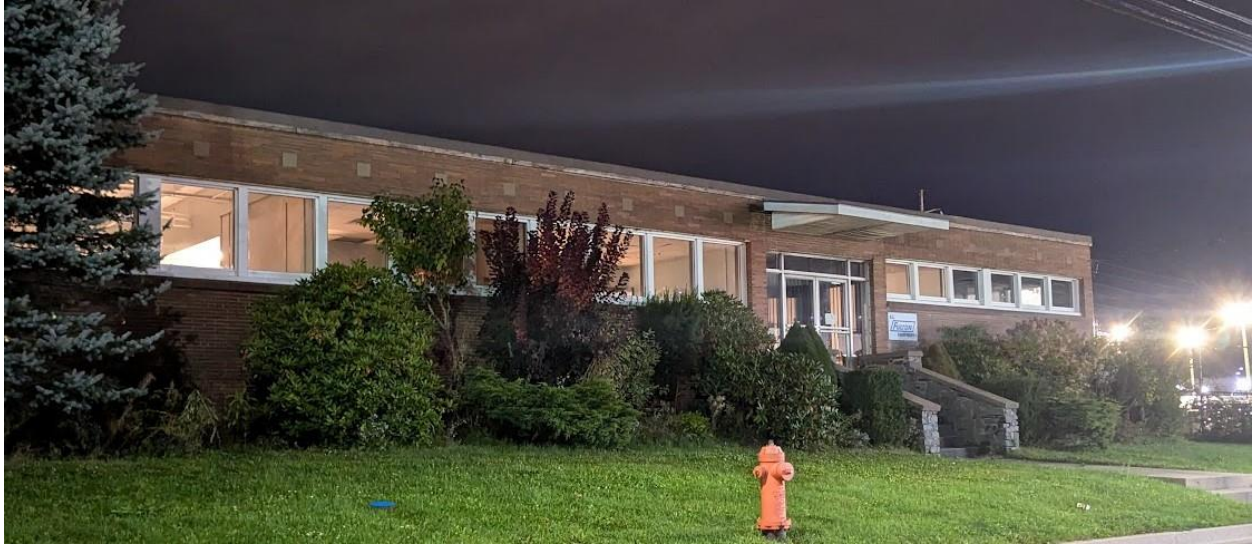
South side of building at night

- 6.5. The building is well lit from the street but has no lighting of its own on this side of the building.
7. The North side of the building backs onto a NS Power access road, separated by wooded area approximately 5 meters in width.

11. Proper lighting should be installed to illuminate the entire property to increase visibility. This would mean adding one light on the North and South sides, three lights on the East side, and three lights in the parking lot, as indicated on the diagram below.

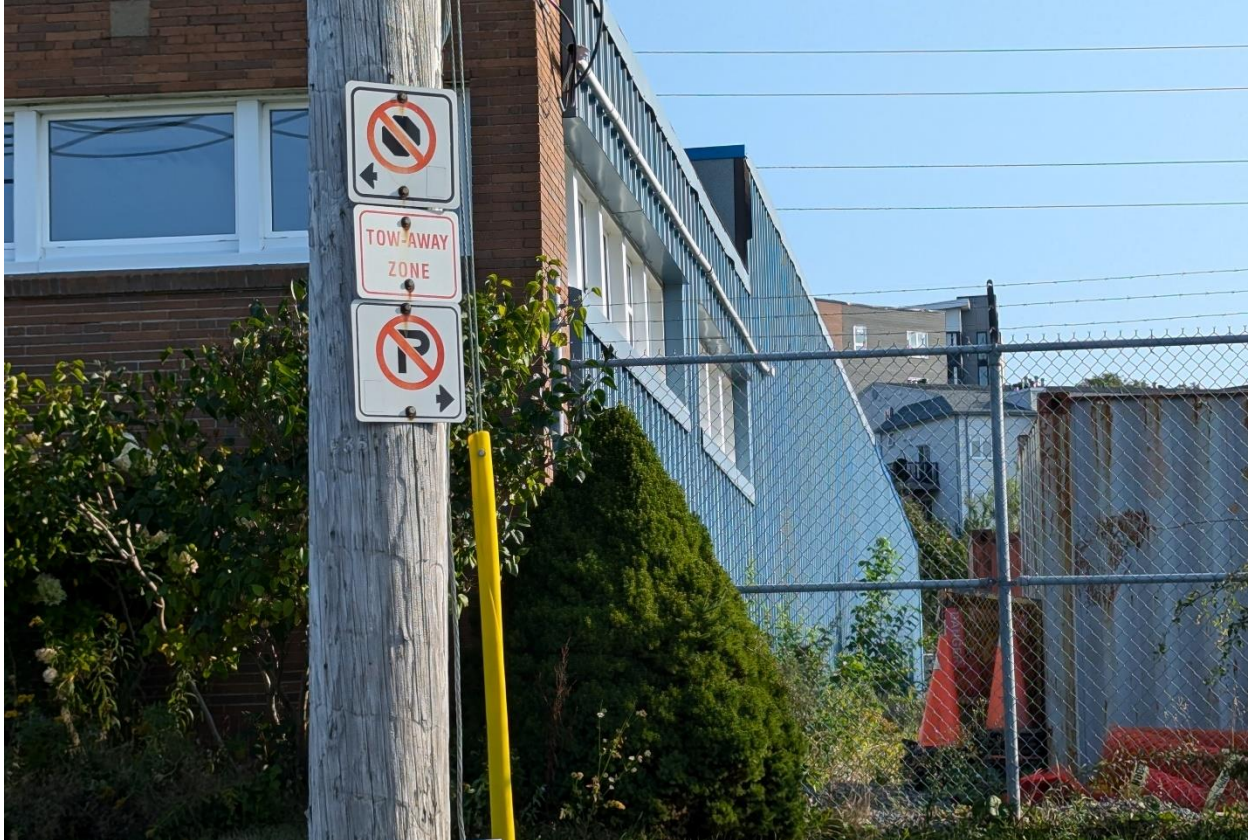
East side of building that is contained within neighbouring property's perimeter fence

- 8.1. The fence surrounding this parking area is 2 m tall and is topped by three strands of barbed wire. The fence abuts snugly to the Kerr Controls building and restricts access to that side of the building.

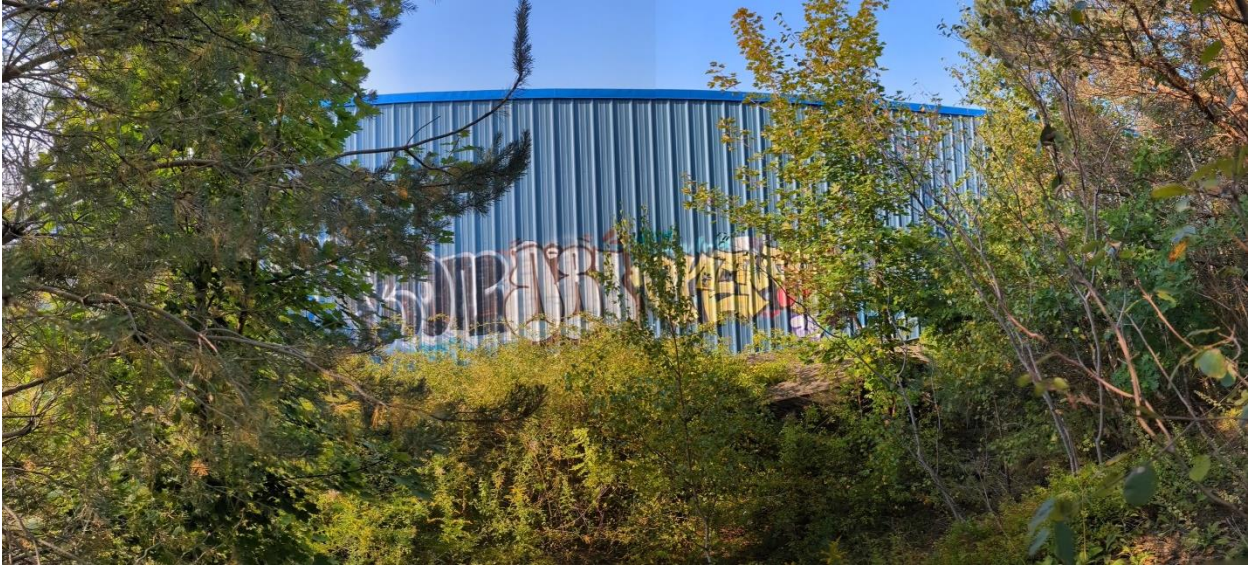
North side of building

- 7.1. This side of the building has no windows or other surveillance and has significant amounts of graffiti on the wall.
  - 7.2. This side of the building is unlit at night.

1. On North side, the wooded area should ideally be cut back to 3 m from the building, or to the property line.
  - 1.1. However, the property line seems to be directly adjacent to the building and parking lot.

- 1.1.1. Perhaps permission from NS Power could be obtained to cut back the wooded area on their property.
    - 1.1.2. If it is not possible to cut back the wooded area, thorny bushes should be planted along the edge of the building to discourage graffiti.

2. On the North side of the building, and elsewhere, all graffiti should be removed.
3. A smoking area should be created near the NW corner of the building to increase incidental monitoring of that area.
