Roof

Roof Visibility ☒ Inspected From Roof

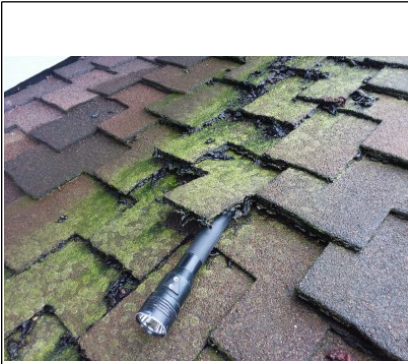
Comments Roof coverings appear to be in overall satisfactory condition with areas of typical maintenance observed including some areas of shingles not fully sealed down and deteriorated sealant around exposed nail heads, sealant can deteriorate over time due to changes in weather and may reseal during warmer temperatures, however, accumulated dirt/debris may prevent full re-sealing and some areas may require hand sealing by licensed roofing contractor to protect shingles against moisture intrusion and lifting during high winds

Unsealed shingles

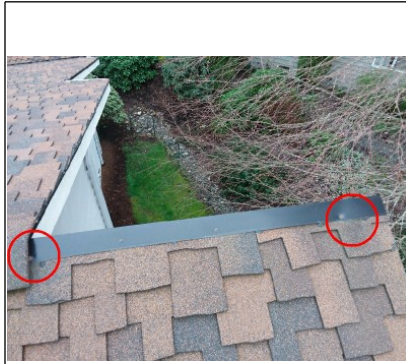
Unsealed nailheads

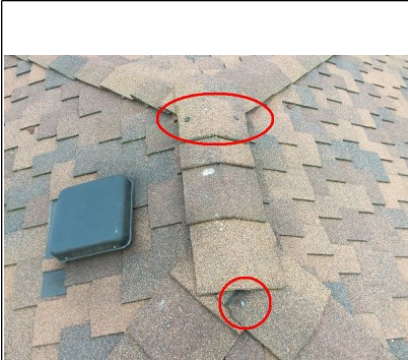
Deteriorated sealant around nail heads

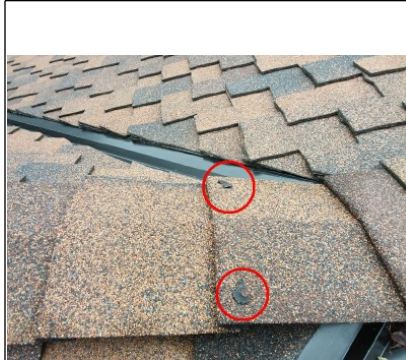
Deteriorated sealant around nail heads

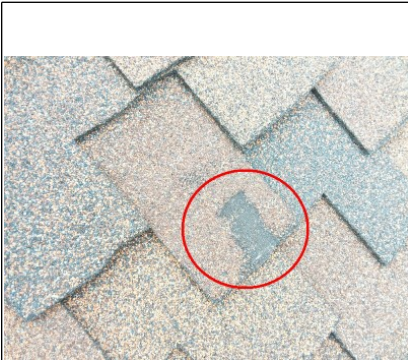
Damaged shingle above garage

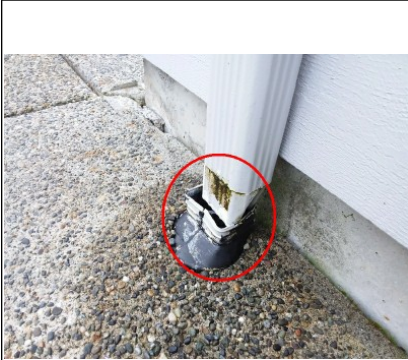
Downspout not fully draining into drain tile system

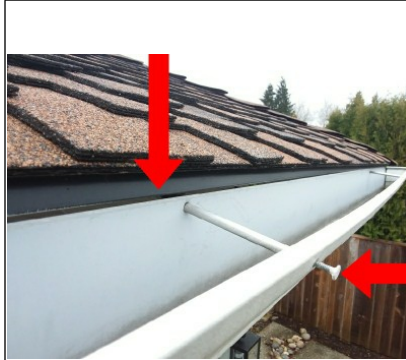
Comments One area of gutters at second-story roof drain onto roofing materials causing excessive buildup of mildew and debris, gutters are not intended to drain directly onto roofing surfaces due to increased deterioration of shingles from excessive moisture/debris accumulation, also observed some gutter attachment spikes not

Comments cont. fully seated, creating poor overlap of drip edge flashing over gutter wall against home, poor overlap can lead to moisture intrusion behind gutters, recommend consultation with qualified gutter servicing contractor for improved drainage of gutters at second story area and to fully secure gutter spikes where needed

Detached gutter spike, flashing not fully overlapping onto gutter

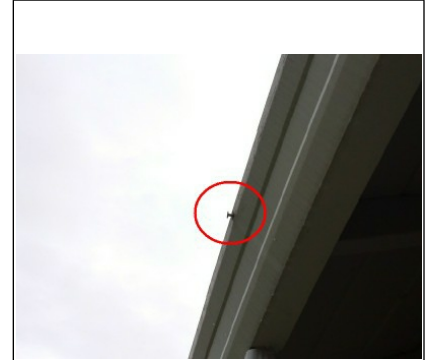
Detached gutter Spike

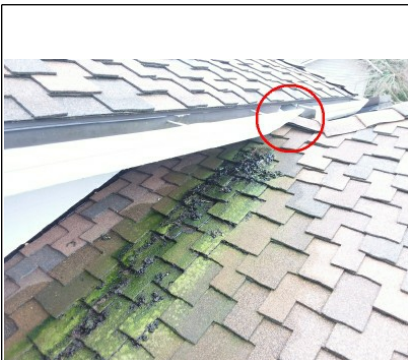
Gutters draining onto roof

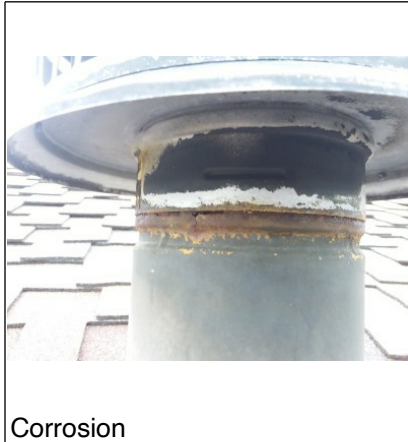
Comments Corrosion observed around gas vent chimney flue at roof, creating a possible moisture intrusion point, moisture intrusion in this area may lead directly into gas-fired appliances causing deterioration of units, recommend cleaning and resealing gaps observed around corroded areas to prevent moisture intrusion

Corrosion

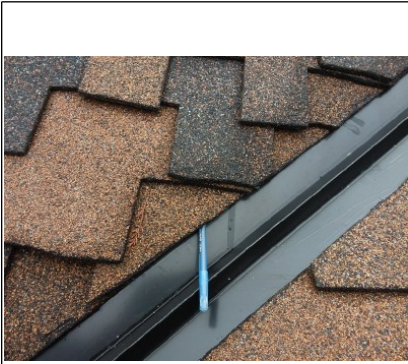
Some areas of unsealed roof valleys observed, unsealed roof valleys can lead to moisture intrusion into Roofing structure

Valley not fully sealed
