UFB Connect - MDU / ROW Checklist - 5

Fabril Solutions Ltd

35 Keri vista rise

134222

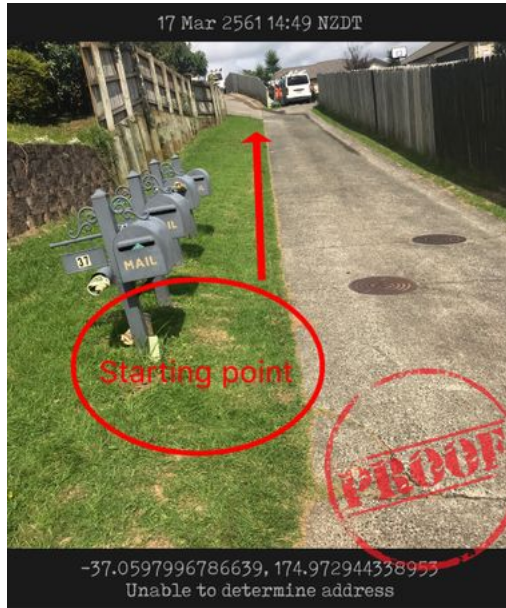
Appendix 1

Question	Response	Details
Photo of MDU/ROW starting point as per design document	Yes	
2) Photos of MDU/ROW starting point as per scoping document.

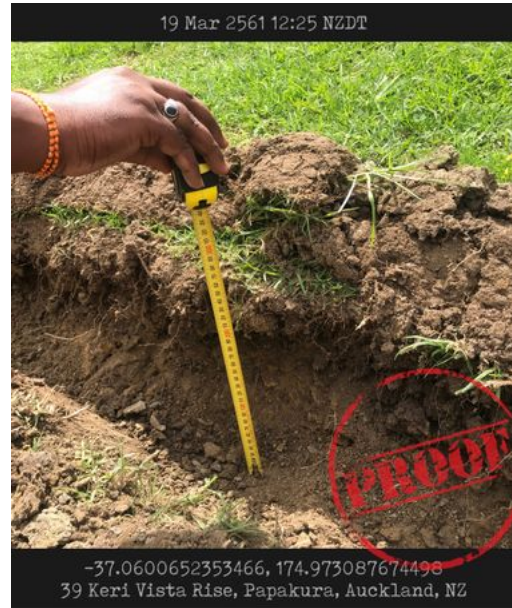
Appendix 2

<p>Appendix 1</p>		
Additional information of MDU/ROW starting point as per scoping document		
Photo of surfaces prior to works e.g trenching / slot cutting	Yes	
Photo of surfaces prior to works e.g trenching / slot cutting

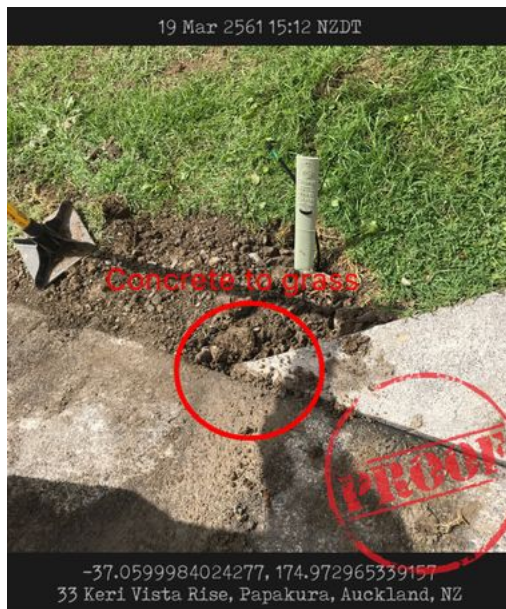
Appendix 9

Question	Response	Details
Photos where change in surface type occurs	Yes	
<p>Photos where change in surface type occurs</p> <div>

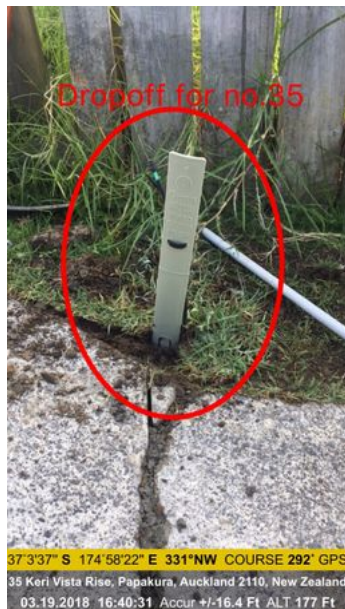
Appendix 11

</div> <p>Appendix 9 Appendix 10</p>		
Additional information where change in surface type occurs		
Photos where assets installed e.g. hand holes, IFDB's, Pedestals, BUD's, boundary pegs	Yes	
<p>Photos where assets installed e.g. hand holes, IFDB's, Pedestals, BUD's, boundary pegs</p> <div>

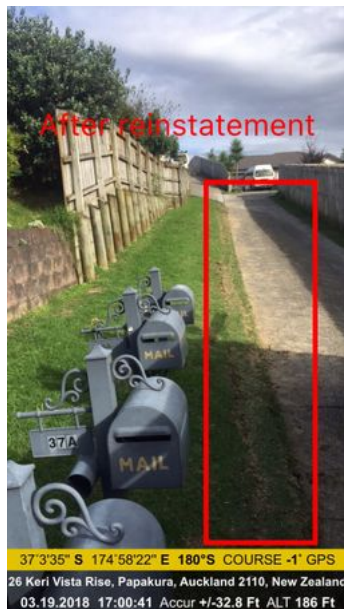
Appendix 15

</div> <p>Appendix 11 Appendix 12 Appendix 13 Appendix 14</p>		
Additional information where assets installed e.g. hand holes, IFDB's, Pedestals, BUD's, boundary pegs		
Photos of surfaces after final permanent reinstatement	Yes	
<p>Photos of surfaces after final permanent reinstatement</p> <div>
