NGA ROW Scoping Document

136749

Duplicate Design VS # 116269
N ROW 7

12A, 12B, 12C Norana Avenue, Remura

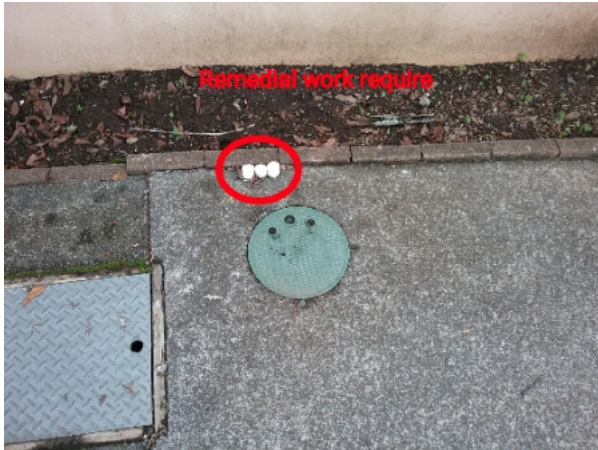
Appendix 1
No Date

Question	Response	Details
Customer / Job Details		Score (0/2) 0%
Was a half scope or full scope completed?	Half scope	
Why?	Could not get in contact with requestor(s)	
Scoping Details		Score (6/35) 17.14%
How many houses down this ROW	3.0	
Drop off located?	Yes	
Take photo(s) of drop off clearly showing number of tubes & location relative to ROW landmarks.		
<div><div>

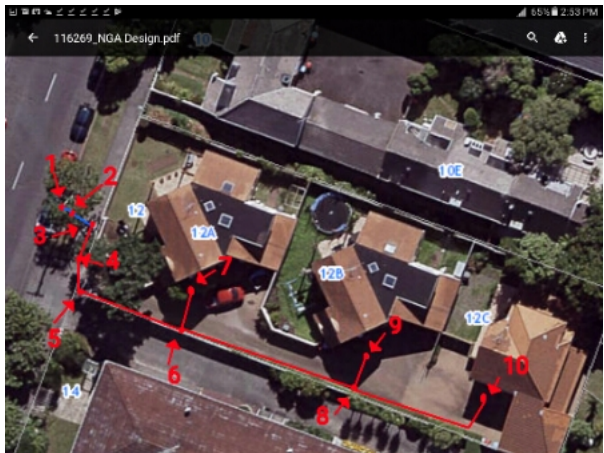
Appendix 16
No Date

<p>Appendix 16 No Date</p>					
Will the ROW be serviced via ABF, fixed fibre or aerially?	Fixed Fibre				
Take photo of servicing FAT or cabinet.

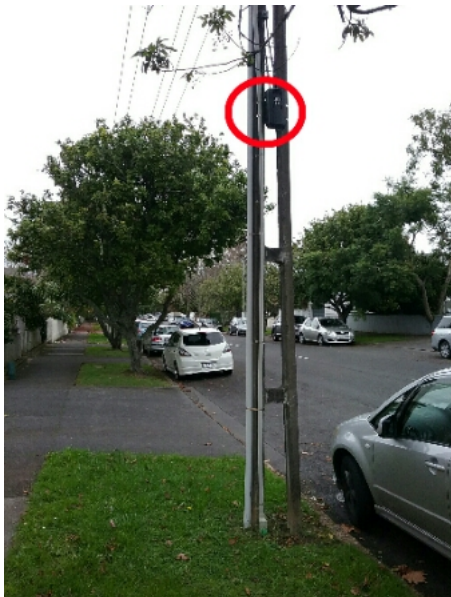
Appendix 17
No Date

<p>Appendix 17 No Date</p>					
Where is the FAT/cabinet located? Distance from FAT or cabinet.	12 Norana Avenue				
Other requirements? I.e TMP, Arborist	No				
Additional Notes	Drop of left in council property. Panel need to replace if build crew can't penetrate from soft soil area. Met Customer #12C Jenny Richard (021852209) and discussed the plan. EWP require. Existing copper route blocked.

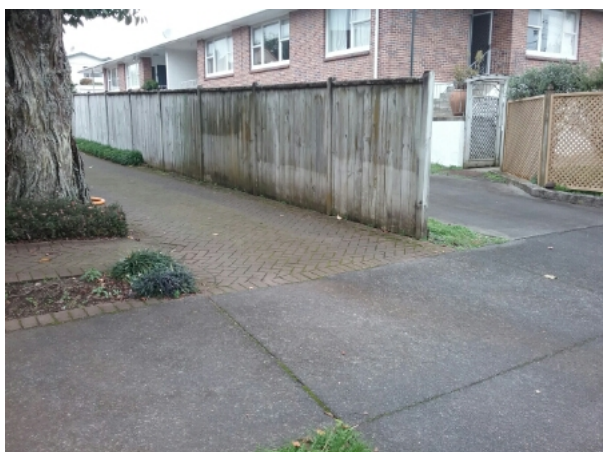
Appendix 18
2/06/17 3:08 PM

Question	Response	Details
Explain why? Are there any surface mount options available? Why were they not used? Are the transitions between surfaces possible, can the bending radius be maintained etc.	Surface clipping done on half of the boundary.	
Take photo(s) clearly showing any surface or route expected to mount infrastructure on or build including transition points, e.g. Retaining walls, fences, existing pits, BDDs duct entry & exits etc. Or any other picture as required to support photos already in scoping section.		
<div>
