# UFB Connect - Faulty Network Billing 5

## 69 Marine Parade

**Service Order number**

133054

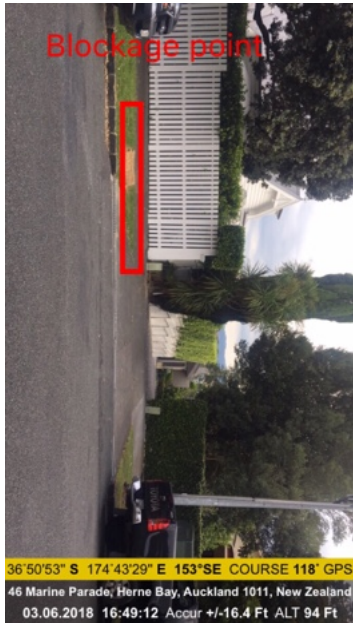
Appendix 1

4.2.1 – Repair of ducted Network Drop to boundary (legacy duct) or FFP to Boundary (Communal Network repair of)	FFP to Boundary (Communal Network repair of)	
FFP to Drop (Communal Network repair of)	50/100mm MH to boundary	
Evidence Cam Image of location before excavation to give perspective of where fault was,
