# UFB Connect - MDU / ROW Checklist - 5

## Fabril Solutions Ltd

15 Marendellas drive

130744

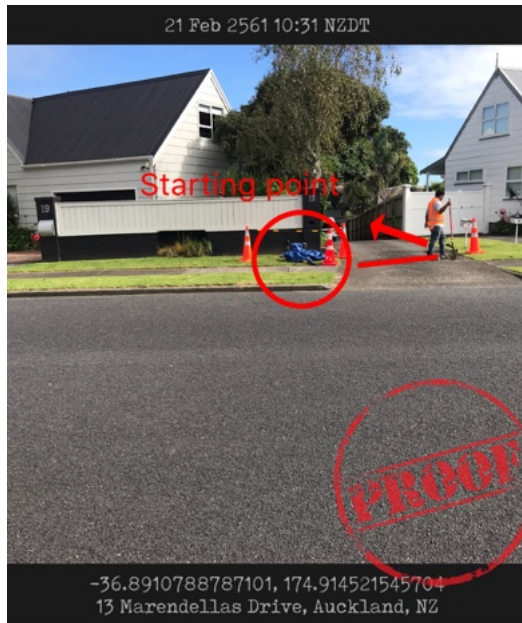
Appendix 1

Question	Response	Details	
Photo of MDU/ROW starting point as per design document	Yes		
2) Photos of MDU/ROW starting point as per scoping document.			
<div>

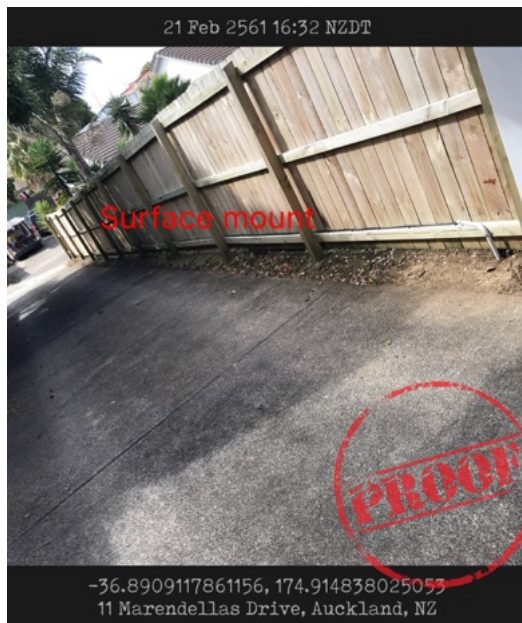
Appendix 3

</div> <div>Appendix 2</div>		
Additional information of MDU/ROW starting point as per scoping document			
Photo of surfaces prior to works e.g trenching / slot cutting	Yes		
Photo of surfaces prior to works e.g trenching / slot cutting			
<div>

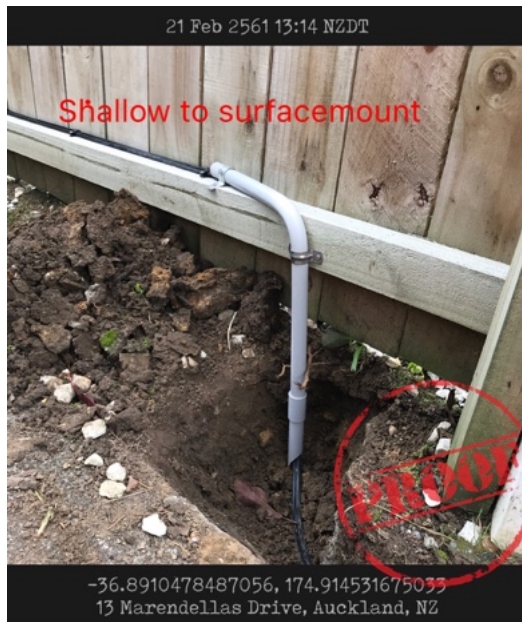
Appendix 7

</div> <div>Appendix 6</div>
Additional information of surfaces prior to works e.g trenching / slot cutting			
Photos where change in methodology occurs e.g. shallow trench to surface mount	Yes		
Photos where change in methodology occurs e.g. shallow trench to surface mount			
<div>

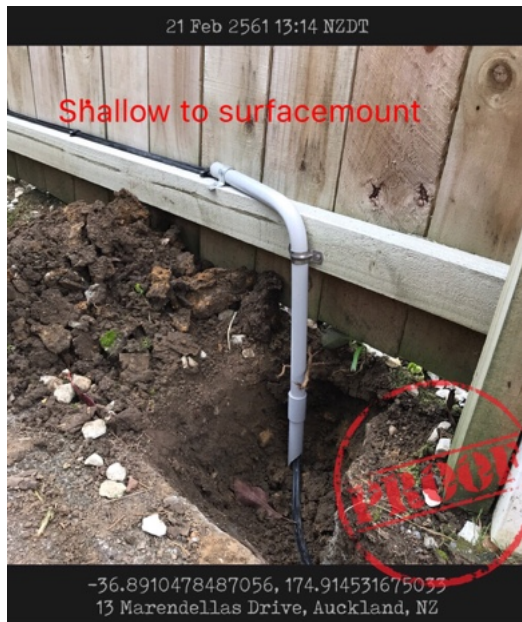
Appendix 11

Question	Response	Details	
Photos where change in surface type occurs	Yes		
Photos where change in surface type occurs

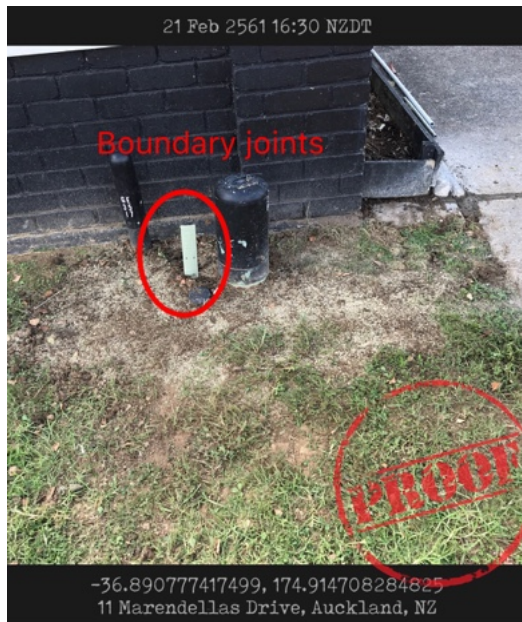
Appendix 15

Appendix 11	Appendix 12	Appendix 13	Appendix 14
Additional information where change in surface type occurs			
Photos where assets installed e.g. hand holes, IFDB's, Pedestals, BUD's, boundary pegs		Yes	
Photos where assets installed e.g. hand holes, IFDB's, Pedestals, BUD's, boundary pegs

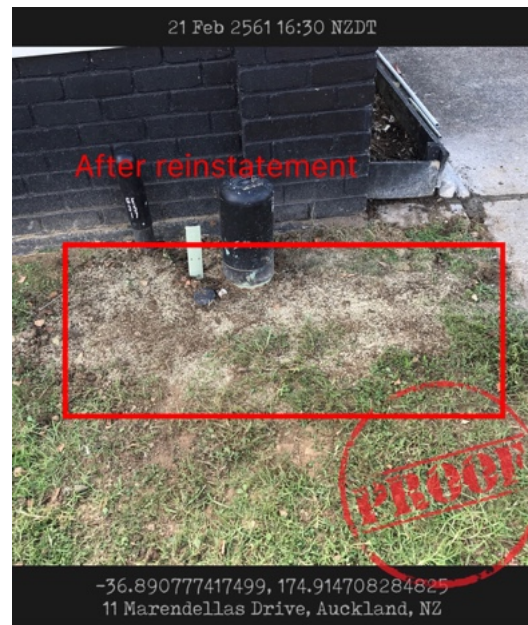
Appendix 18

Appendix 15	Appendix 16	Appendix 17	
Additional information where assets installed e.g. hand holes, IFDB's, Pedestals, BUD's, boundary pegs			
Photos of surfaces after final permanent reinstatement		Yes	
Photos of surfaces after final permanent reinstatement
