UFB Connect - MDU / ROW Checklist - 5

Fabril Solutions Ltd

153b Riddell road

133661

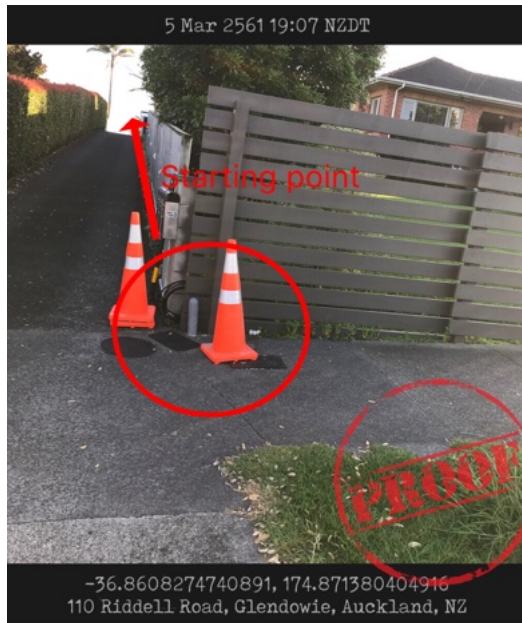
Appendix 1

Question	Response	Details		
Photo of MDU/ROW starting point as per design document	Yes			
2) Photos of MDU/ROW starting point as per scoping document.

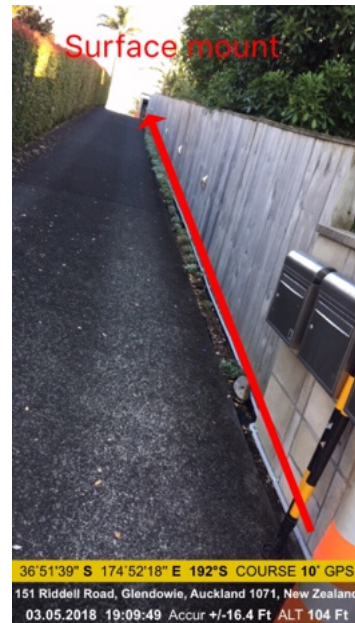
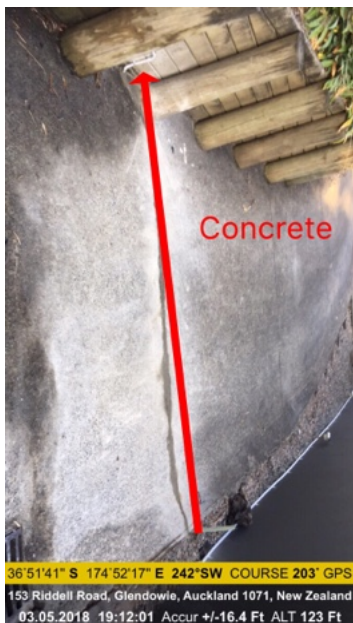
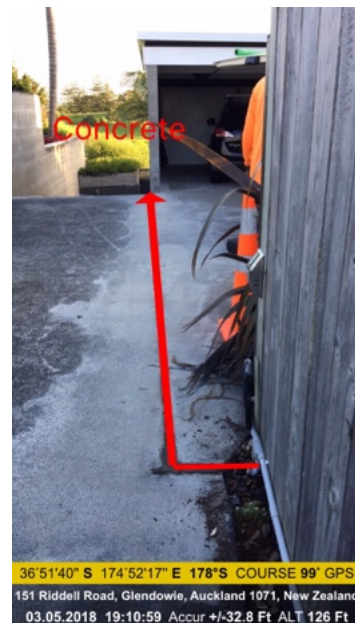
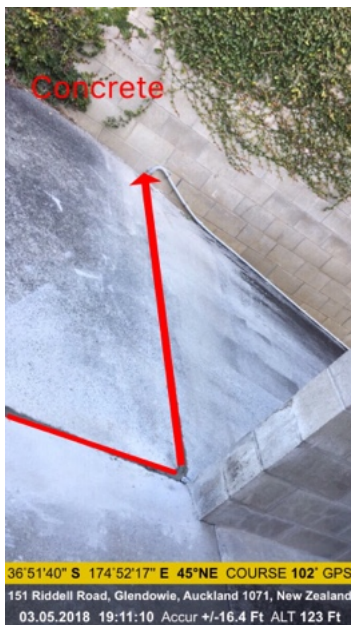
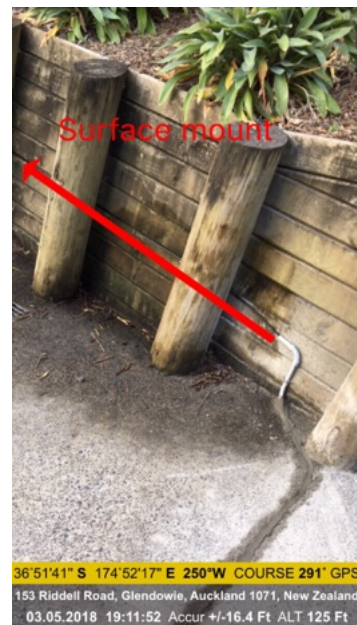
Appendix 1				
Additional information of MDU/ROW starting point as per scoping document				
Photo of surfaces prior to works e.g trenching / slot cutting	Yes			
Photo of surfaces prior to works e.g trenching / slot cutting

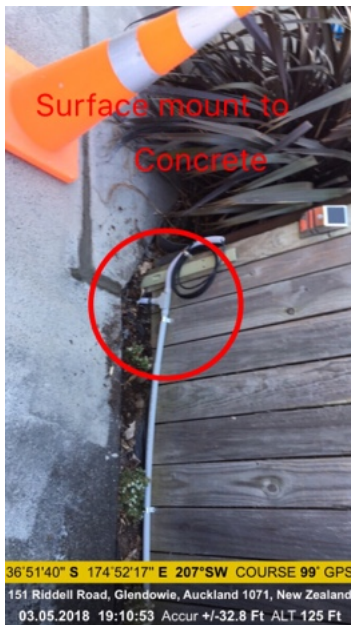
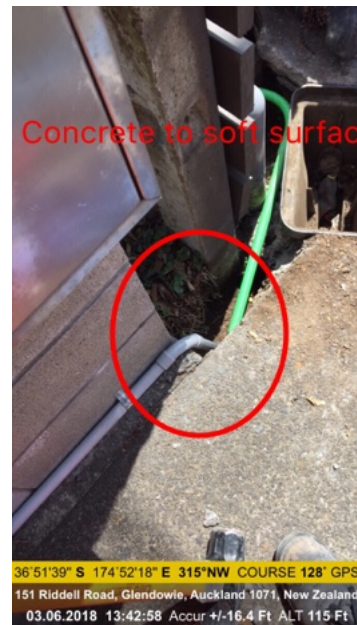
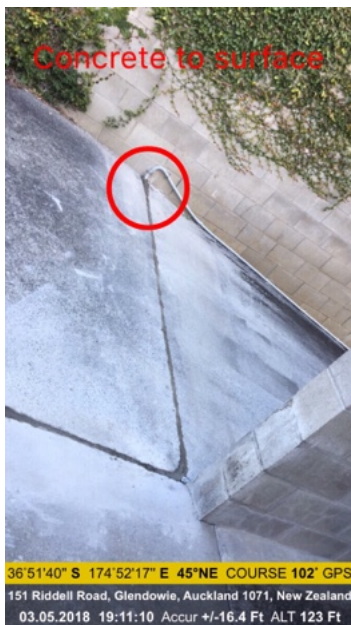
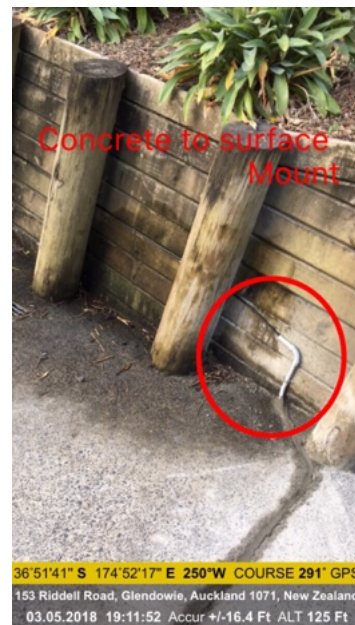
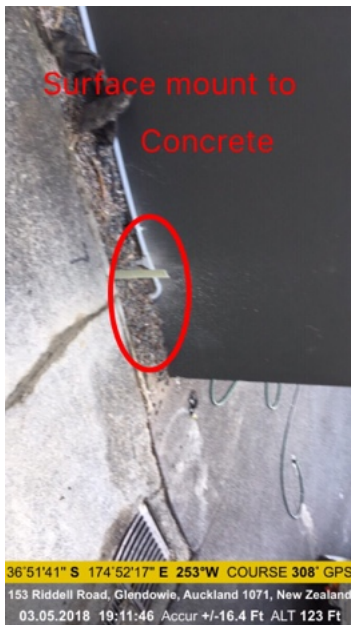
Appendix 2	Appendix 3	Appendix 4	Appendix 5	Appendix 6
Additional information of surfaces prior to works e.g trenching / slot cutting				
Photos where change in methodology occurs e.g. shallow trench to surface mount	Yes			
Photos where change in methodology occurs e.g. shallow trench to surface mount

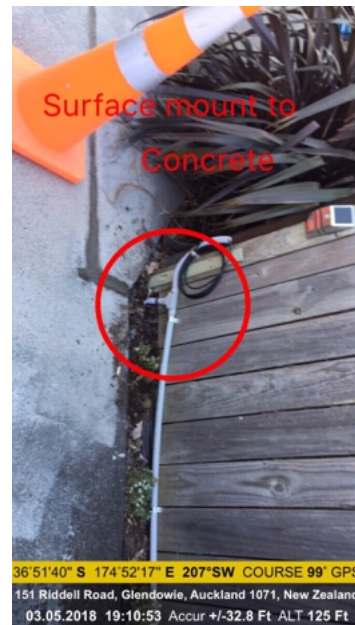
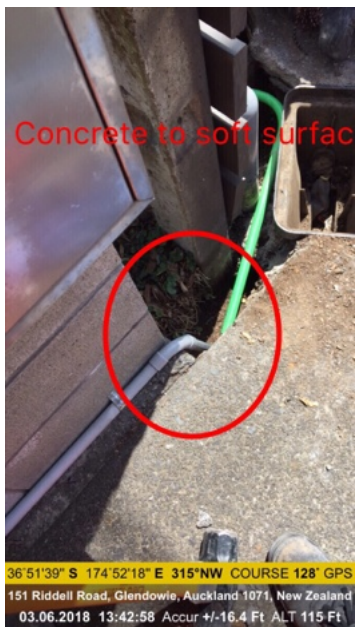
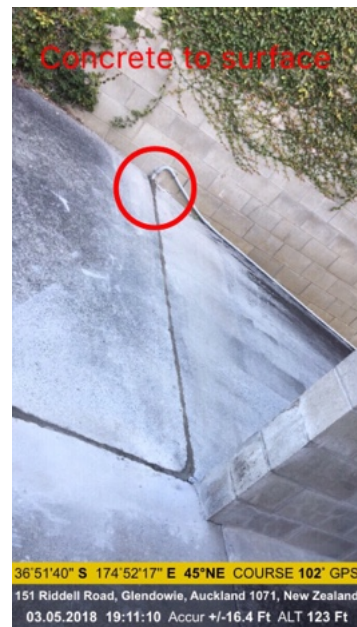
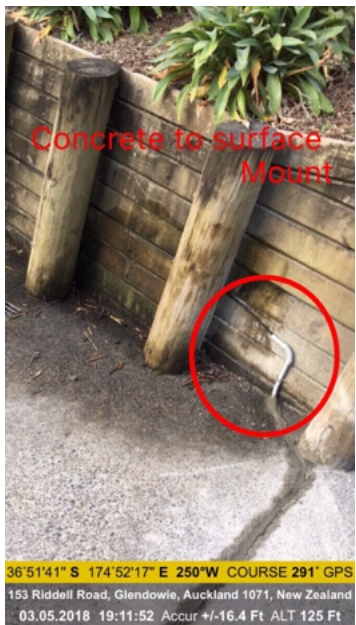
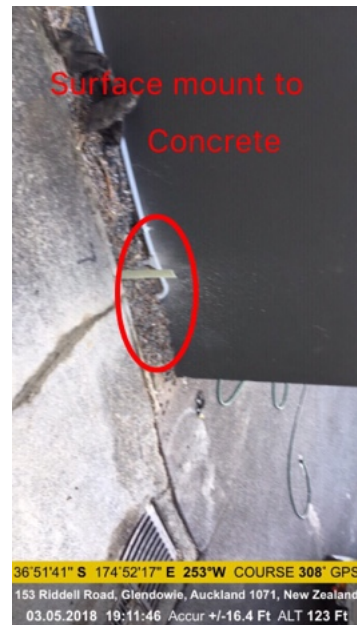
Question	Response	Details		
Photos where change in surface type occurs	Yes			
Photos where change in surface type occurs

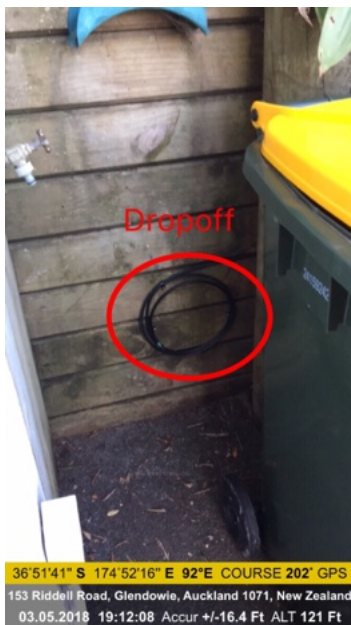
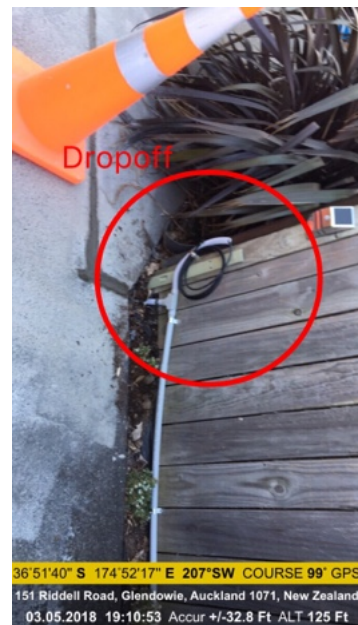
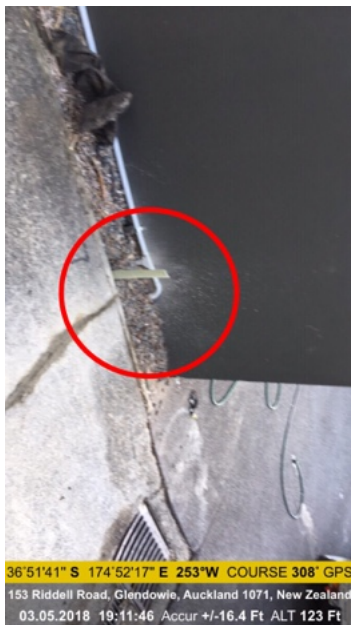
<p>Appendix 16</p>
Additional information where change in surface type occurs				
Photos where assets installed e.g. hand holes, IFDB's, Pedestals, BUD's, boundary pegs	Yes			
Photos where assets installed e.g. hand holes, IFDB's, Pedestals, BUD's, boundary pegs

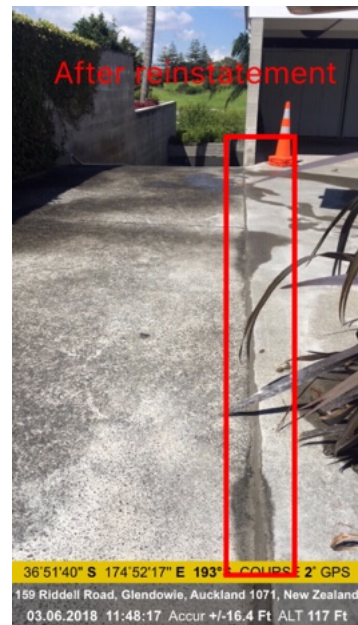
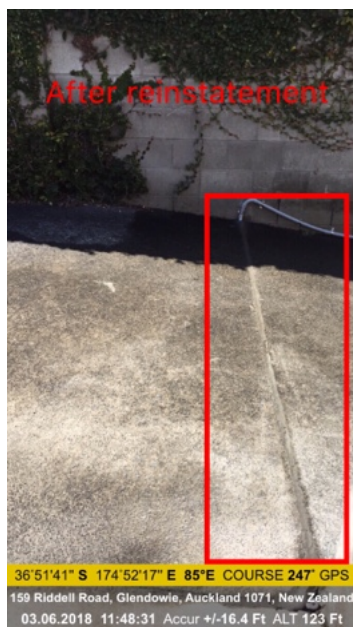
<p>Appendix 19</p>		
Additional information where assets installed e.g. hand holes, IFDB's, Pedestals, BUD's, boundary pegs				
Photos of surfaces after final permanent reinstatement	Yes			
Photos of surfaces after final permanent reinstatement
