UFB Connect - MDU / ROW Checklist - 5

Fabril Solutions Ltd

125 Keri vista rise, papakura

16 Mar 2018 08:16 AM

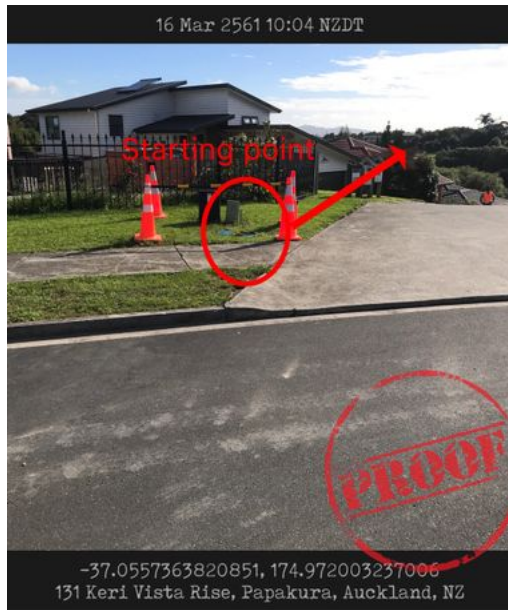
Appendix 1

Question	Response	Details
Photo of MDU/ROW starting point as per design document	Yes	
2) Photos of MDU/ROW starting point as per scoping document.

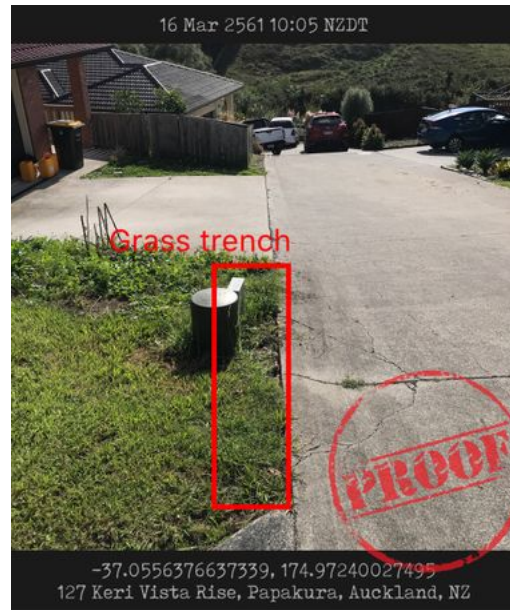
Appendix 2

<p>Appendix 1</p>		
Additional information of MDU/ROW starting point as per scoping document		
Photo of surfaces prior to works e.g trenching / slot cutting	Yes	
Photo of surfaces prior to works e.g trenching / slot cutting

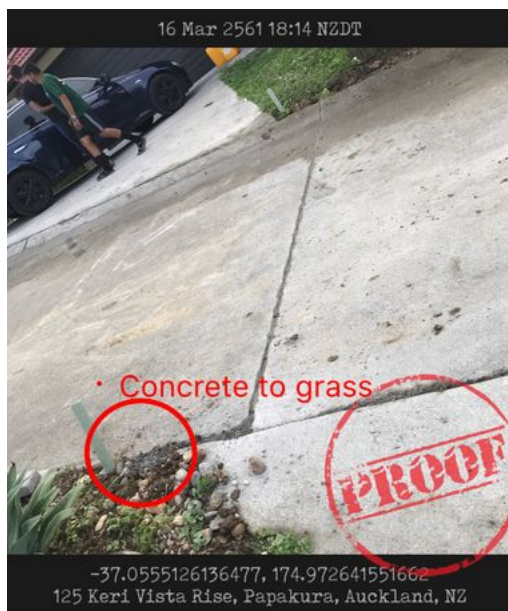
Appendix 9

Question	Response	Details
Photos where change in surface type occurs	Yes	
Photos where change in surface type occurs

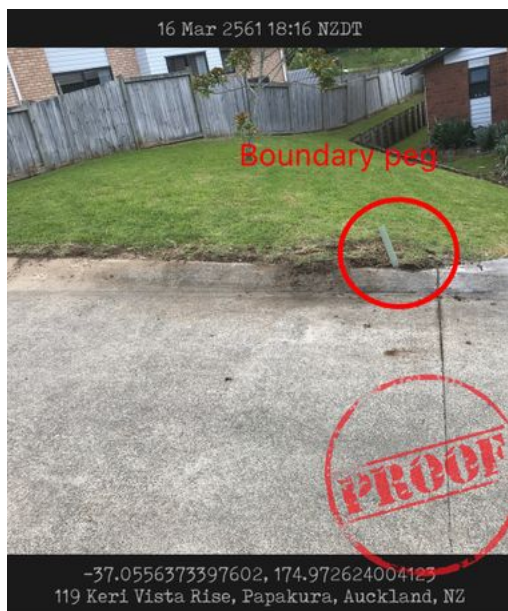
Appendix 13

Appendix 12		
Additional information where change in surface type occurs		
Photos where assets installed e.g. hand holes, IFDB's, Pedestals, BUD's, boundary pegs	Yes	
Photos where assets installed e.g. hand holes, IFDB's, Pedestals, BUD's, boundary pegs

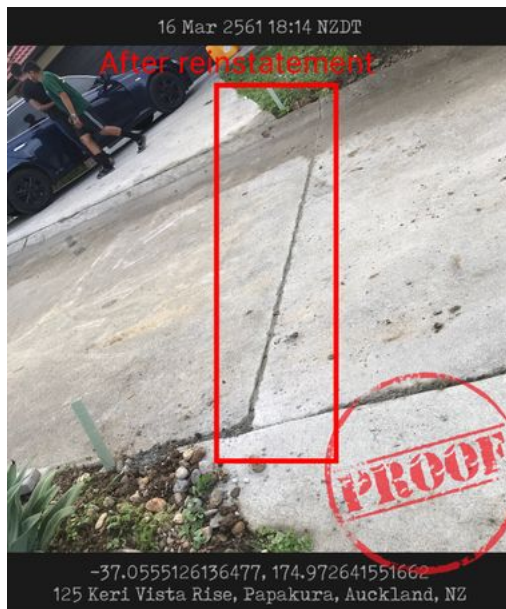
Appendix 17

Appendix 16		
Additional information where assets installed e.g. hand holes, IFDB's, Pedestals, BUD's, boundary pegs		
Photos of surfaces after final permanent reinstatement	Yes	
Photos of surfaces after final permanent reinstatement
