UFB Connect - MDU / ROW Checklist - 5

Fabril Solutions Ltd

2/136 Bradbury road, botany downs

22/02/2561 BE, 9:59 AM

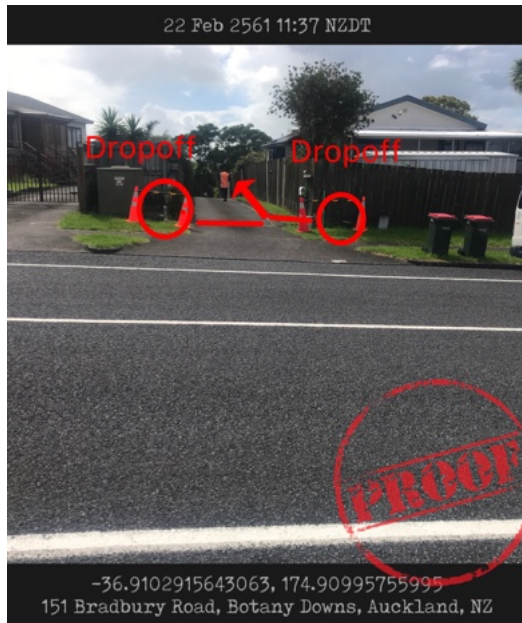
Appendix 1

Question	Response	Details			
Photo of MDU/ROW starting point as per design document	Yes				
2) Photos of MDU/ROW starting point as per scoping document.

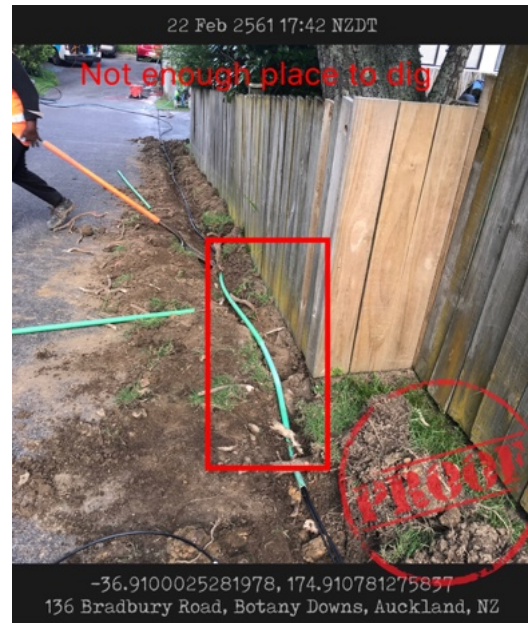
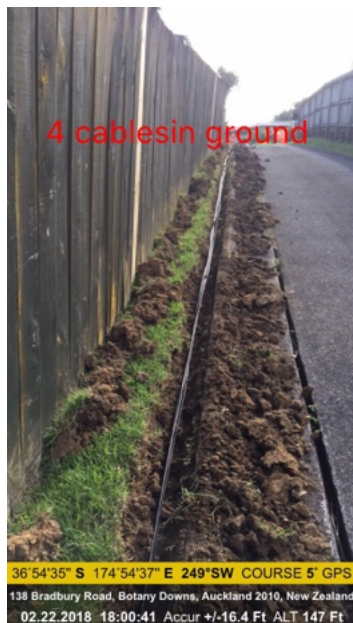
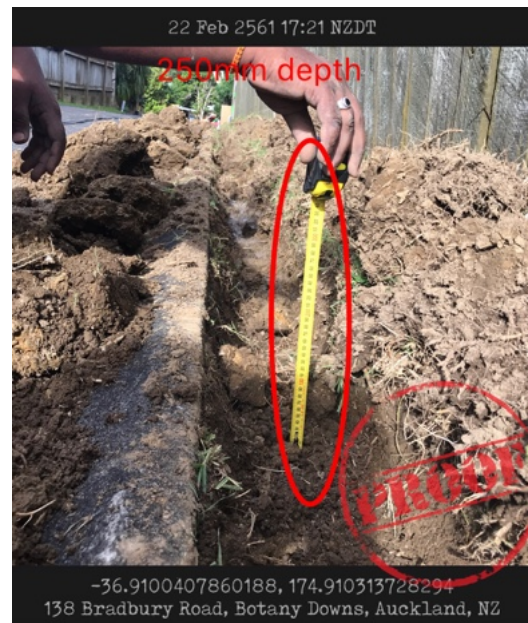
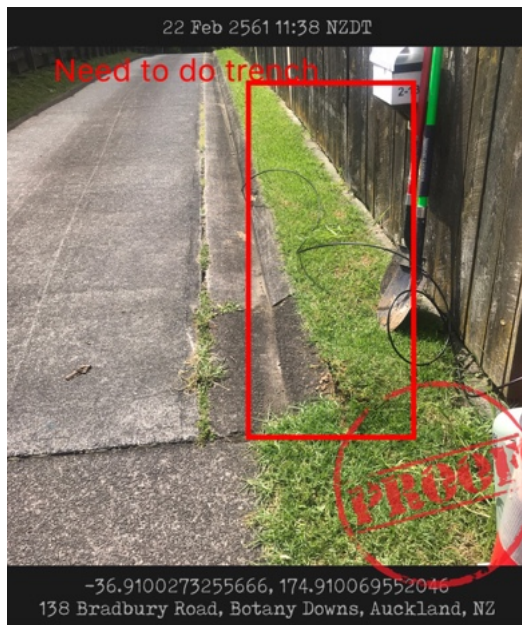
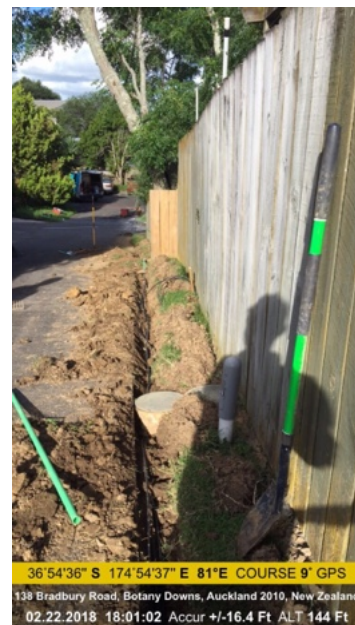
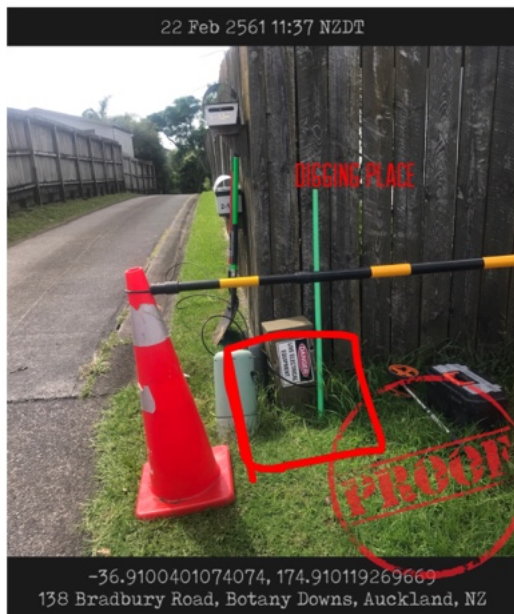
Appendix 1					
Additional information of MDU/ROW starting point as per scoping document					
Photo of surfaces prior to works e.g trenching / slot cutting	Yes				
Photo of surfaces prior to works e.g trenching / slot cutting

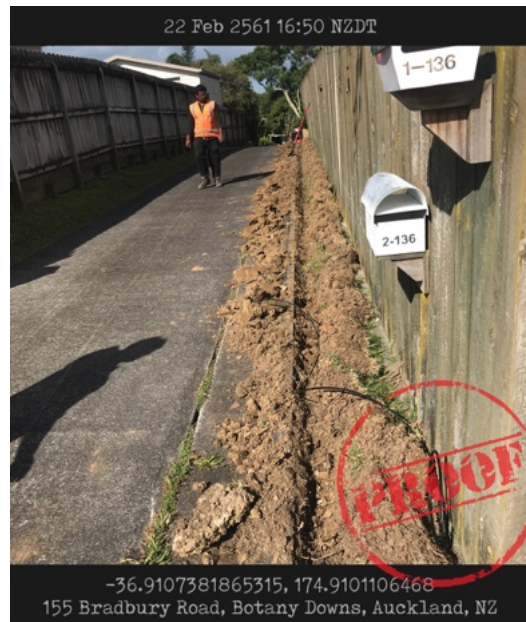
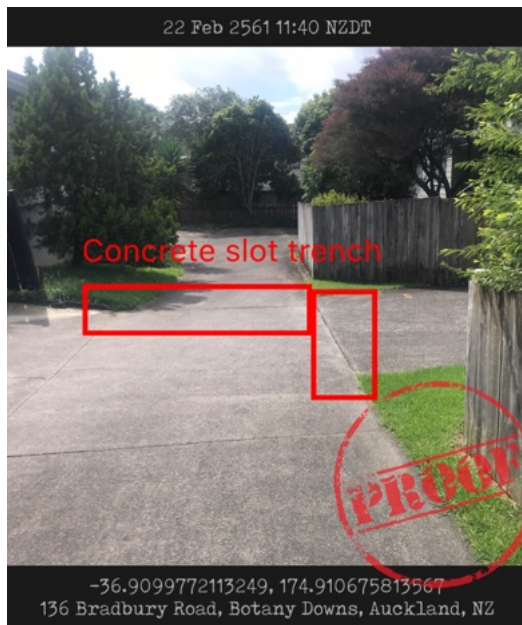
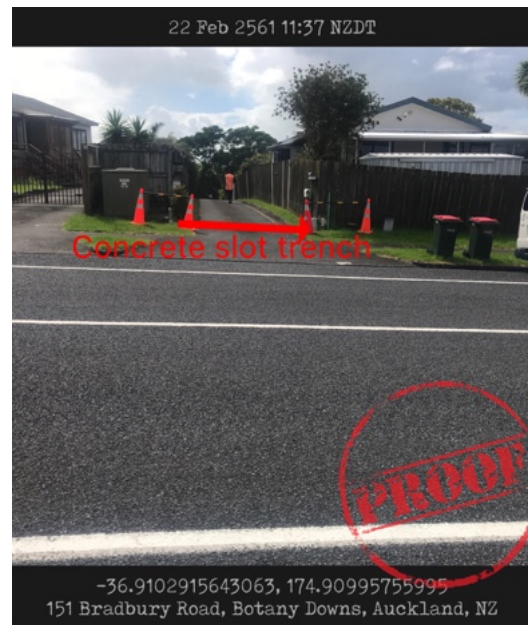
Appendix 8	Appendix 9	Appendix 10			
Additional information of surfaces prior to works e.g trenching / slot cutting					
Photos where change in methodology occurs e.g. shallow trench to surface mount	Yes				
Photos where change in methodology occurs e.g. shallow trench to surface mount

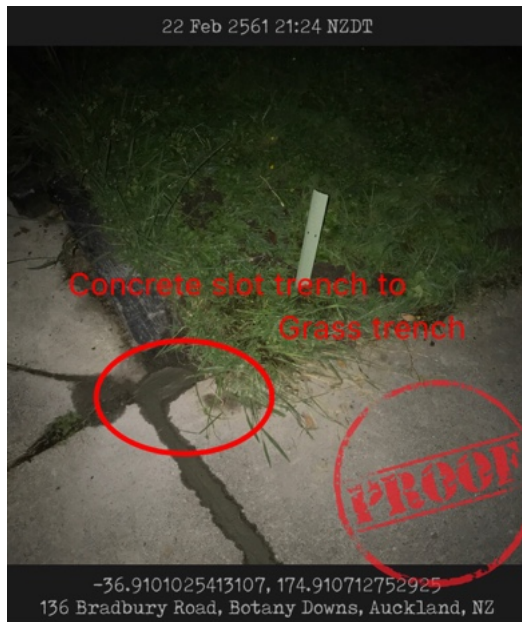
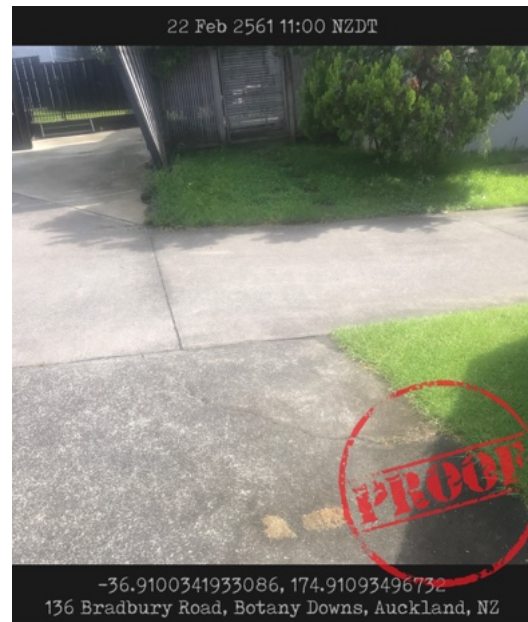
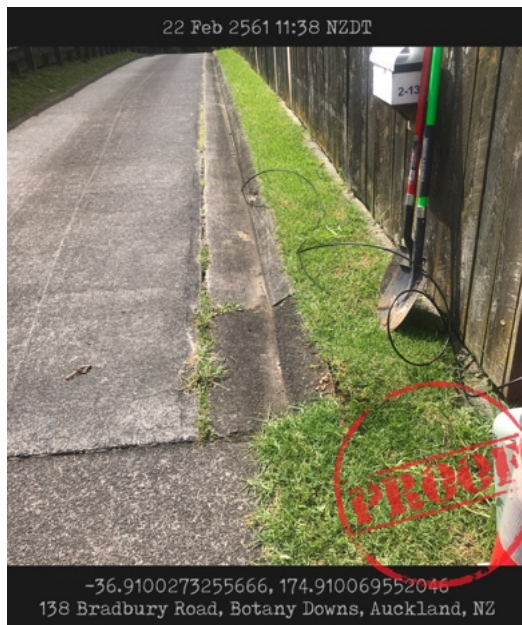
</div> <div> Appendix 11 Appendix 12 Appendix 13 </div>	
Additional information where change in methodology occurs e.g. shallow trench to surface mount	
Photos where change in surface type occurs	Yes
Photos where change in surface type occurs	
Additional information where change in surface type occurs	
Photos where assets installed e.g. hand holes, IFDB's, Pedestals, BUD's, boundary pegs	Yes
Photos where assets installed e.g. hand holes, IFDB's, Pedestals, BUD's, boundary pegs	
<div>

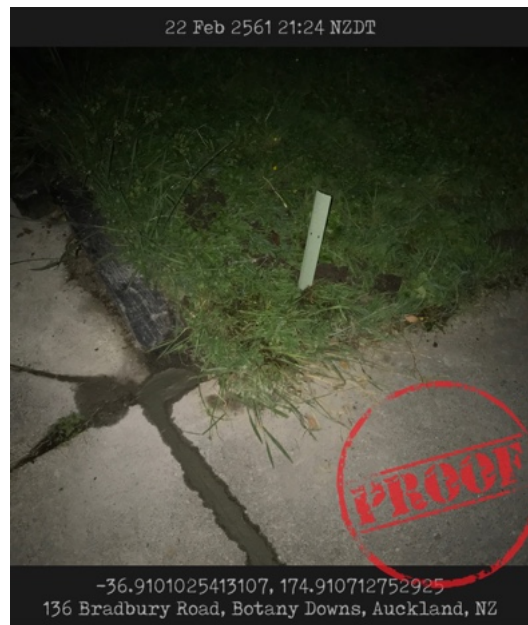
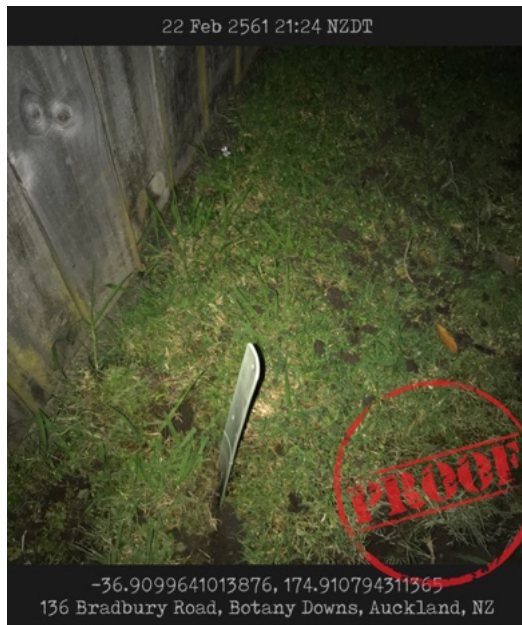
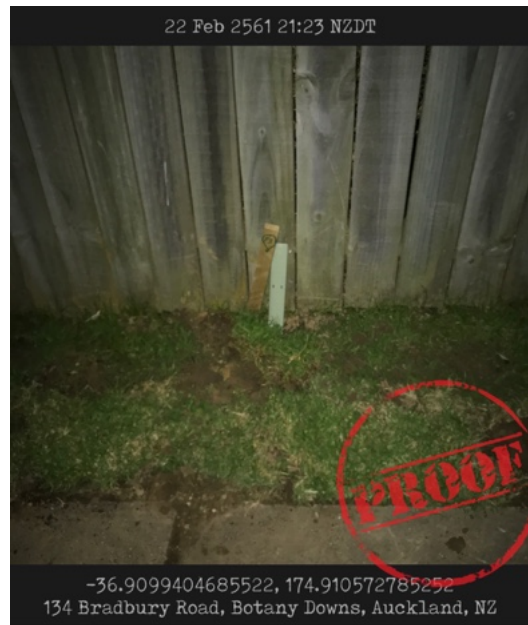
</div> <div> Appendix 14 Appendix 15 Appendix 16 </div>	
Additional information where assets installed e.g. hand holes, IFDB's, Pedestals, BUD's, boundary pegs	
Photos of surfaces after final permanent reinstatment	Yes
Photos of surfaces after final permanent reinstatment	
<div>

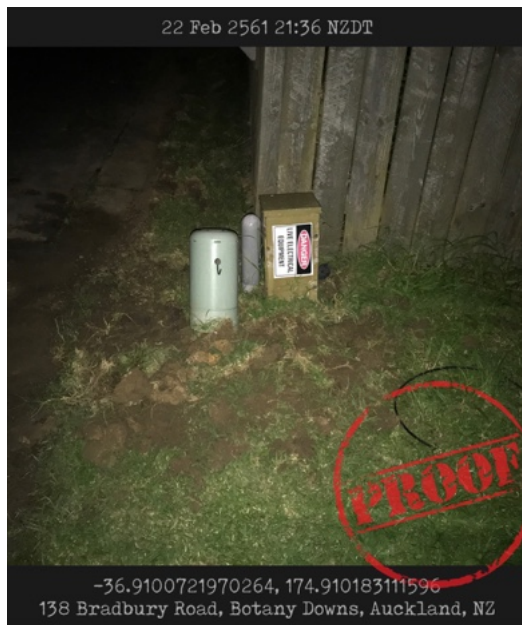
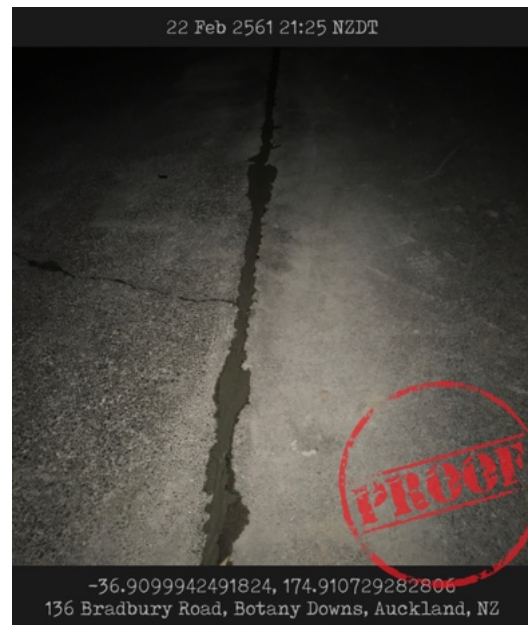
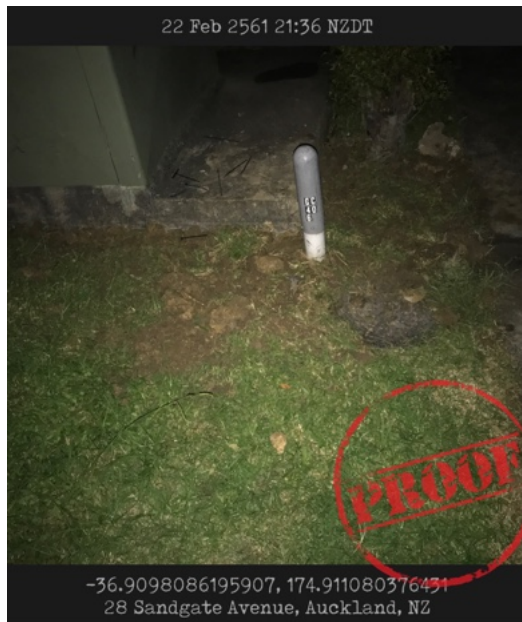
</div> <div> Appendix 17 Appendix 18 Appendix 19 </div>	
Additional information - e.g dimensions of concrete cut, removed and reisntated.
