# UFB Connect - MDU / ROW Checklist - 5

## Fabril Solutions Ltd

53 keri vista rise

138350

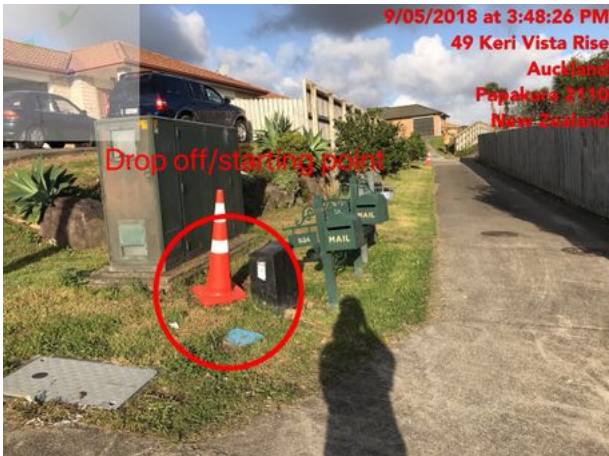
Appendix 1

Question	Response	Details
Photo of MDU/ROW starting point as per design document	Yes	
2) Photos of MDU/ROW starting point as per scoping document.

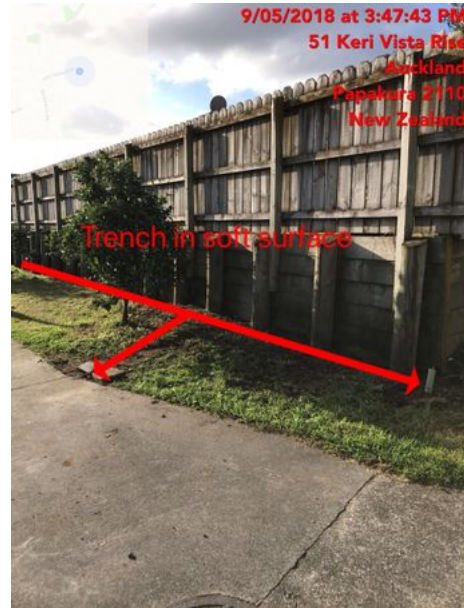
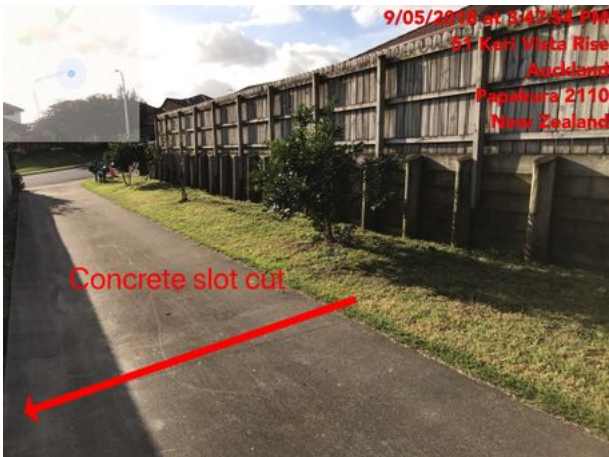
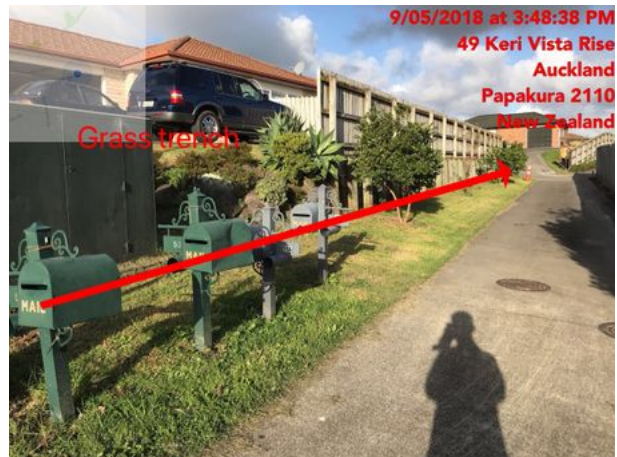
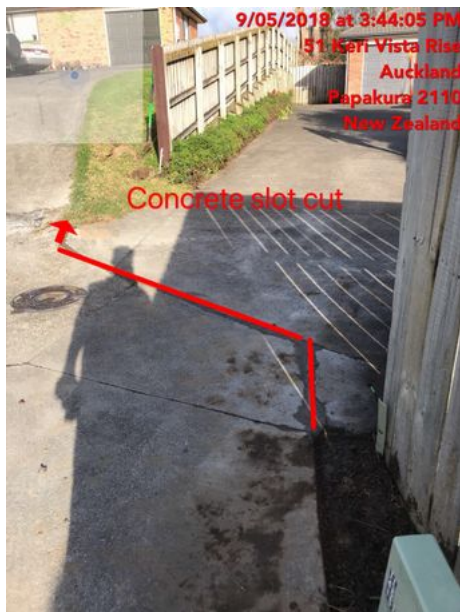
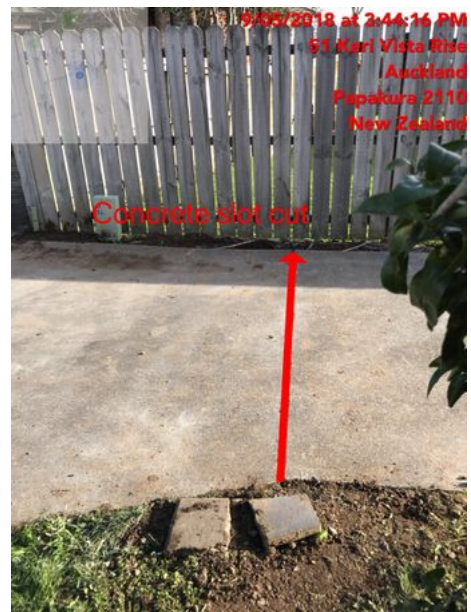
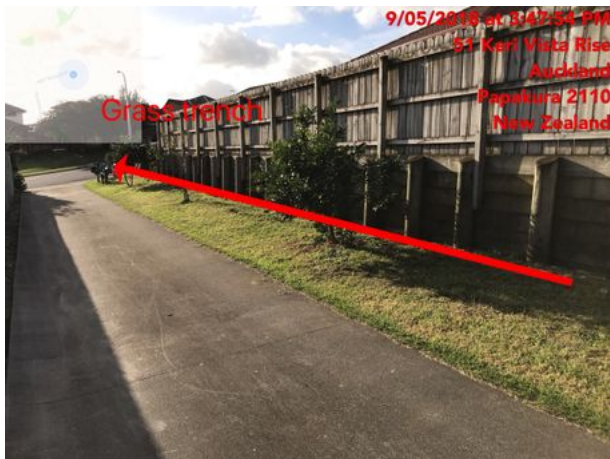
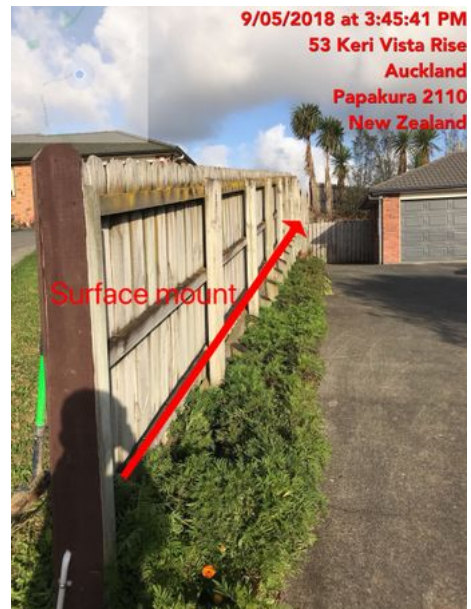
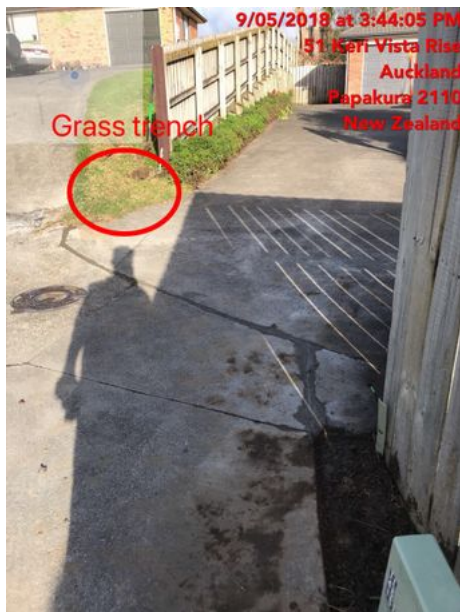
<p>Appendix 1</p>		
Additional information of MDU/ROW starting point as per scoping document		
Photo of surfaces prior to works e.g trenching / slot cutting	Yes	
Photo of surfaces prior to works e.g trenching / slot cutting		
<div style="display: flex; flex-wrap: wrap;"> <div style="width: 33%;">

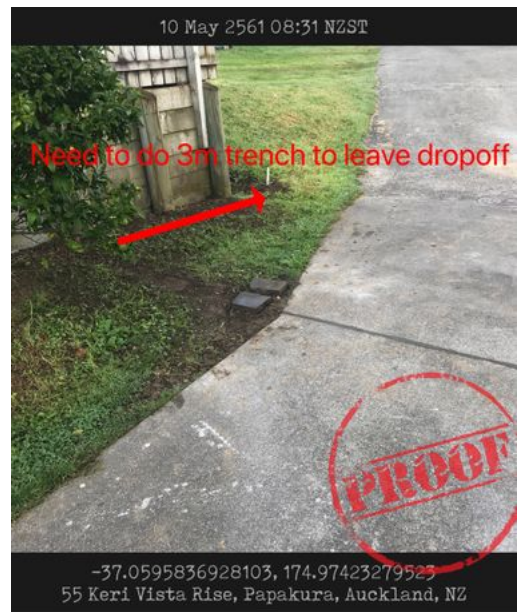
Appendix 10

Question	Response	Details
<p>Photos where change in methodology occurs e.g. shallow trench to surface mount</p>

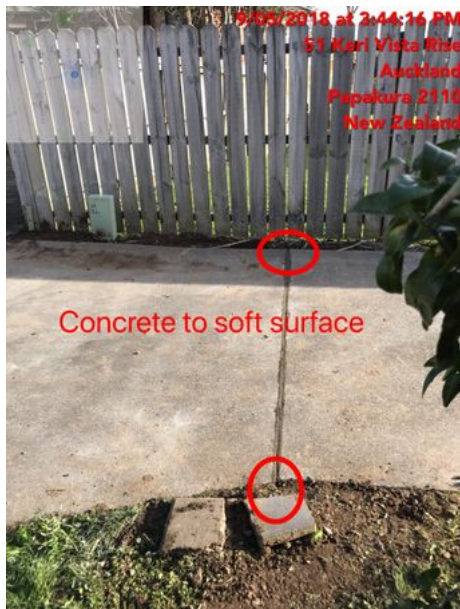
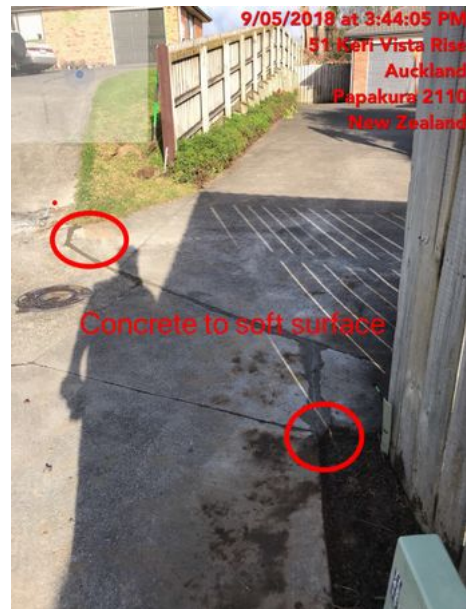
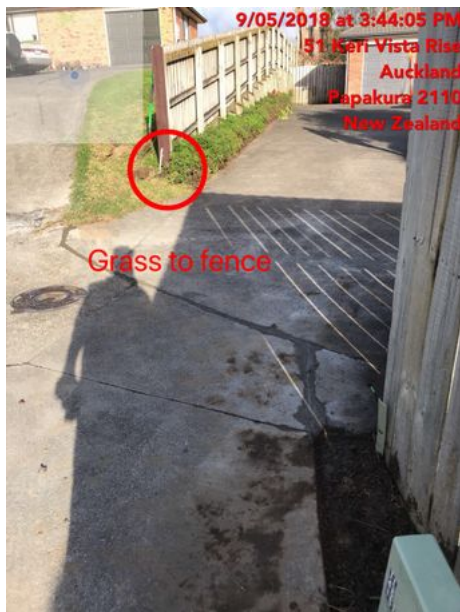
<p>Appendix 10</p>		
Additional information where change in methodology occurs e.g. shallow trench to surface mount		
Photos where change in surface type occurs	Yes	
<p>Photos where change in surface type occurs</p>

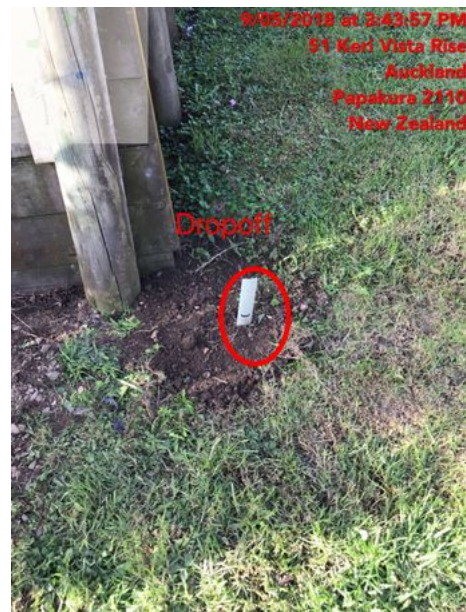
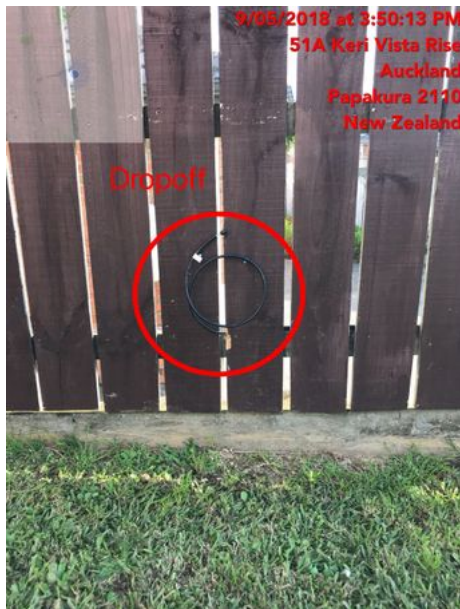
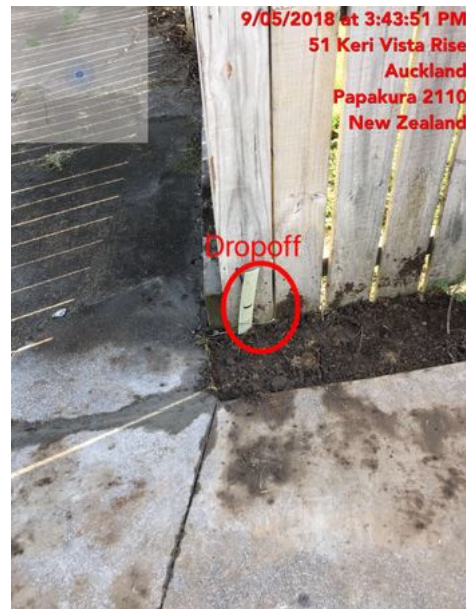
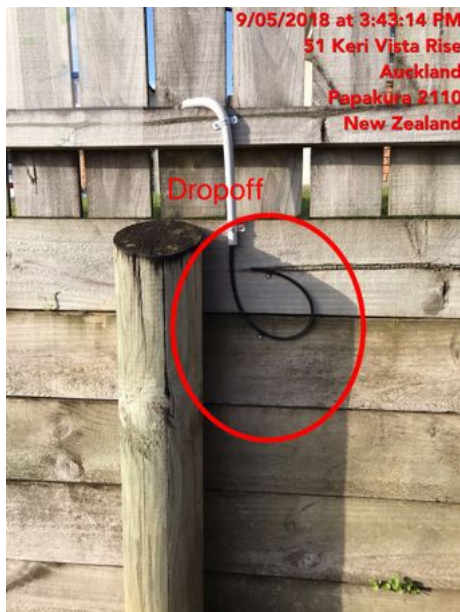
<p>Appendix 13</p>		
Additional information where change in surface type occurs		
Photos where assets installed e.g. hand holes, IFDB's, Pedestals, BUD's, boundary pegs	Yes	
<p>Photos where assets installed e.g. hand holes, IFDB's, Pedestals, BUD's, boundary pegs</p>

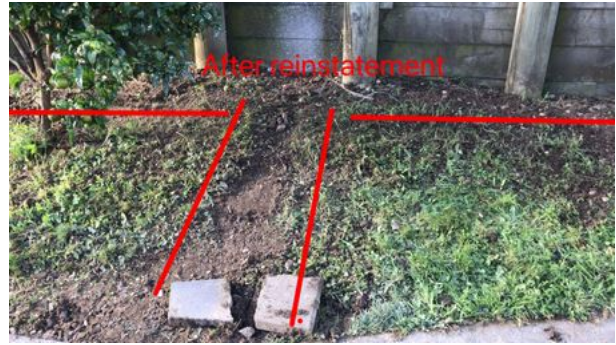
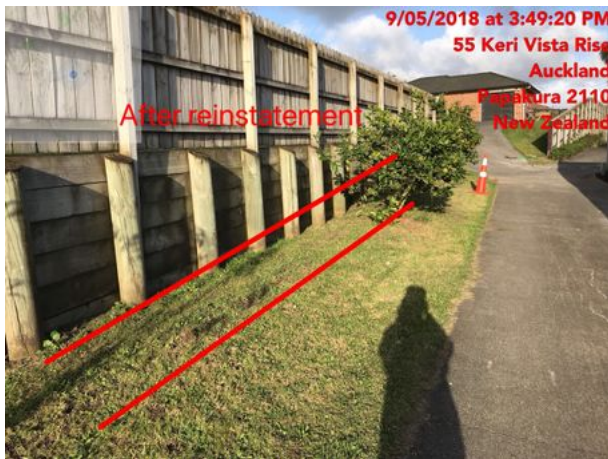
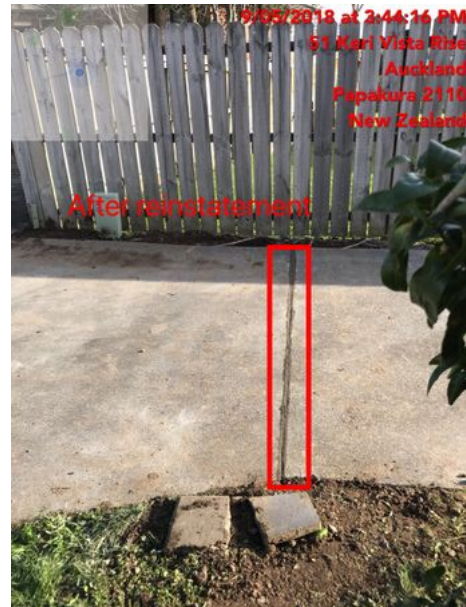
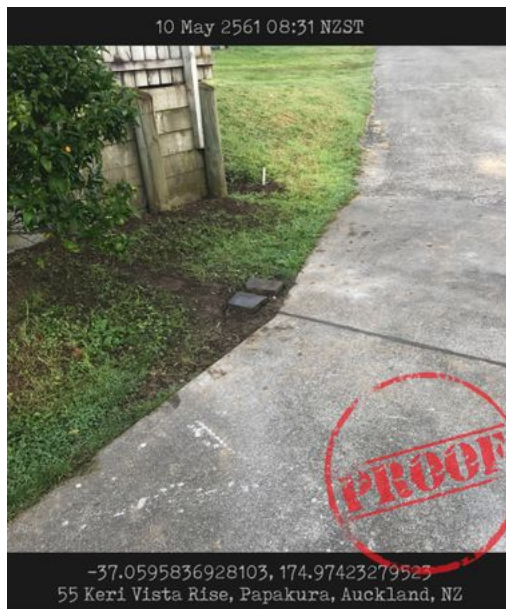
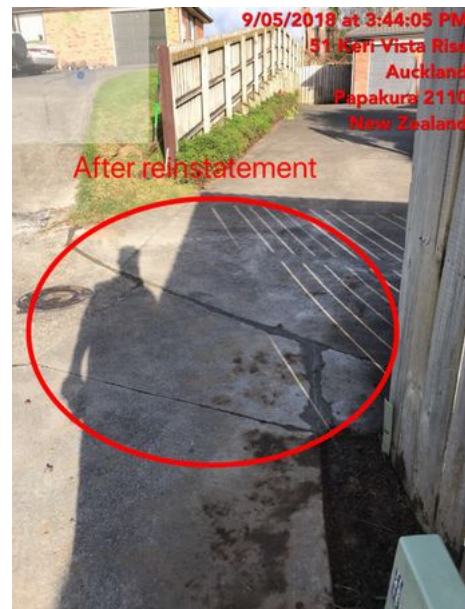
Question	Response	Details		
Photos of surfaces after final permanent reinstatment
