# UFB Connect - MDU / ROW Checklist - 5

## Fabril Solutions Ltd

33 Cranbrook Place

136763

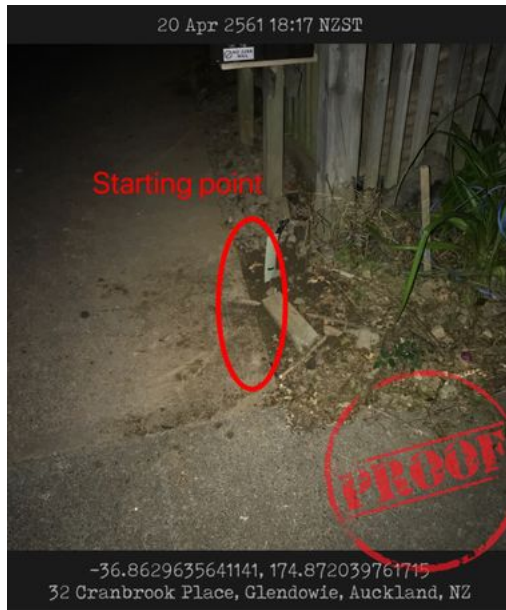
Appendix 1

Question	Response	Details
Photo of MDU/ROW starting point as per design document	Yes	
2) Photos of MDU/ROW starting point as per scoping document.		
<div style="display: flex; justify-content: space-around; align-items: flex-end;"> <div style="text-align: center;">

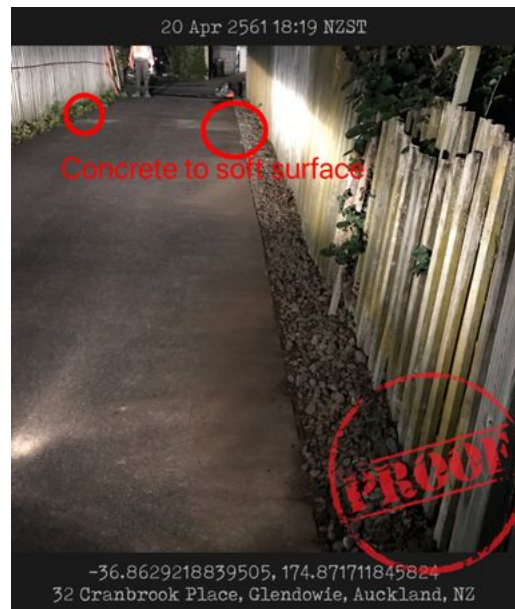
Appendix 6

Question	Response	Details
<p>Photos where change in surface type occurs</p>   <p>Appendix 6</p>		
Additional information where change in surface type occurs		
Photos where assets installed e.g. hand holes, IFDB's, Pedestals, BUD's, boundary pegs	Yes	
<p>Photos where assets installed e.g. hand holes, IFDB's, Pedestals, BUD's, boundary pegs</p>   <p>Appendix 7</p>   <p>Appendix 8</p>   <p>Appendix 9</p>		
Additional information where assets installed e.g. hand holes, IFDB's, Pedestals, BUD's, boundary pegs		
Photos of surfaces after final permanent reinstatement	Yes	
<p>Photos of surfaces after final permanent reinstatement</p>   <p>Appendix 10</p>   <p>Appendix 11</p>		
Additional information - e.g dimensions of concrete cut, removed and reinstated.	NA	
Is site ready for provisioning?	Yes
