UFB Connect - MDU / ROW Checklist - 5

Fabril Solutions Ltd

6A burnsall Place, Avondale

133226

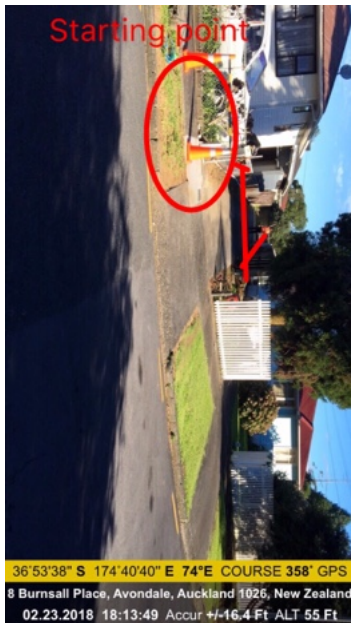
Appendix 1

Question	Response	Details
Photo of MDU/ROW starting point as per design document	Yes	
2) Photos of MDU/ROW starting point as per scoping document.

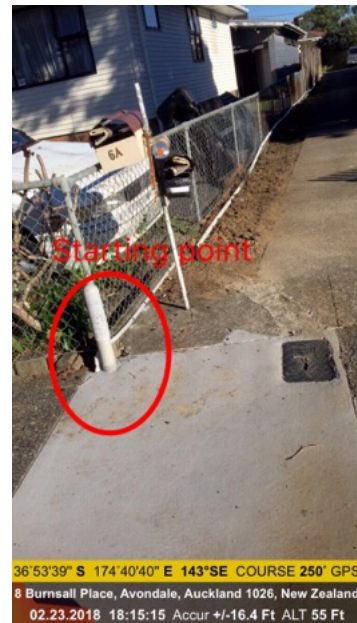
Appendix 2

<p>Appendix 2</p>		
Additional information of MDU/ROW starting point as per scoping document		
Photo of surfaces prior to works e.g trenching / slot cutting	Yes	
Photo of surfaces prior to works e.g trenching / slot cutting

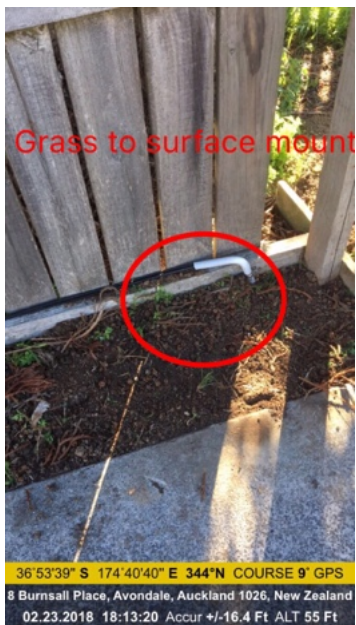
Appendix 9

<p>Appendix 8</p>		
Additional information of surfaces prior to works e.g trenching / slot cutting		
Photos where change in methodology occurs e.g. shallow trench to surface mount	Yes	
Photos where change in methodology occurs e.g. shallow trench to surface mount

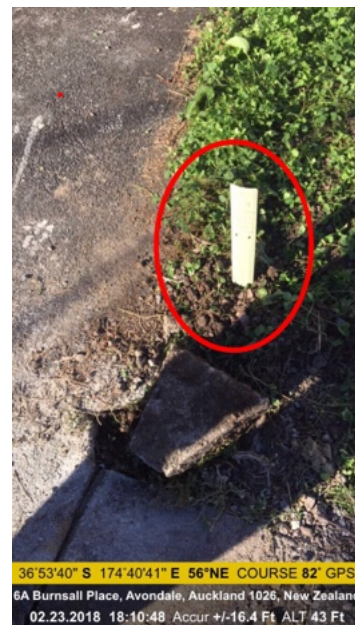
Appendix 14

Question	Response	Details
Photos where change in surface type occurs		
Photos where assets installed e.g. hand holes, IFDB's, Pedestals, BUD's, boundary pegs	Yes	
Photos where assets installed e.g. hand holes, IFDB's, Pedestals, BUD's, boundary pegs		
<div>

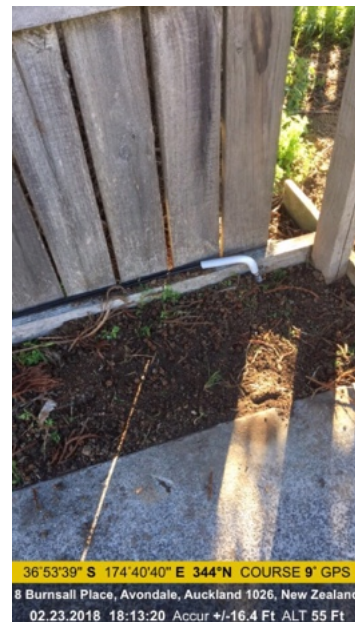
Appendix 16

<p>Appendix 15</p></div>	
Additional information where assets installed e.g. hand holes, IFDB's, Pedestals, BUD's, boundary pegs		
Photos of surfaces after final permanent reinstatement	Yes	
Photos of surfaces after final permanent reinstatement		
<div>
