UFB Connect - MDU / ROW Checklist - 5

Fabril Solutions Ltd

#132082

07 May 2018 04:29 AM

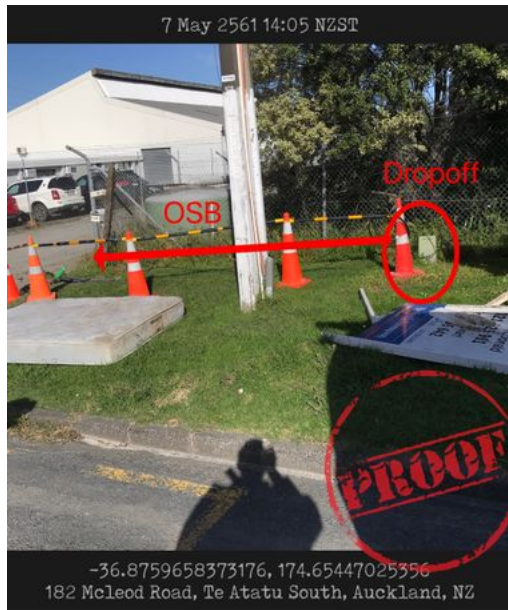
Appendix 1

Question	Response	Details
Photo of MDU/ROW starting point as per design document	Yes	
2) Photos of MDU/ROW starting point as per scoping document.

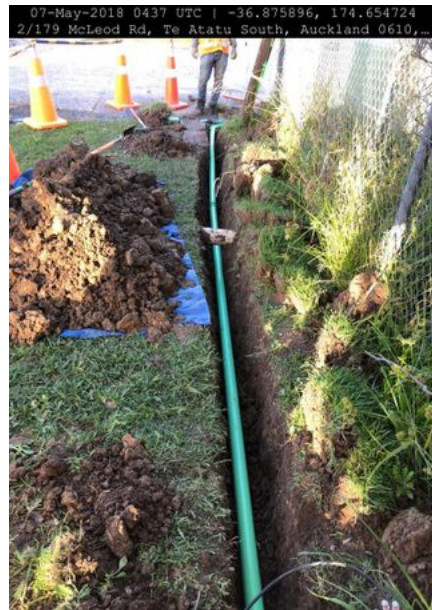
Appendix 2

<p>Appendix 2 Appendix 3 Appendix 4 Appendix 5 Appendix 6</p>		
Additional information of surfaces prior to works e.g trenching / slot cutting	Customer buried 50mm duct in the whole driveway for 2 customers.	
Photos where change in methodology occurs e.g. shallow trench to surface mount	Yes	
Photos where change in methodology occurs e.g. shallow trench to surface mount

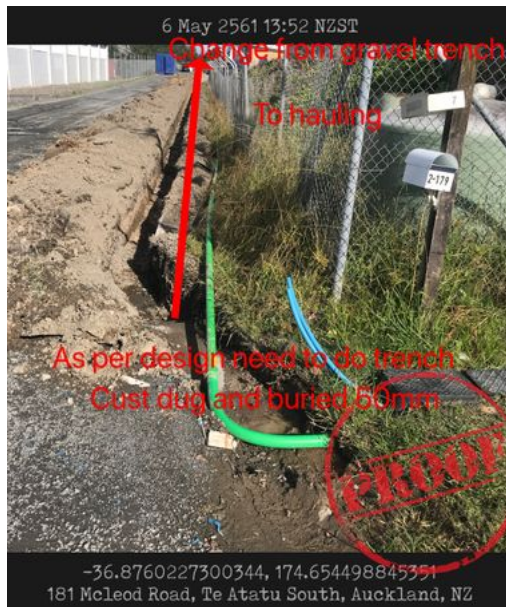
Appendix 7

Question	Response	Details
Additional information where change in methodology occurs e.g. shallow trench to surface mount	Customer buried 50mm duct along the driveway for 2 customers. We need to do haul 2*ruggedize through existing 59mm duct	
Photos where change in surface type occurs	No - N/A	
Why no photos where change is surface type occurs?	It's an hauling job. There are no changes in surface type	
Photos where assets installed e.g. hand holes, IFDB's, Pedestals, BUD's, boundary pegs	Yes	
Photos where assets installed e.g. hand holes, IFDB's, Pedestals, BUD's, boundary pegs		
<div><div>
