# UFB Connect - MDU / ROW Checklist - 5

## Fabril Solutions Ltd

739 NEW NORTH ROAD

133862

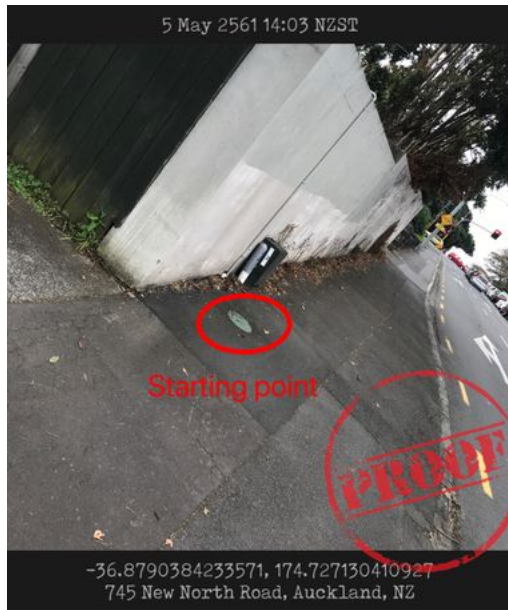
Appendix 1

Question	Response	Details
Photo of MDU/ROW starting point as per design document	Yes	
2) Photos of MDU/ROW starting point as per scoping document.

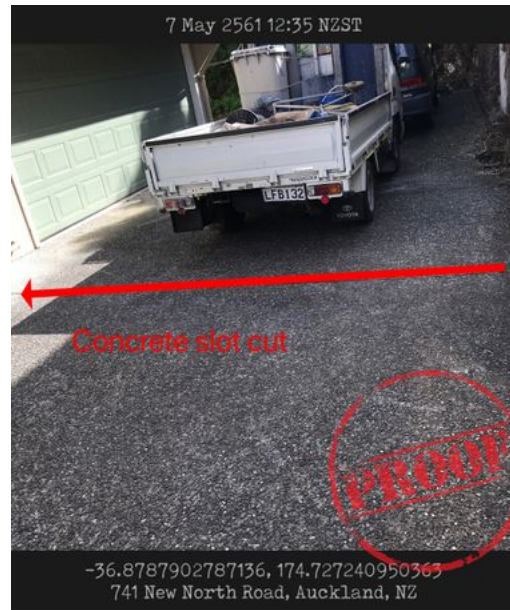
Appendix 2

<p>Appendix 1</p>		
Additional information of MDU/ROW starting point as per scoping document		
Photo of surfaces prior to works e.g trenching / slot cutting	Yes	
Photo of surfaces prior to works e.g trenching / slot cutting

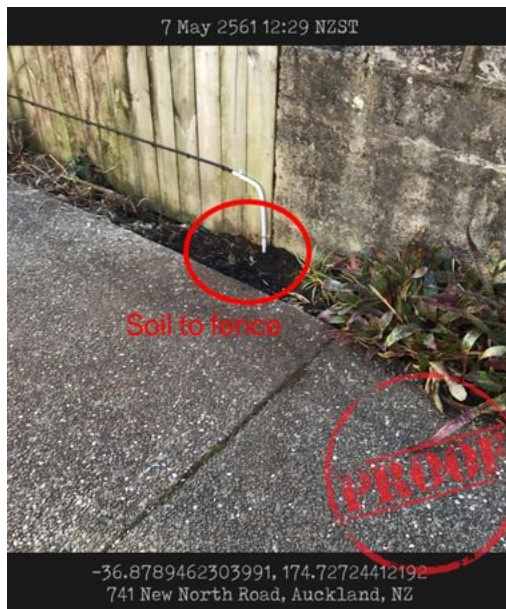
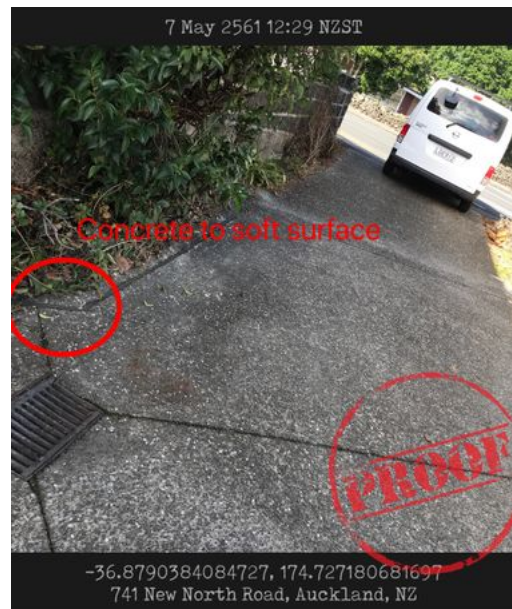
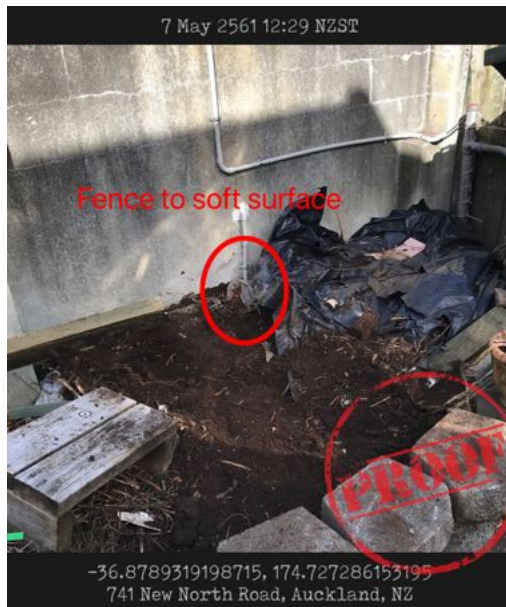
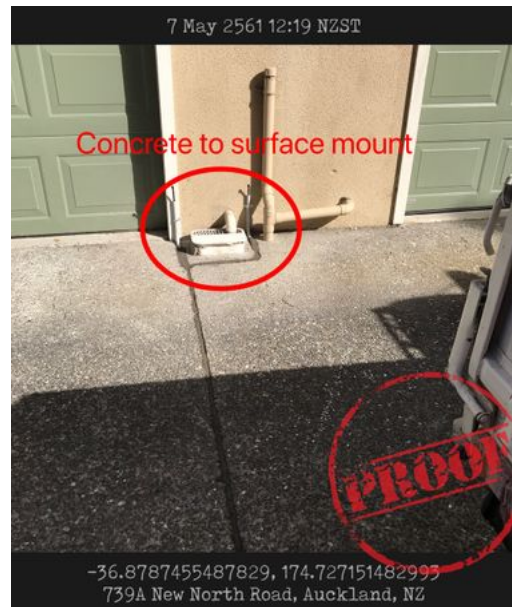
Question	Response	Details
Photos where change in surface type occurs	Yes	
<p>Photos where change in surface type occurs</p> <div>

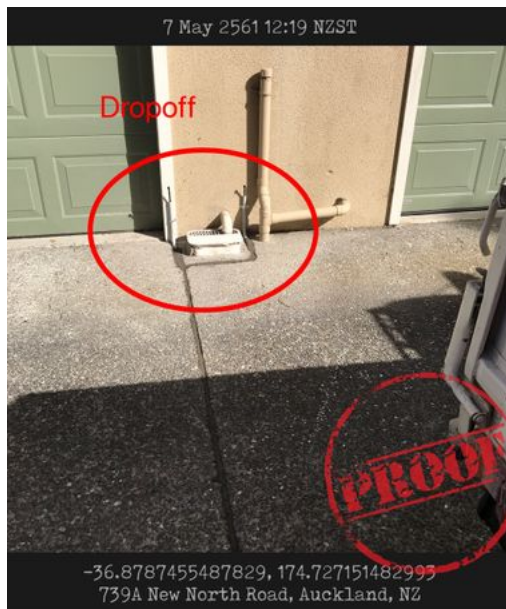
Appendix 13

</div> <div> <p>Appendix 9</p> <p>Appendix 10</p> <p>Appendix 11</p> <p>Appendix 12</p> </div>		
Additional information where change in surface type occurs		
Photos where assets installed e.g. hand holes, IFDB's, Pedestals, BUD's, boundary pegs	Yes	
<p>Photos where assets installed e.g. hand holes, IFDB's, Pedestals, BUD's, boundary pegs</p> <div>

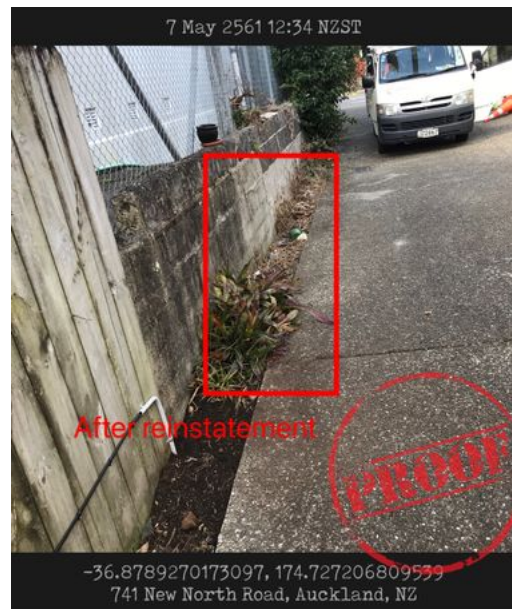
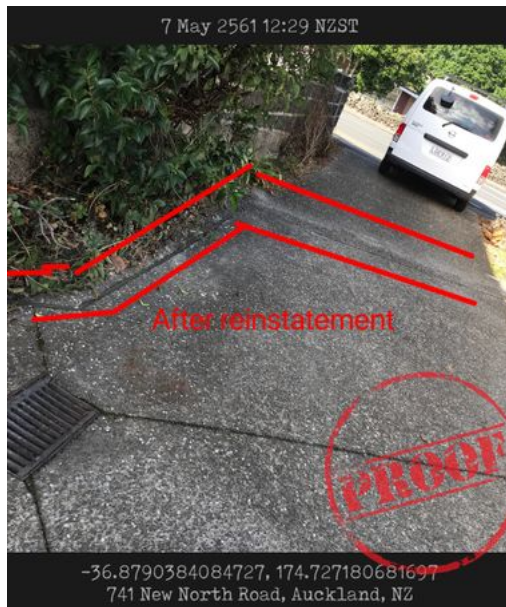
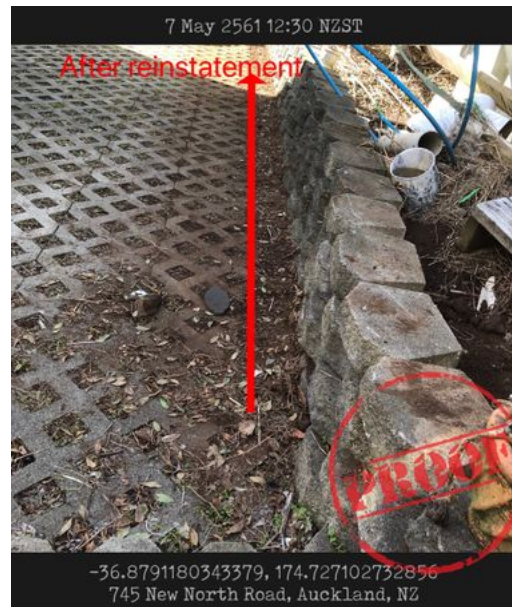
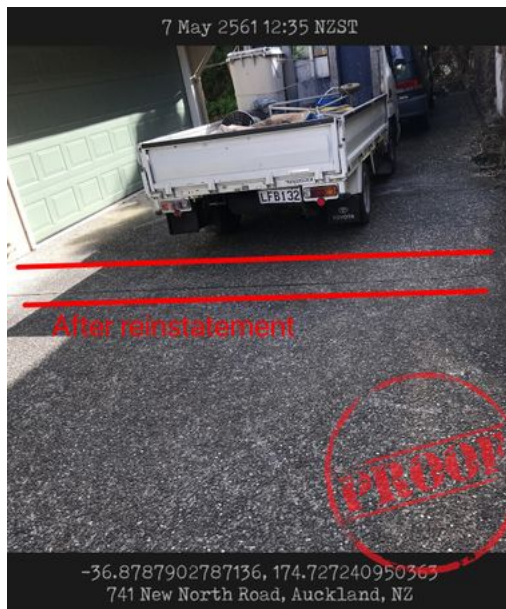
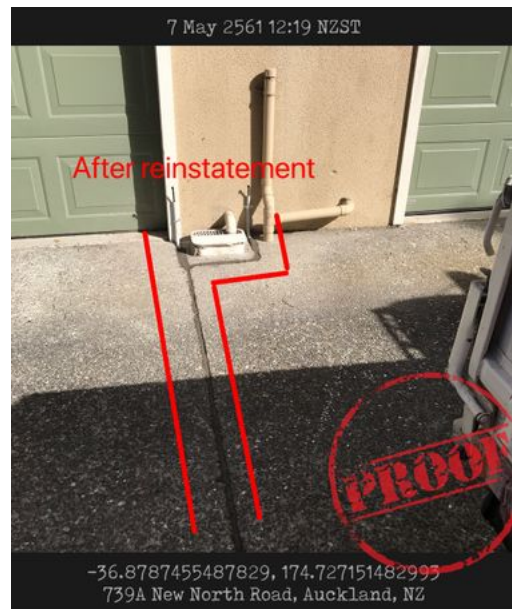
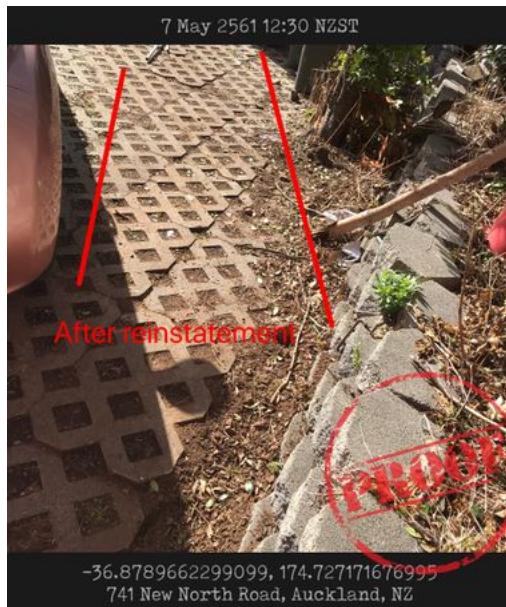
Question	Response	Details
Photos of surfaces after final permanent reinstatement
