UFB Connect - MDU / ROW Checklist - 5

Fabril Solutions Ltd

12B Norana Avenue

04 May 2018 11:31 PM

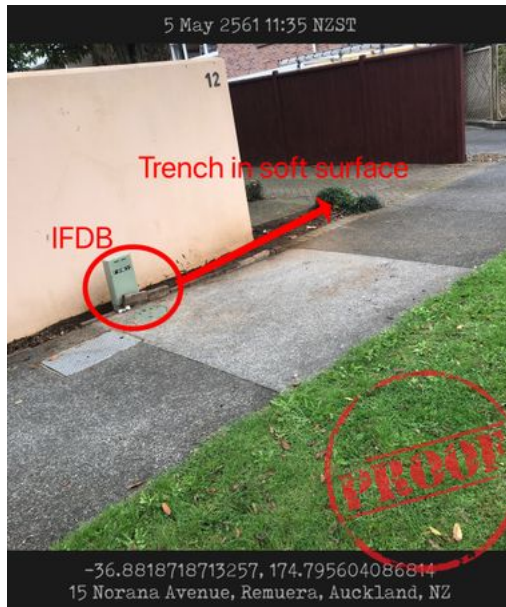
Appendix 1

Question	Response	Details
Photo of MDU/ROW starting point as per design document	Yes	
2) Photos of MDU/ROW starting point as per scoping document.		
<div style="display: flex; justify-content: space-around; align-items: flex-end;"> <div style="text-align: center;">

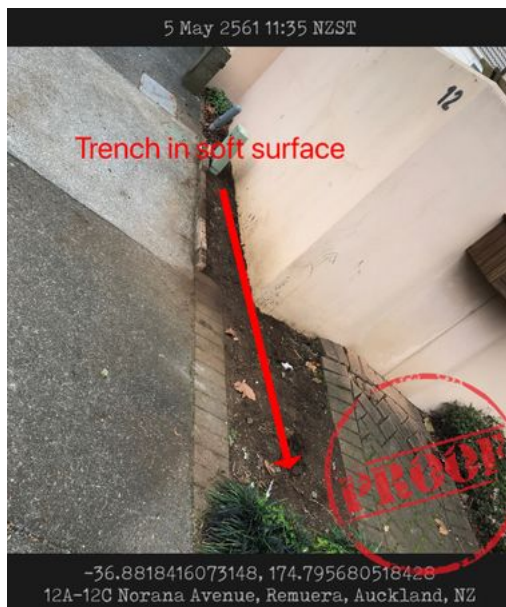
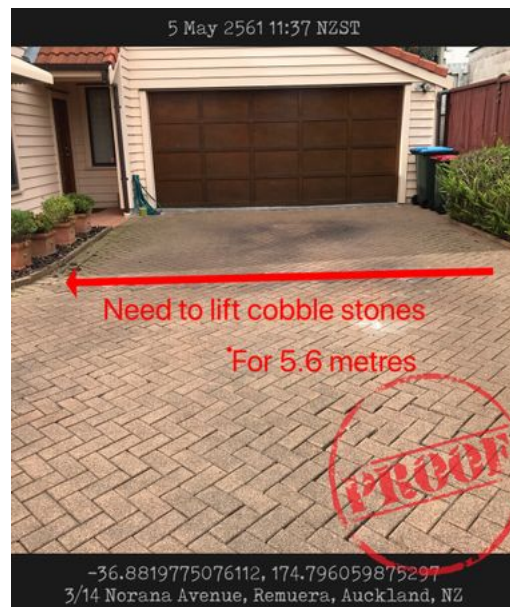
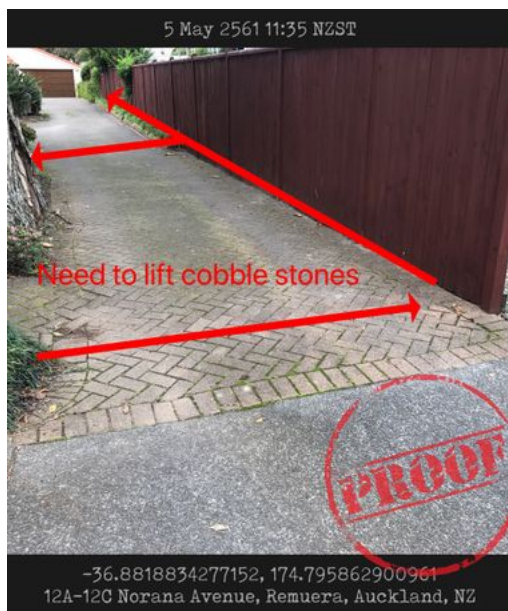
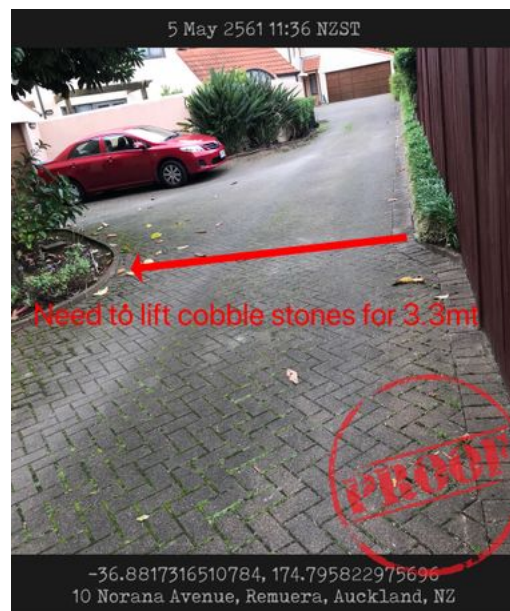
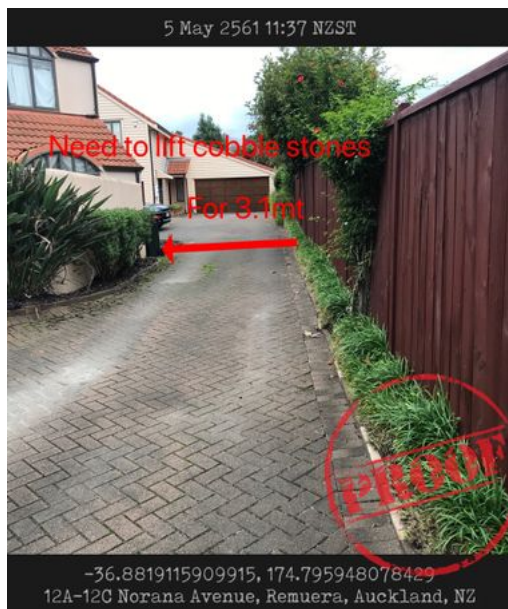
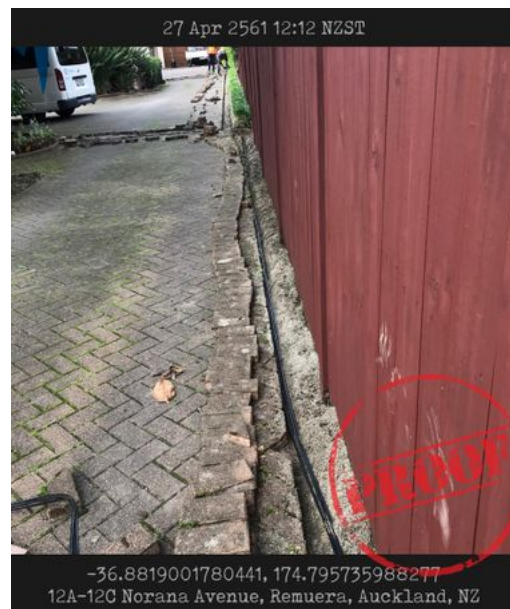
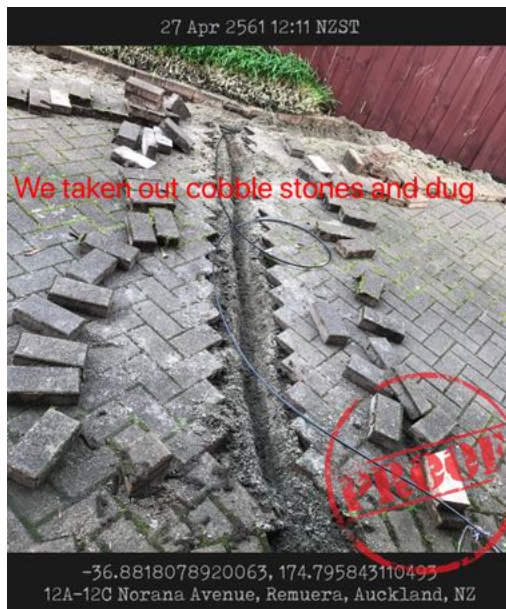
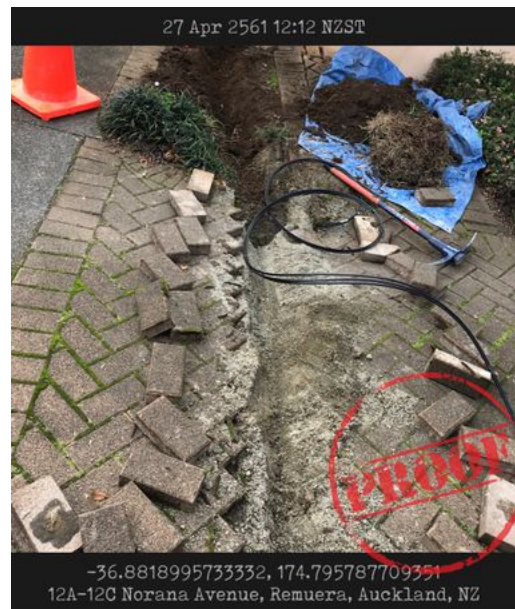
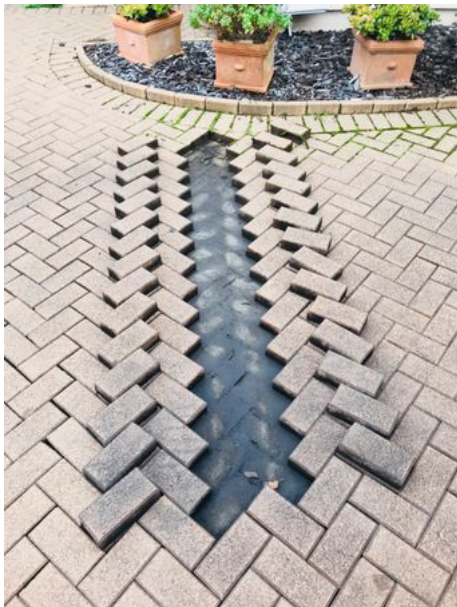
<p>Appendix 2</p> </div> </div>		
Additional information of MDU/ROW starting point as per scoping document		
Photo of surfaces prior to works e.g trenching / slot cutting	Yes	
Photo of surfaces prior to works e.g trenching / slot cutting		
<div style="display: grid; grid-template-columns: repeat(6, 1fr); gap: 10px;"> <div style="text-align: center;">

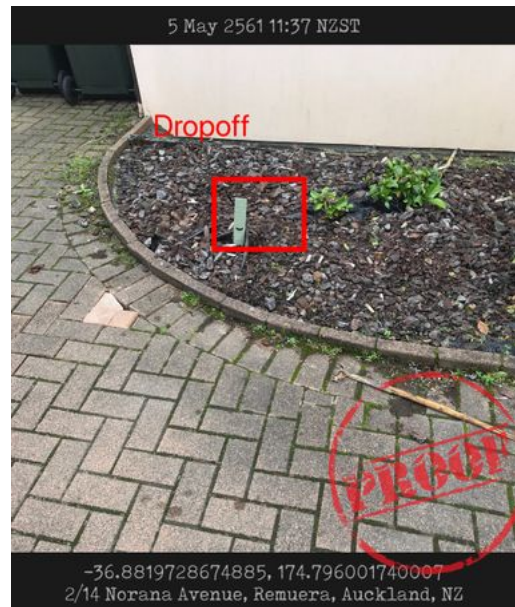
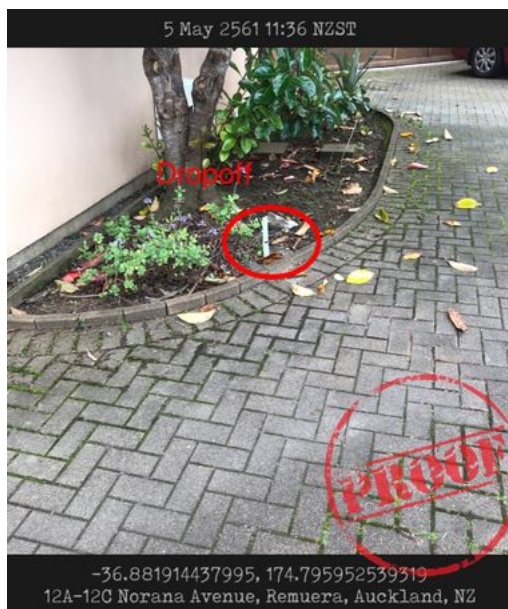
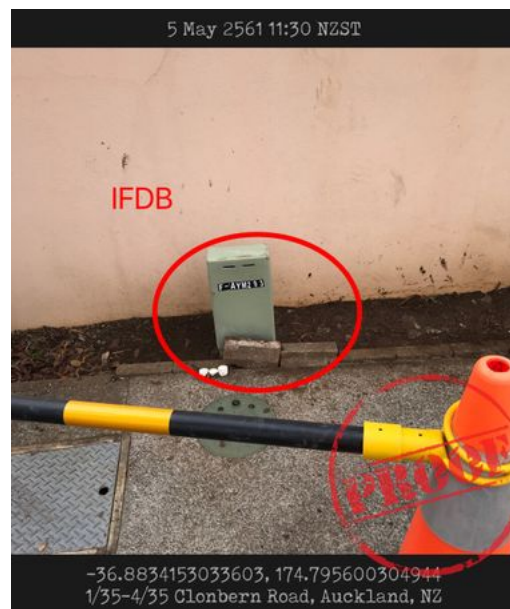
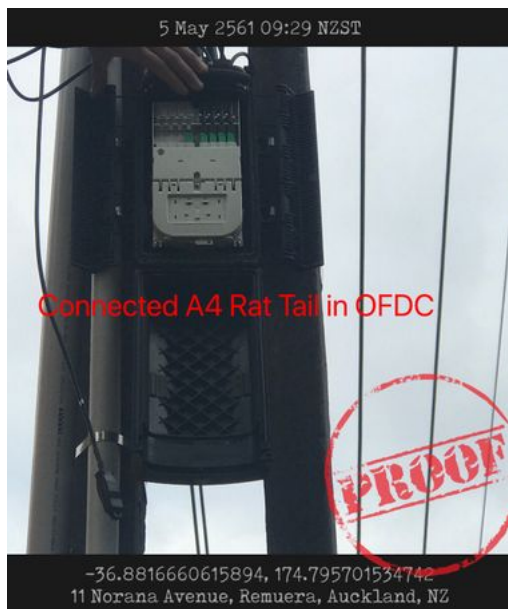
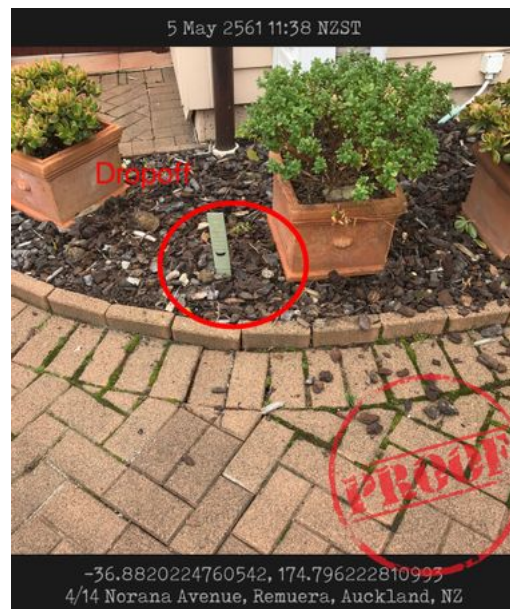
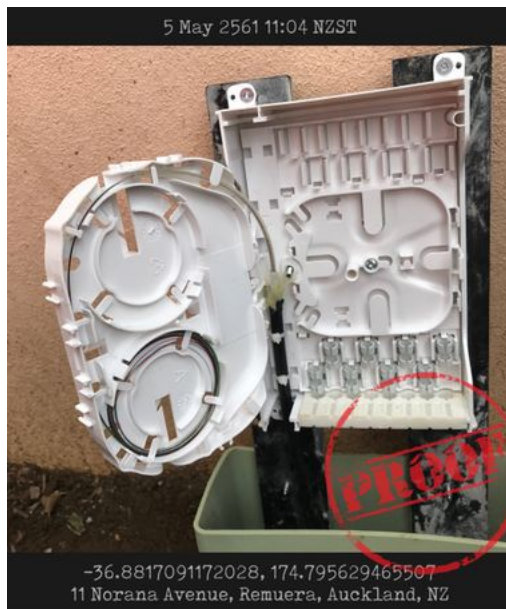
Question	Response	Details
Photos where change in surface type occurs	No - N/A	
Why no photos where change is surface type occurs?	There is no changes in surface type	
Photos where assets installed e.g. hand holes, IFDB's, Pedestals, BUD's, boundary pegs	Yes	
<p>Photos where assets installed e.g. hand holes, IFDB's, Pedestals, BUD's, boundary pegs</p> <div>

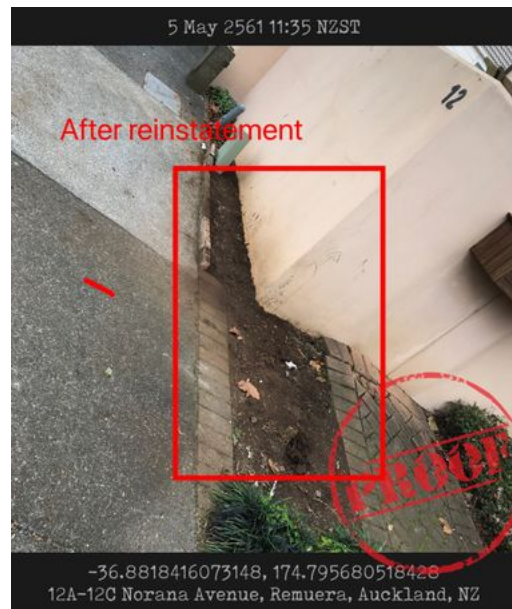
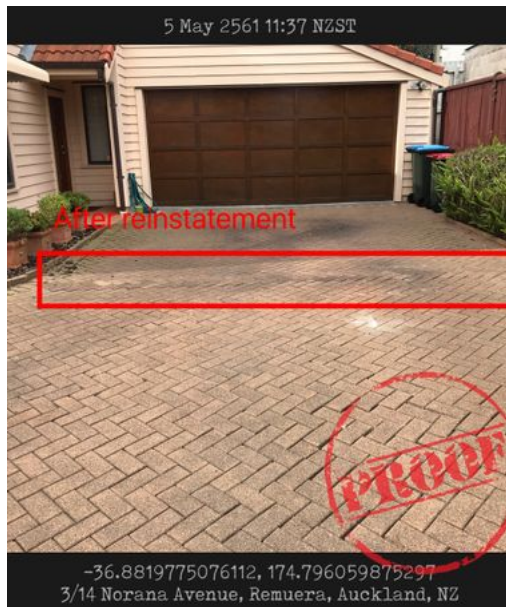
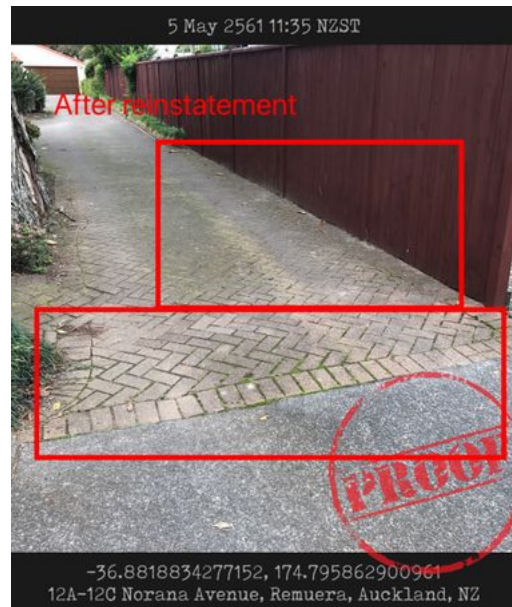
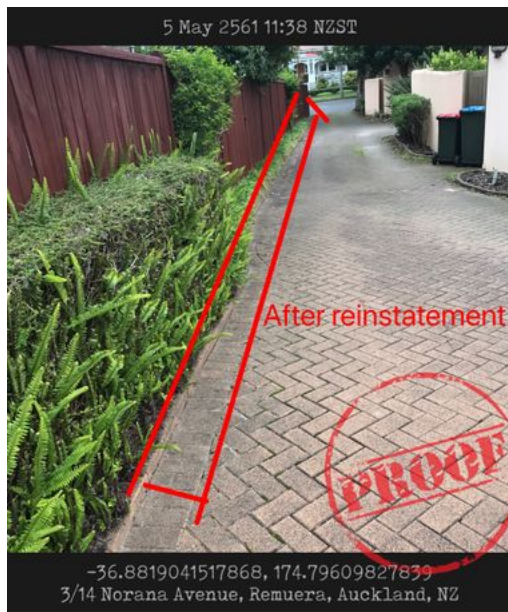
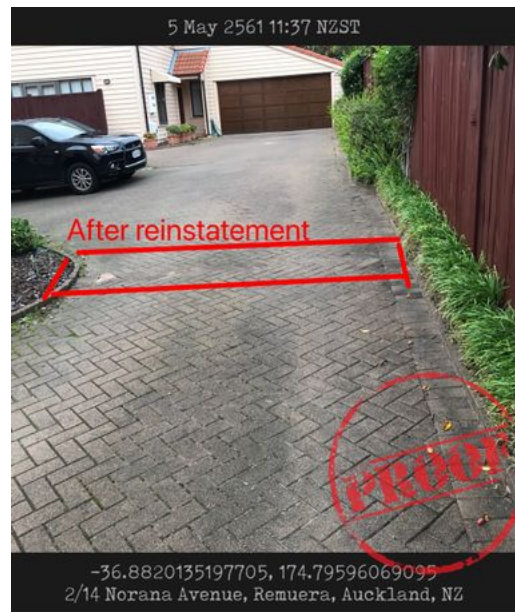
</div> <div> <p>Appendix 12</p> <p>Appendix 13</p> <p>Appendix 14</p> <p>Appendix 15</p> <p>Appendix 16</p> <p>Appendix 17</p> </div>		
Additional information where assets installed e.g. hand holes, IFDB's, Pedestals, BUD's, boundary pegs		
Photos of surfaces after final permanent reinstatment	Yes	
<p>Photos of surfaces after final permanent reinstatment</p> <div>
