UFB Connect - MDU / ROW Checklist - 5

Fabril Solutions Ltd

8 Latham avenue

15 May 2018 10:45 PM

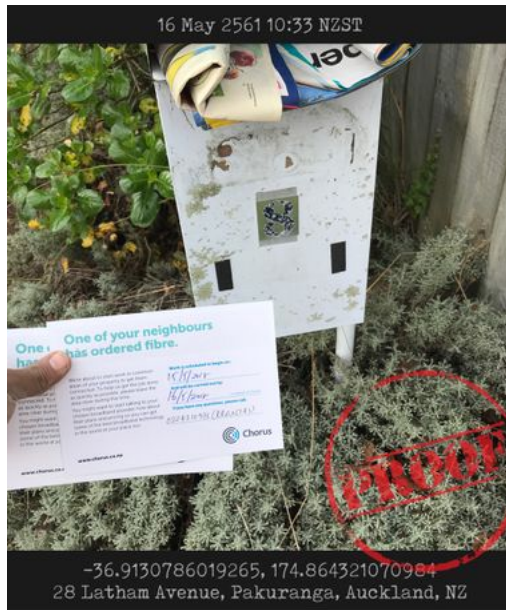
Appendix 1

Question	Response	Details
Photo of MDU/ROW starting point as per design document	Yes	
2) Photos of MDU/ROW starting point as per scoping document.		
<div style="display: flex; justify-content: space-around; align-items: flex-end;"> <div style="text-align: center;">

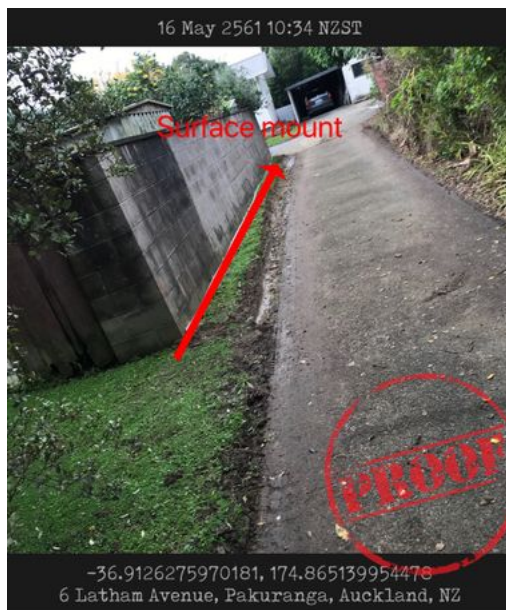
Appendix 3

<p>Appendix 2</p> </div> </div>		
Additional information of MDU/ROW starting point as per scoping document		
Photo of surfaces prior to works e.g trenching / slot cutting	Yes	
Photo of surfaces prior to works e.g trenching / slot cutting		
<div style="display: flex; justify-content: space-around; align-items: flex-end;"> <div style="text-align: center;">

Additional information of surfaces prior to works e.g trenching / slot cutting	Clip conduit on wall for 14.5 metres	
Photos where change in methodology occurs e.g. shallow trench to surface mount	No - N/A	
Why no photo's where methodology changes?	No changes in methodology	
Photos where change in surface type occurs	Yes

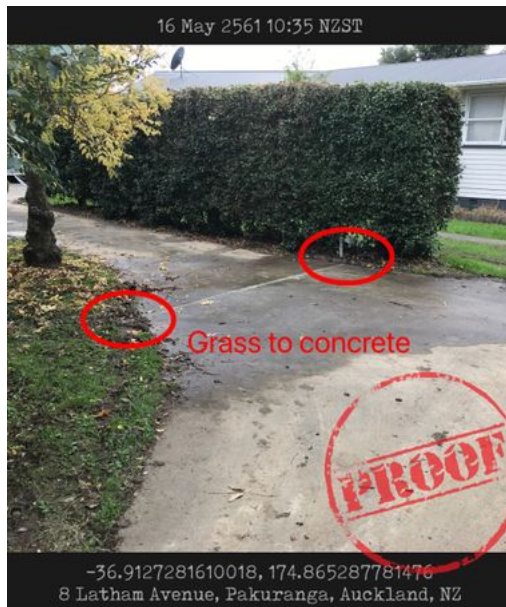
Appendix 7

Question	Response	Details
<p>Photos where change in surface type occurs</p> <div>

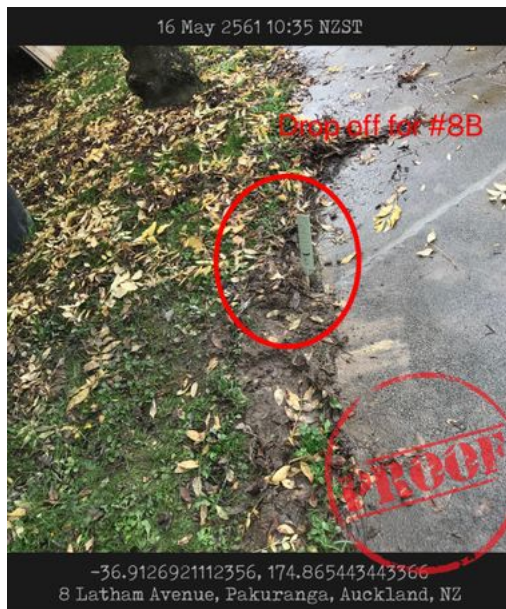
Appendix 9

</div> <p>Appendix 7 Appendix 8</p>		
Additional information where change in surface type occurs		
Photos where assets installed e.g. hand holes, IFDB's, Pedestals, BUD's, boundary pegs		Yes
<p>Photos where assets installed e.g. hand holes, IFDB's, Pedestals, BUD's, boundary pegs</p> <div>

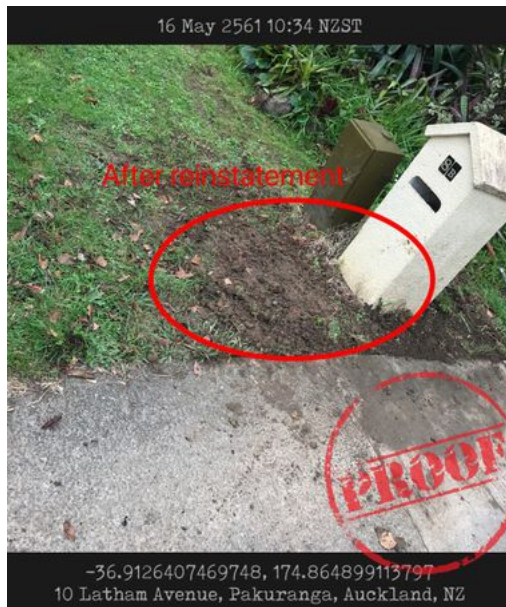
Appendix 11

</div> <p>Appendix 9 Appendix 10</p>		
Additional information where assets installed e.g. hand holes, IFDB's, Pedestals, BUD's, boundary pegs		
Photos of surfaces after final permanent reinstatement		Yes
<p>Photos of surfaces after final permanent reinstatement</p> <div>
