UFB Connect - MDU / ROW Checklist - 5

Fabril Solutions Ltd

180b Barrack Road

136569

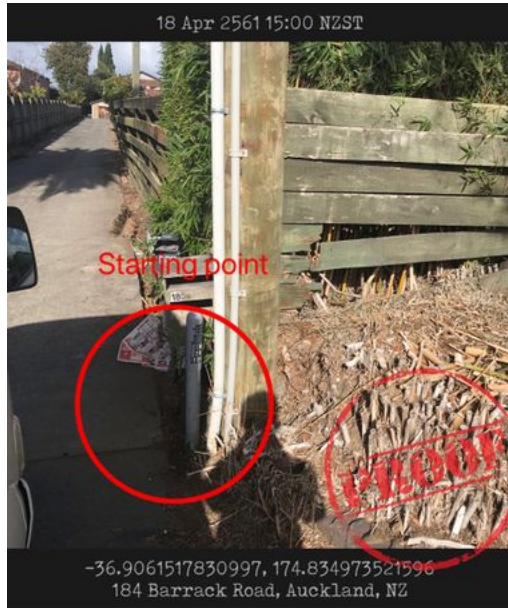
Appendix 1

Question	Response	Details
Photo of MDU/ROW starting point as per design document	Yes	
2) Photos of MDU/ROW starting point as per scoping document.

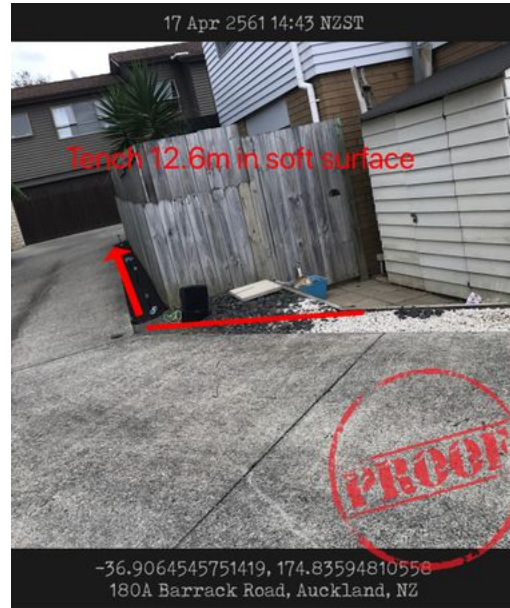
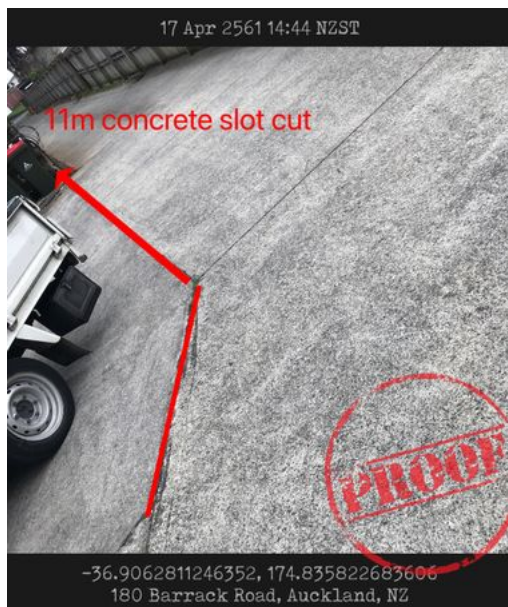
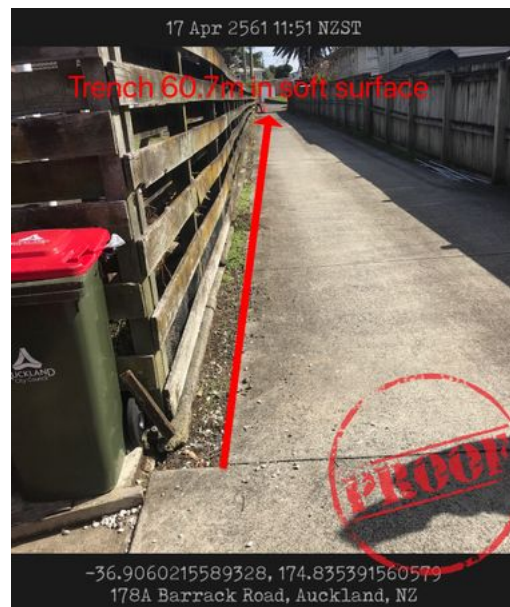
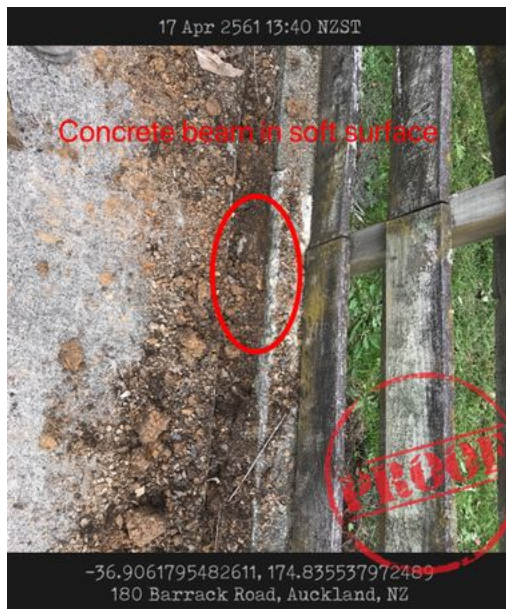
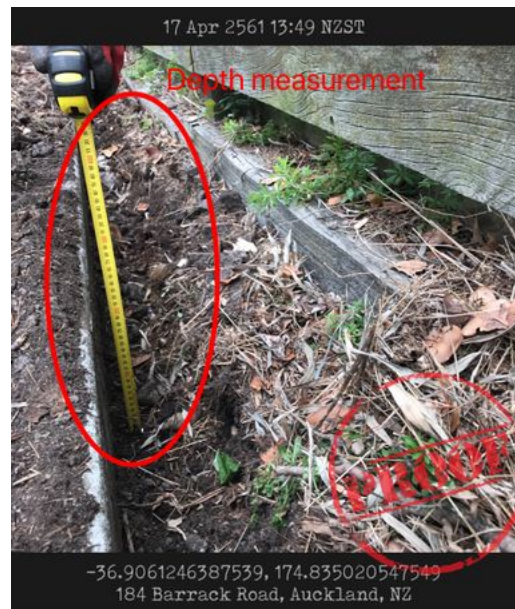
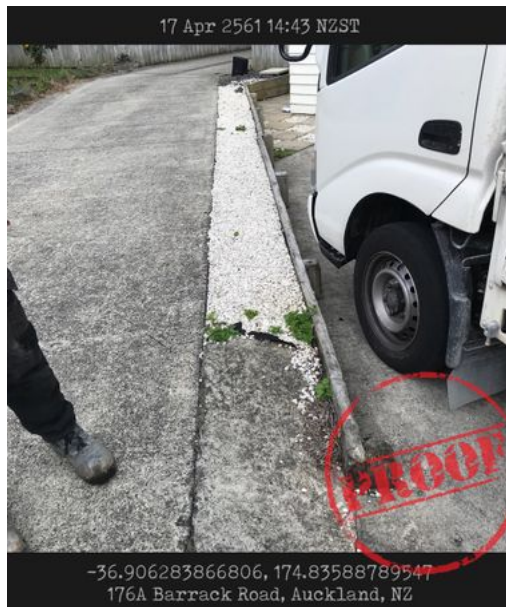
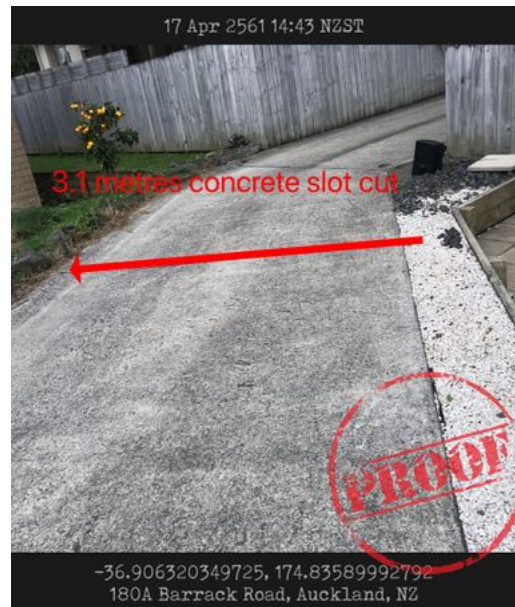
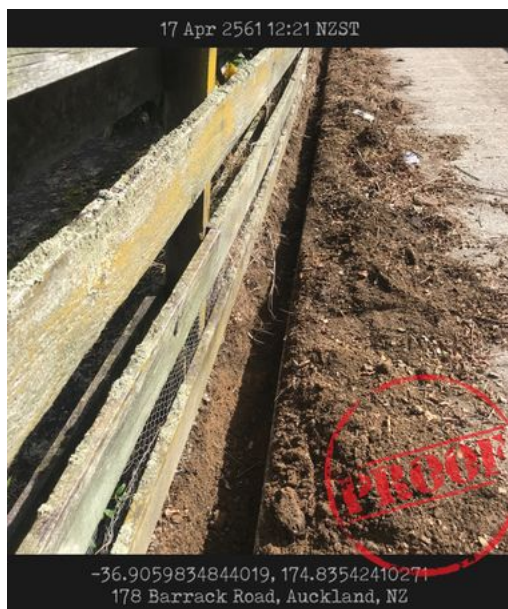
<p>Appendix 1</p>		
Additional information of MDU/ROW starting point as per scoping document		
Photo of surfaces prior to works e.g trenching / slot cutting	Yes	
Photo of surfaces prior to works e.g trenching / slot cutting

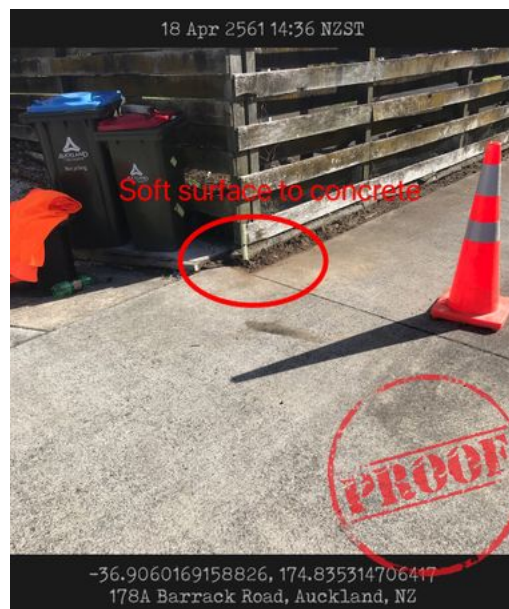
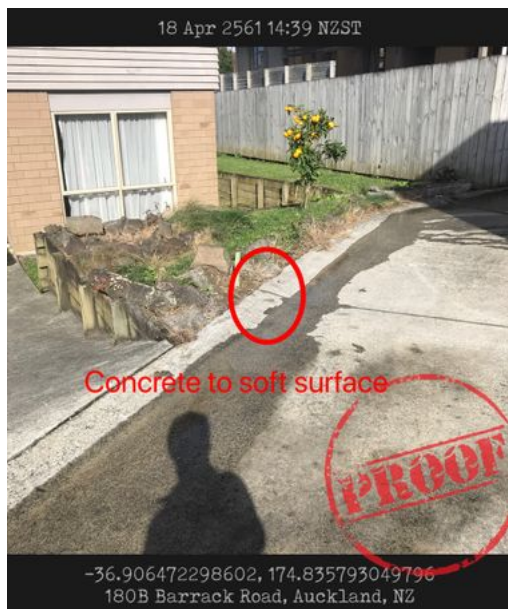
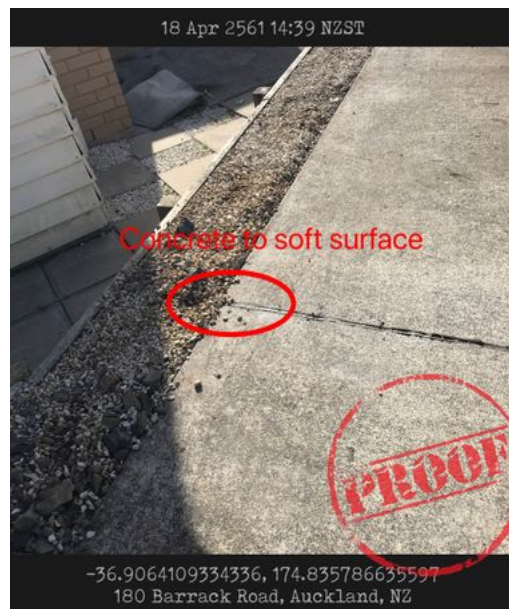
Question	Response	Details
Photos where change in surface type occurs	Yes	
<p>Photos where change in surface type occurs</p> <div>

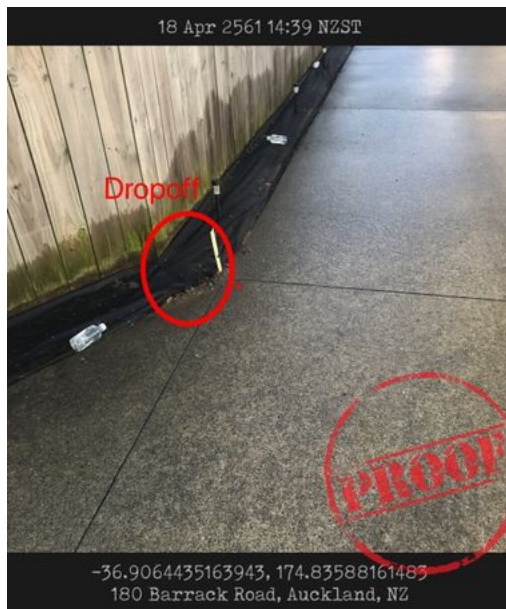
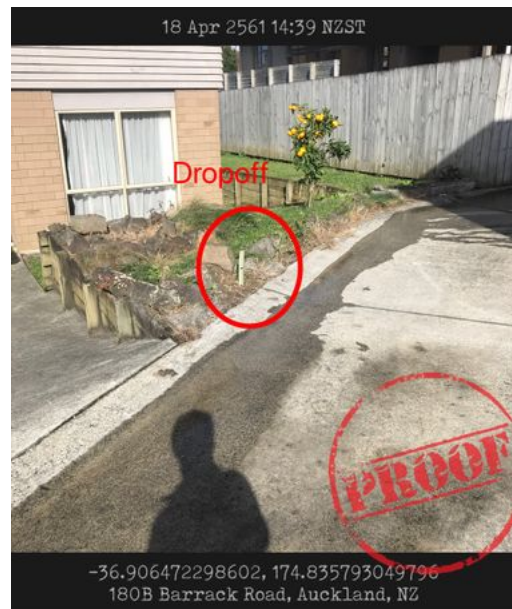
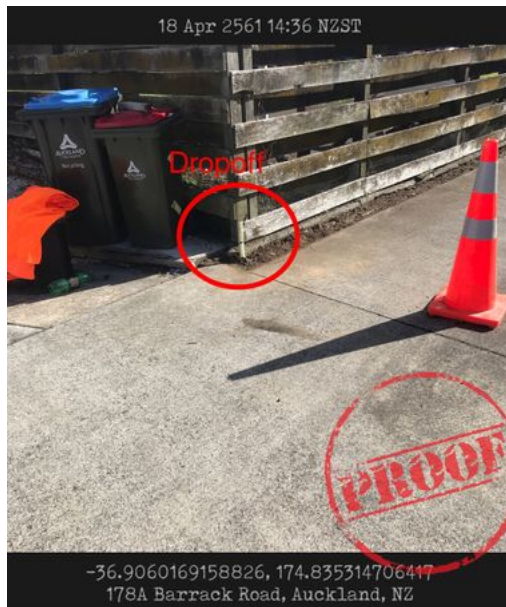
</div> <div> <p>Appendix 10</p> <p>Appendix 11</p> <p>Appendix 12</p> </div>		
Additional information where change in surface type occurs		
Photos where assets installed e.g. hand holes, IFDB's, Pedestals, BUD's, boundary pegs	Yes	
<p>Photos where assets installed e.g. hand holes, IFDB's, Pedestals, BUD's, boundary pegs</p> <div>

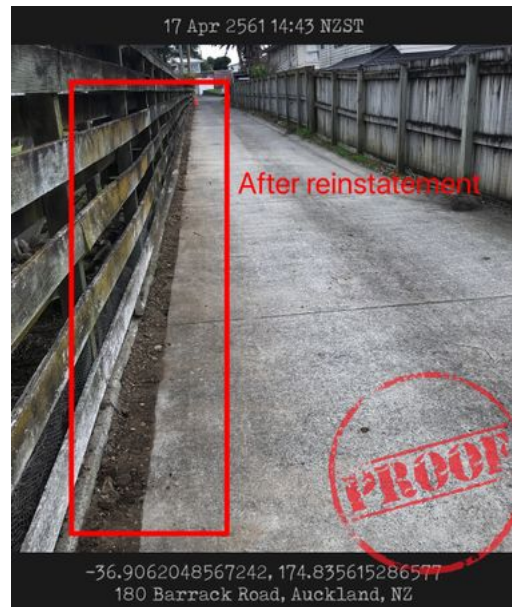
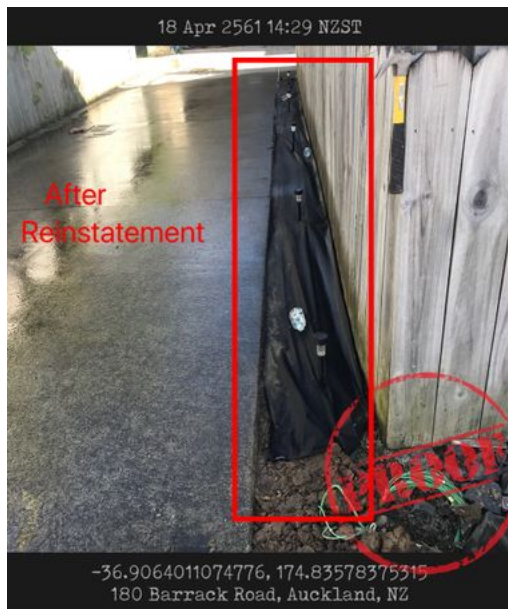
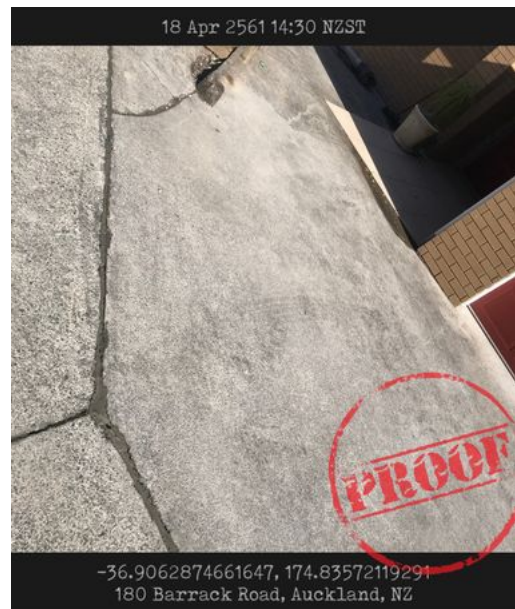
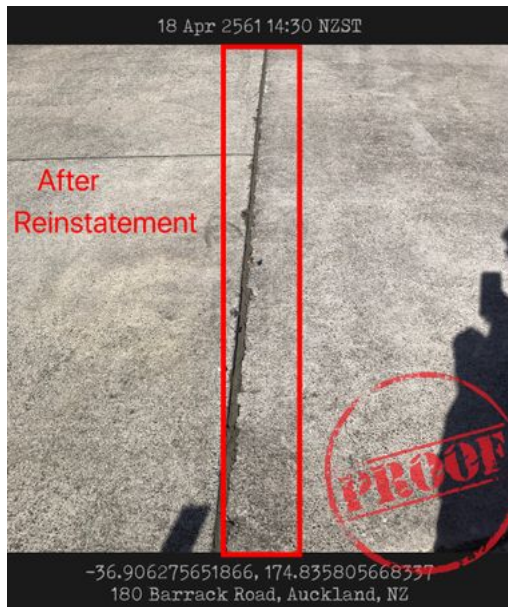
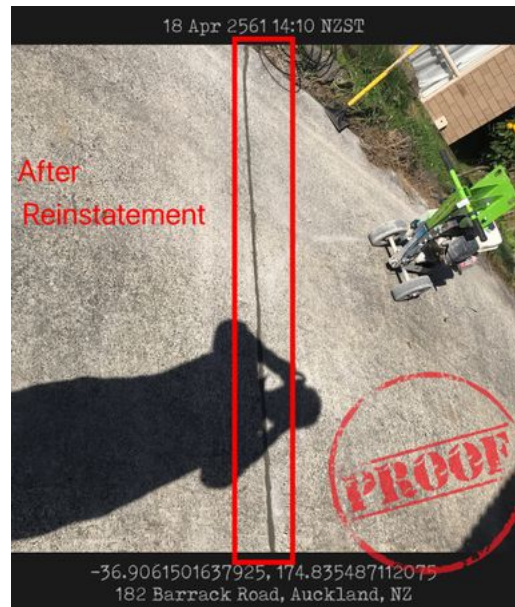
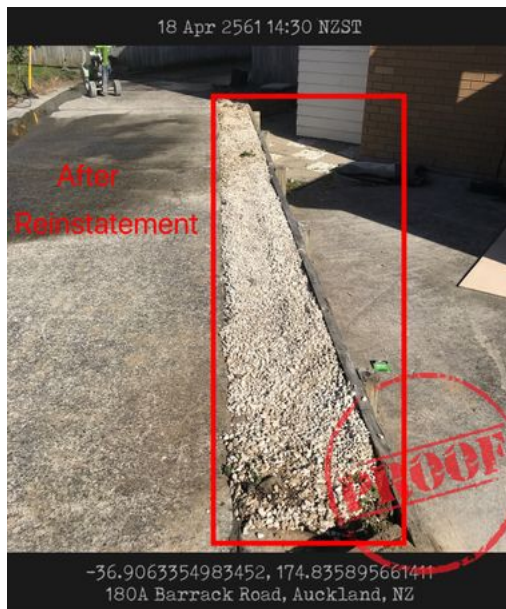
Question	Response	Details			
Photos of surfaces after final permanent reinstatment
