UFB Connect - MDU / ROW Checklist - 5

Fabril Solutions Ltd

1/5 Prictor street, papakura

08 May 2018 09:32 PM

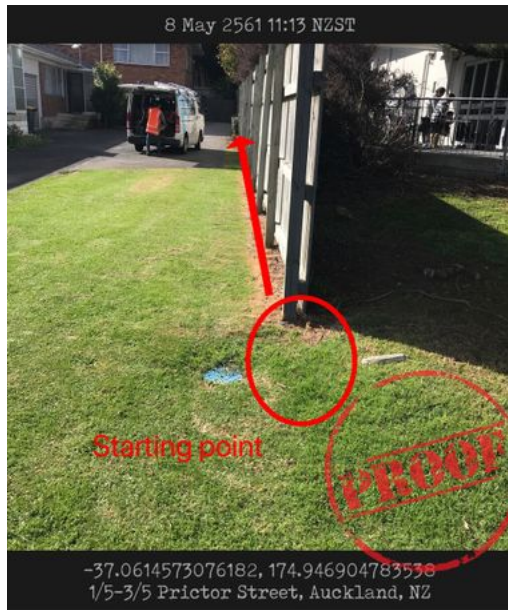
Appendix 1

Question	Response	Details
Photo of MDU/ROW starting point as per design document	Yes	
2) Photos of MDU/ROW starting point as per scoping document.

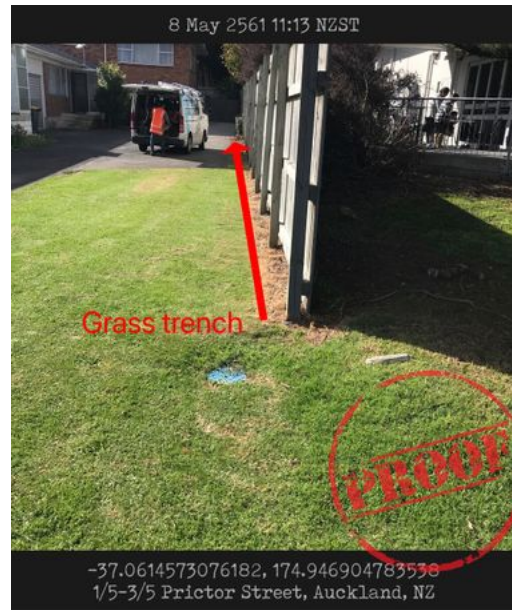
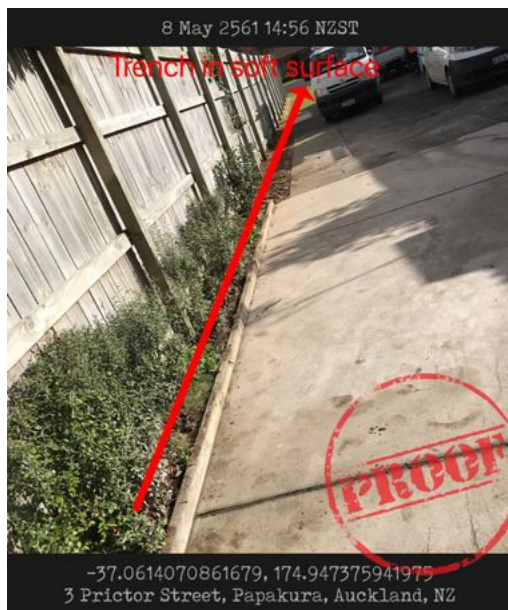
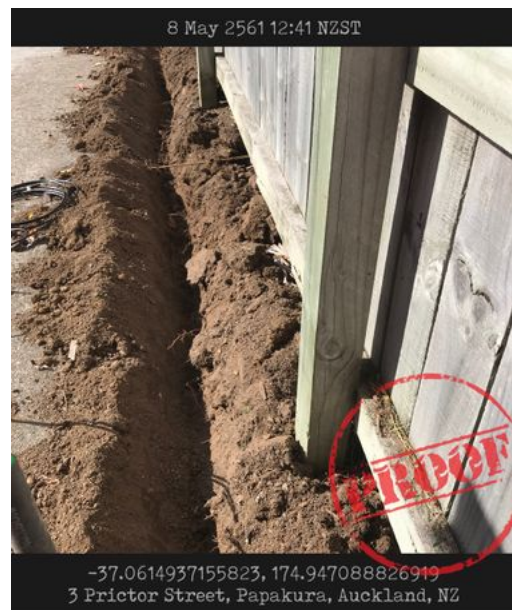
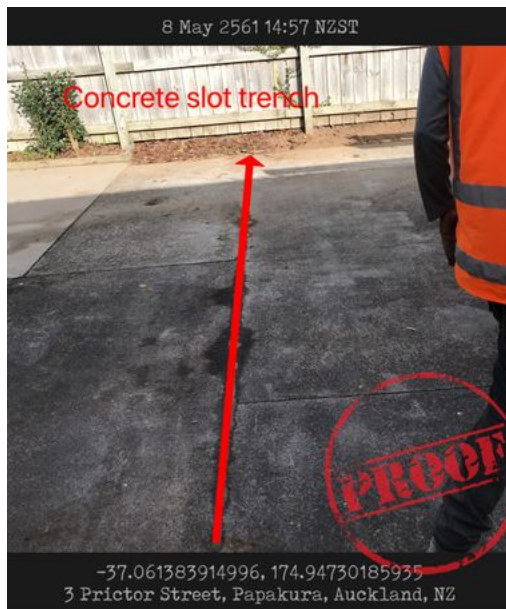
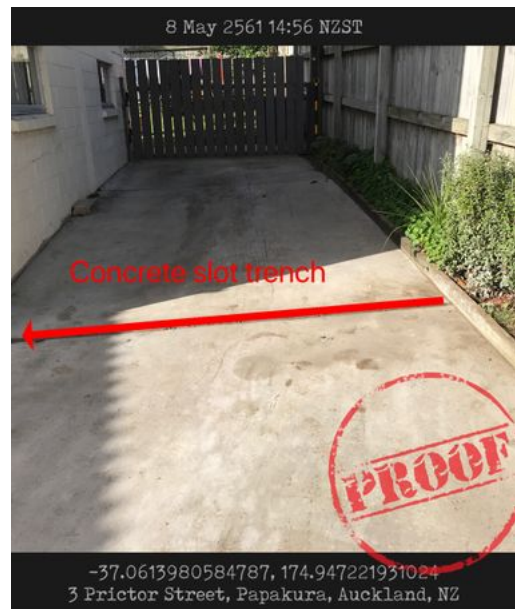
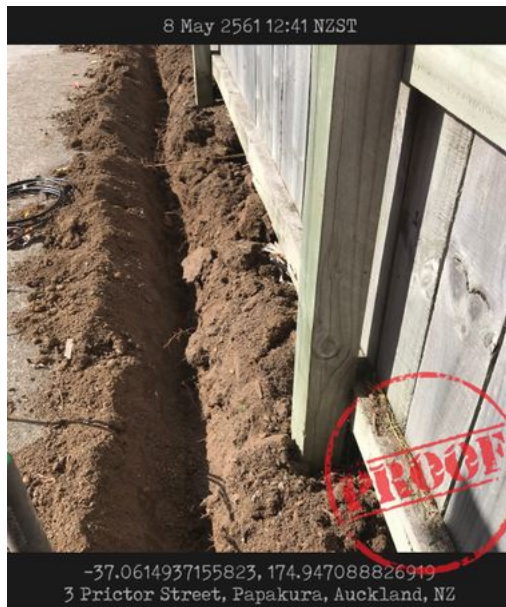
<p>Appendix 1</p>		
Additional information of MDU/ROW starting point as per scoping document		
Photo of surfaces prior to works e.g trenching / slot cutting	Yes	
Photo of surfaces prior to works e.g trenching / slot cutting

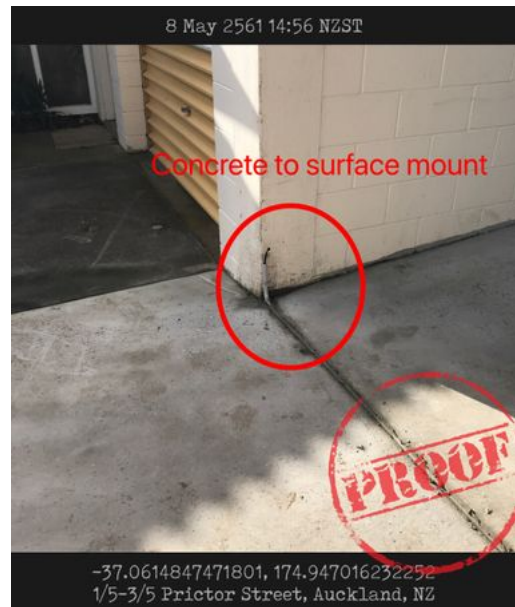
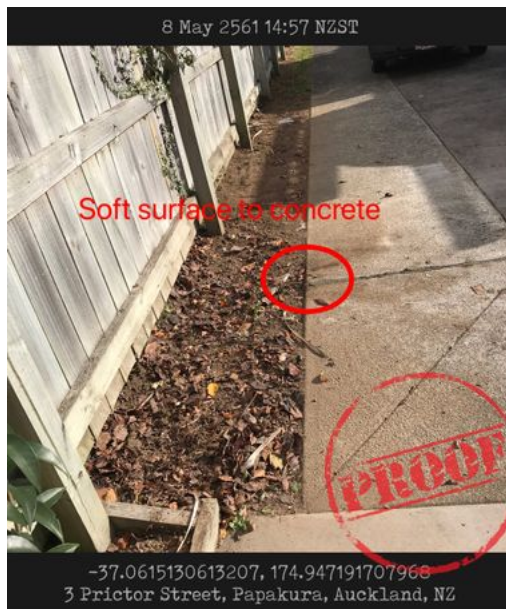
Question	Response	Details
Photos where change in surface type occurs	Yes	
<p>Photos where change in surface type occurs</p> <div>

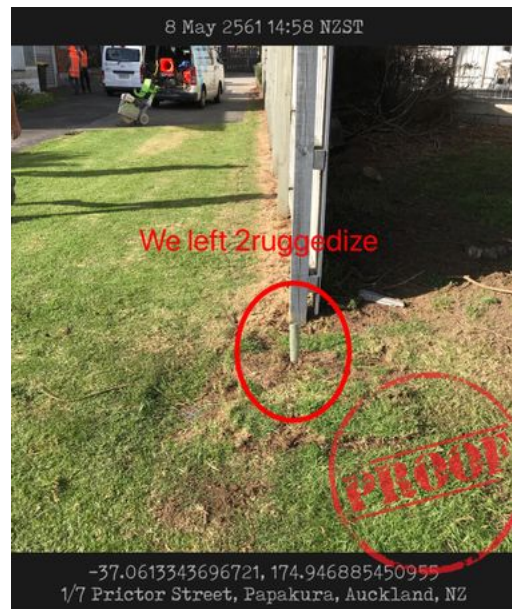
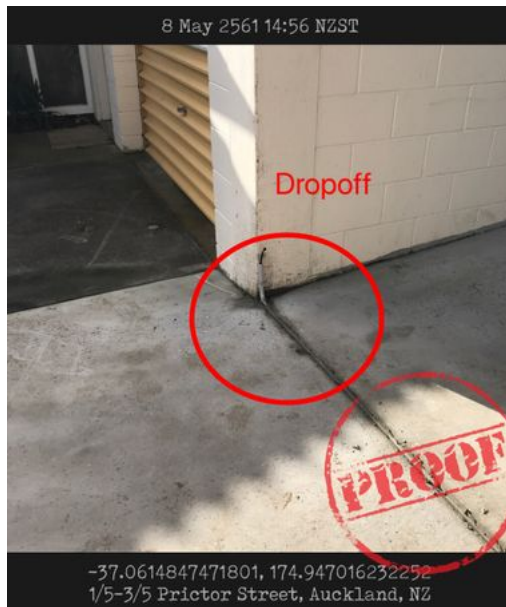
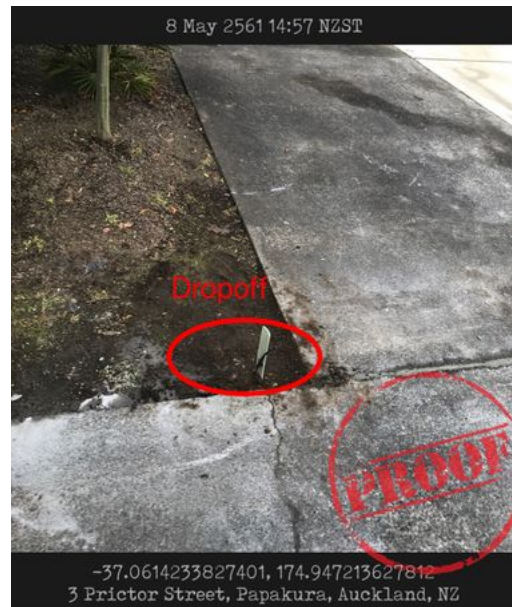
</div> <p>Appendix 8 Appendix 9</p>		
Additional information where change in surface type occurs		
Photos where assets installed e.g. hand holes, IFDB's, Pedestals, BUD's, boundary pegs	Yes	
<p>Photos where assets installed e.g. hand holes, IFDB's, Pedestals, BUD's, boundary pegs</p> <div>

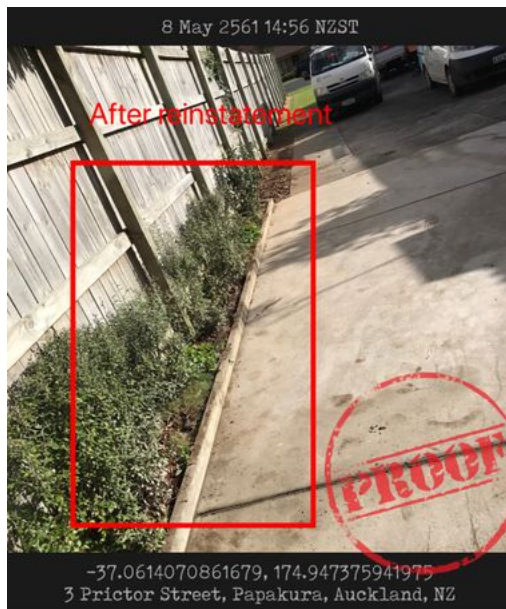
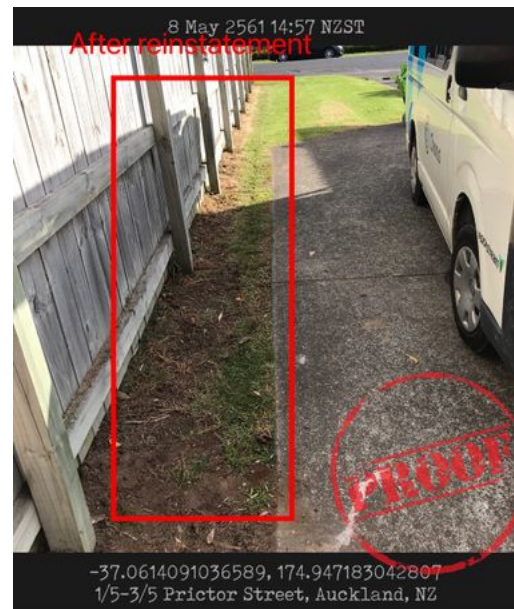
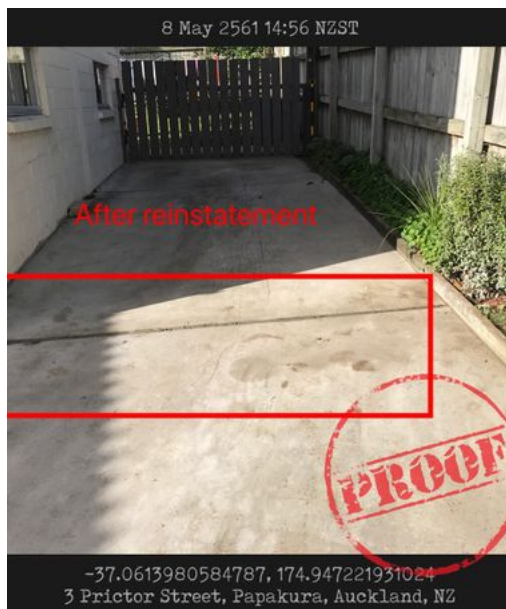
</div> <p>Appendix 10 Appendix 11 Appendix 12</p>		
Additional information where assets installed e.g. hand holes, IFDB's, Pedestals, BUD's, boundary pegs		
Photos of surfaces after final permanent reinstatment	Yes	
<p>Photos of surfaces after final permanent reinstatment</p> <div>
