Mid Term Evaluation of Soil Piping in Highland and Foothills of Kerala to avoid Disaster

DRAFT REPORT

Indian Institute of Public Administration

Date of report: 16th February, 2015

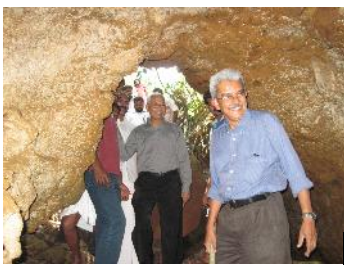
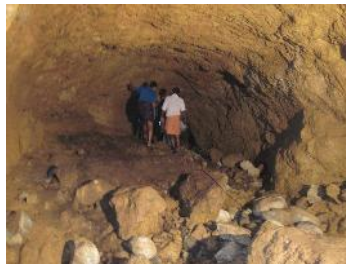
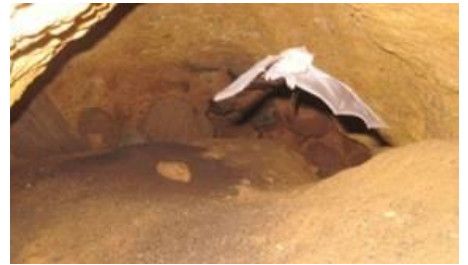
Figure 3: Different views of a matured pipe in Cherupuzha

Tunnel entrance

linear extension of tunnel

Tunnel inside view

Located in the Kottathalachimala, near Cherupuzha, Kannur this pipe is old and matured. At present soil erosion is very low inside the tunnel. The geophysical experiments were conducted at this locality. In fact this entire village is affected by soil piping process. The tunnel opening is seen at the place where subsidence has taken place. Presence of bats in the tunnel is indicative of the presence of oxygen in the tunnel. Since the tunnel is wide and

accessible. 2D resistivity surveys were conducted across known sections to determine the type of survey method suitable for pipe discovery. Geophysical surveys indicated that this tunnel is 50m in length and branching at the end is indicated. The tunnel attains a max dimension of 3 meters height and 4meters width. The sections clearly indicate that the Saprolite section of the laterite is eroded producing huge tunnels. Chemical analysis of the soil samples indicated the presence of Gibbsite and exchangeable sodium which are responsible for the mobility of the clay. This gives the clue for chemical amelioration as a mitigation method. The lighting is artificially generated inside for the tunnel for inspection.

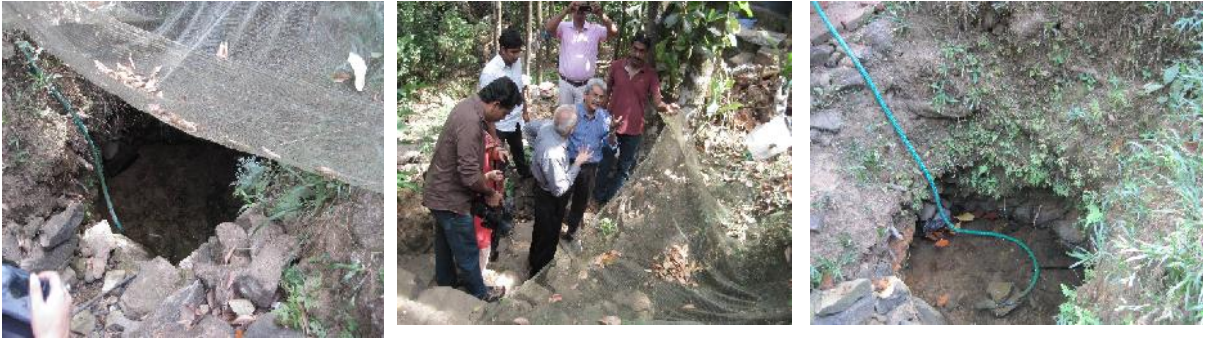
Figure 5: Inspection of a pipe outlet at Kottathalachimala

This is an outlet of the pipe, which is interconnected by a number of pipes. The discharge is perennial. This is demonstrated by the pumping out the water stagnated inside the outlet. This pipe draws water from a big catchment. It is also seems to have connection with ponds in this area which is indicated by presence of small fish in the discharge .

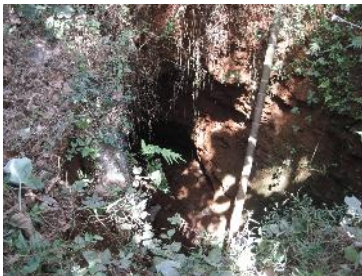
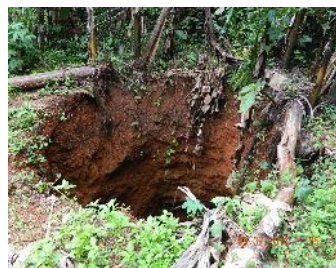
Figure 6: Subsidence crater at Kottathalachimala

This subsidence occurred in 2013. This is a well like land subsidence occurred near a house. Pipes are observed at the bottom. The out flow pipe is found cutting across a house. The residents of this house are evacuated during high rains.

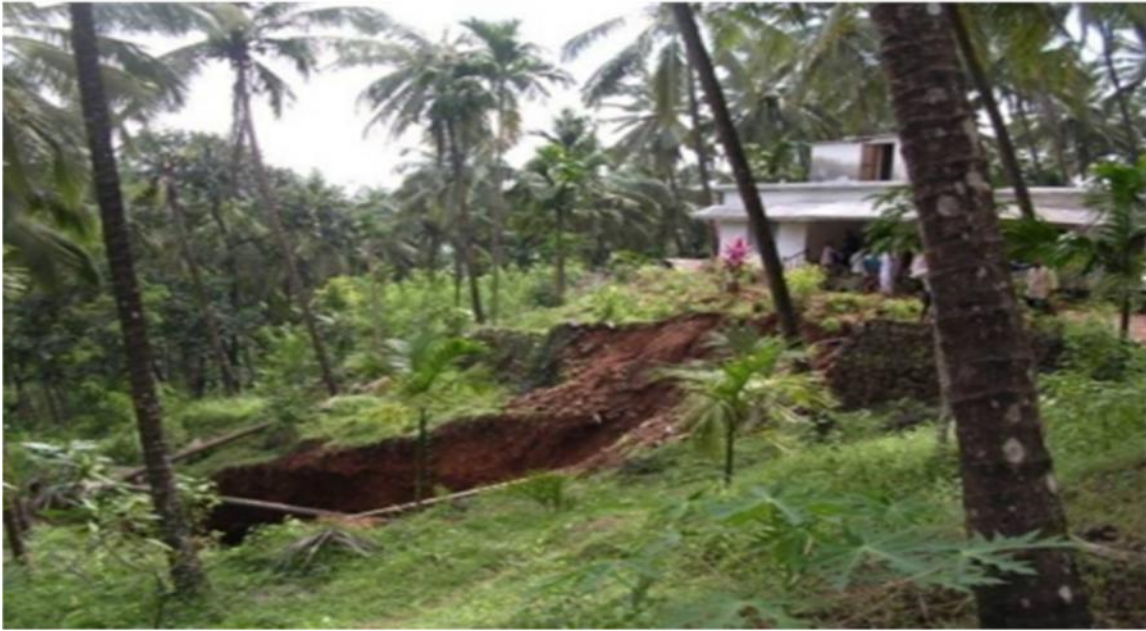
Figure 7: Subsidence affected house at Chattivayal, Chemparathi

Soil piping was first detected in this locality in 2005. A newly constructed house owned by Mrs. Lissy Francis was totally damaged and became unfit for dwelling. All wells in this locality do not yield even during high rains. This entire area in this locality including village roads are affected by underground piping.

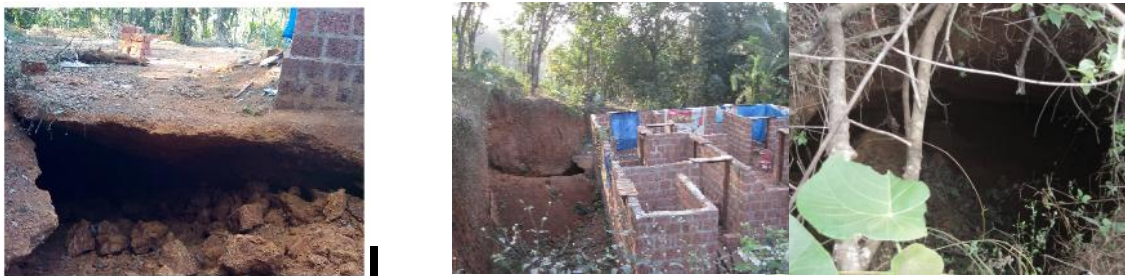
Figure 9: Subsidence at a newly affected site at Kasaragod

IIPA team visited a newly affected site in the Kasaragod district. This is one of the recent subsidence occurred in the State. This has occurred on 8.10.2014. Subsidence has occurred

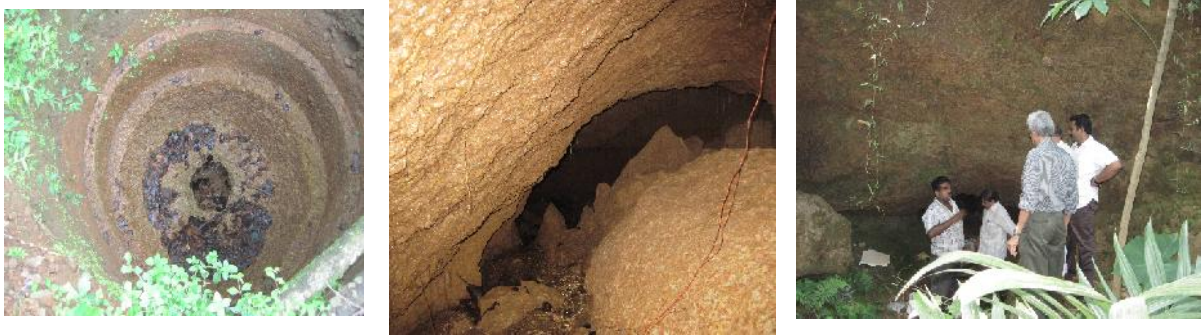
Figure 10: A well being affected by soil pipes in village Ayyankunnu

The team visited Ayyankunnu locality near Iritty in the Kannur district. A classic example of pipes affecting the ground water regime of an area. Most of the wells in this locality are affected by the soil piping processes. The team visited the pipe formations of nearby localities. Here huge underground tunnels are developed making the area unfit for any purposes.

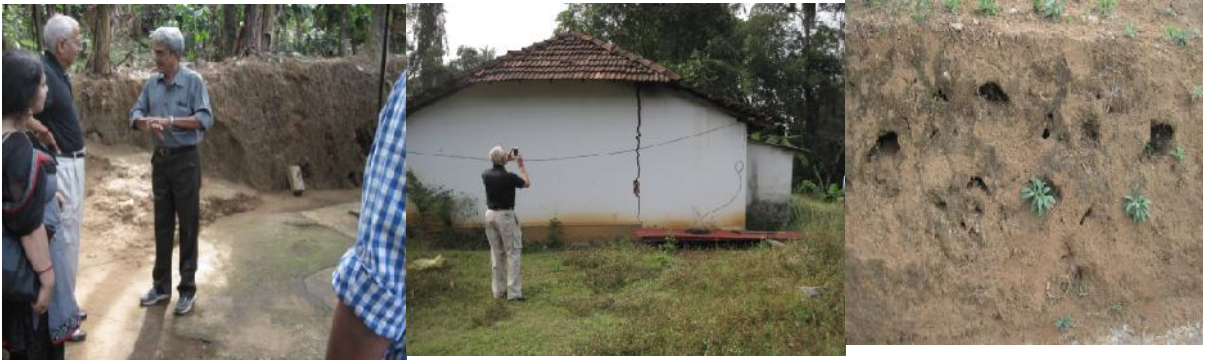
Figure 11 : Subsidence at Residence near Banasursagar Dam

During 2006 a subsidence had occurred in the compound of Liberty Manooty a resident of Padinjarethara Panchayat. Water started gushing out this subsidence pit. This flow of water continued for four months. This locality is located very close to the Banasurasagar Dam in the Wayanad district of Kerala. Mitigation of the subsided area was done with the help of Nirmiti Kendra, a Government agency without considering any causative factors. As a result of that, during monsoon water sprouts out from the reclaimed area. This indicates that the mitigation should be carried out using chemical amelioration and physical interventions. The second picture indicates a soil piping affected landscape. Close to this place, vertical cracks are observed on the walls of a house indicative of an impending danger.

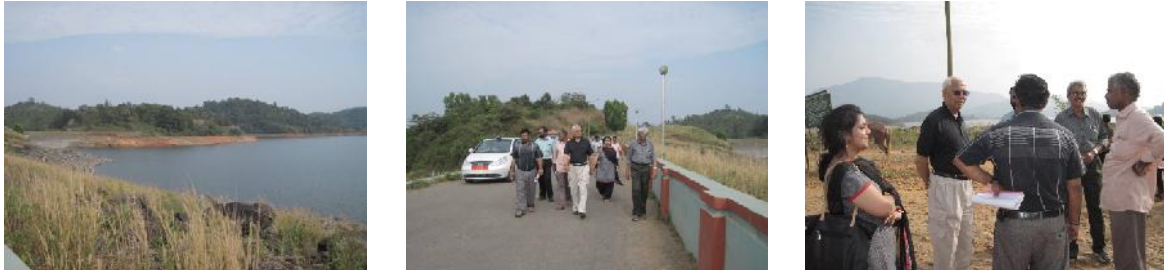
Figure 12 : Banasurasagar Dam

The longest earth Dam in India is situated very closed to the earlier location. This dam is built using locally available earth. This study has indicated that the soil has exchangeable sodium and it is dispersive in nature. So this dam is prone to soil piping and careful examination is required. The team discussed this matter with the Senior Engineers and ADM, Wayanad

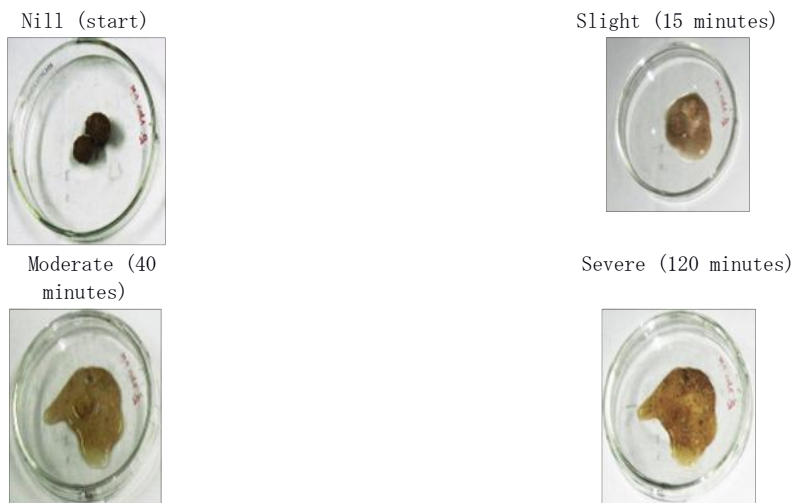
The most outstanding relation to the pipe formation is the presence of highly exchangeable Na percentage as it favors soil dispersion and initiation of the piping process at the subsurface levels. This observation has been further substantiated with the Dispersion Test, conducted by CESS .Soil erosion occurs in dispersive soils (Vacher et.al. 2004) which typically contain greater than 6.0% exchangeable sodium (ESP). These soils are known as sodic soils or Sodosols (Isbell 2002), or in the past may have been referred to as Solodic,Solonetz or Solodized –solonetz (Doyle and Habraken1993).Other soils such as Vertisols , Kurosols and Kandosols may also contain sodic or dispersive soil layers. The soil aggregates easily dispersed when it was immersed with water. Hence the soil can be treated as a dispersive soil. Dispersion is an indicator of sodic soil as it occurs when sodium is present.

Figure: 14 Dispersion test on a soil sample prone to piping, Peringassery Idukki

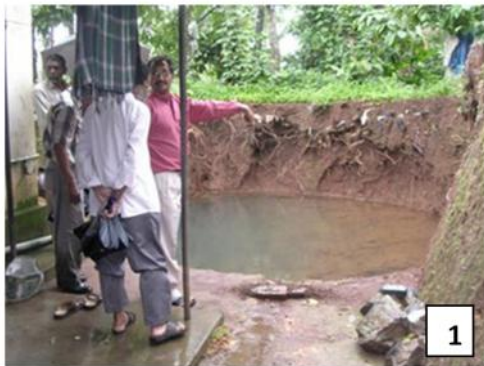
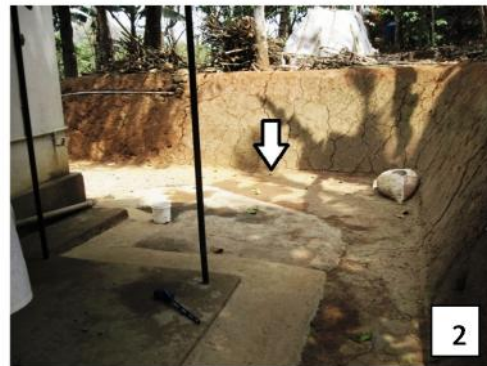
Figure 15 : Subsidence at Banasurasagar, Vythiri taluk Wayanand

During 2006, a portion of the land belonging to Mr Mamooty a resident of the Padinjarethara village (Loc N 11°41'33" / E75°54'16") subsided and water started gushing out with huge force. The water pressure was enormous and the discharge continued for months together. This indicates that the water is flowing under a very high hydraulic head. Interestingly this area is located very near to the Banasurasagar dam. Investigations revealed that this subsidence is also caused by soil piping. This locality is connected by an underground pipe downstream and emerges out as a spring.

1. Before Filling subsided area 2006

2. After filling subsided area 2014

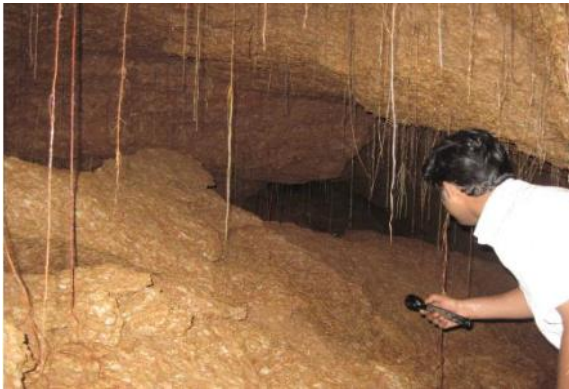
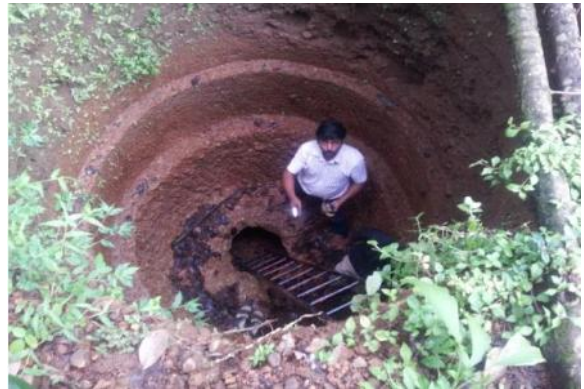
Soil Piping is growing on a large scale with almost over 11 districts affected out of 14 in Kerala. The data base created on the soil piping incidences is being gradually updated by incorporating new incidences. The incident occurred in July 2014 in the Niranganpara locality in Ayyankunnu panchayath, Thalasseri taluk in the Kannur district which evoked lot of media attention. A subsidence has occurred inside a well (GPS location is N12°02'09.4"E75°45'07.2"). The affected locality is in the foot hills and surrounded by hilly area. Piping has affected the saprolite portion of the laterite. Piping outlet is located at 120m north of this area. The soil is 1.5m thick and overlying the well-developed laterite. The slope of the terrain as well as the tunnel orientation is towards North West direction. The underground tunnels formed are found to be affecting the affecting the ground water storage of the wells in this area.

Inside view of tunnel

Piping affected well

Figure 16 : Soil piping affected well at Niranganpara, Kannur
