Illinois Commerce Commission
Assessment of AmerenCIPS'
Reliability Report and Reliability Performance
for Calendar Year 2006

Pursuant to 83 Illinois Administrative Code 411.140

December 19, 2007

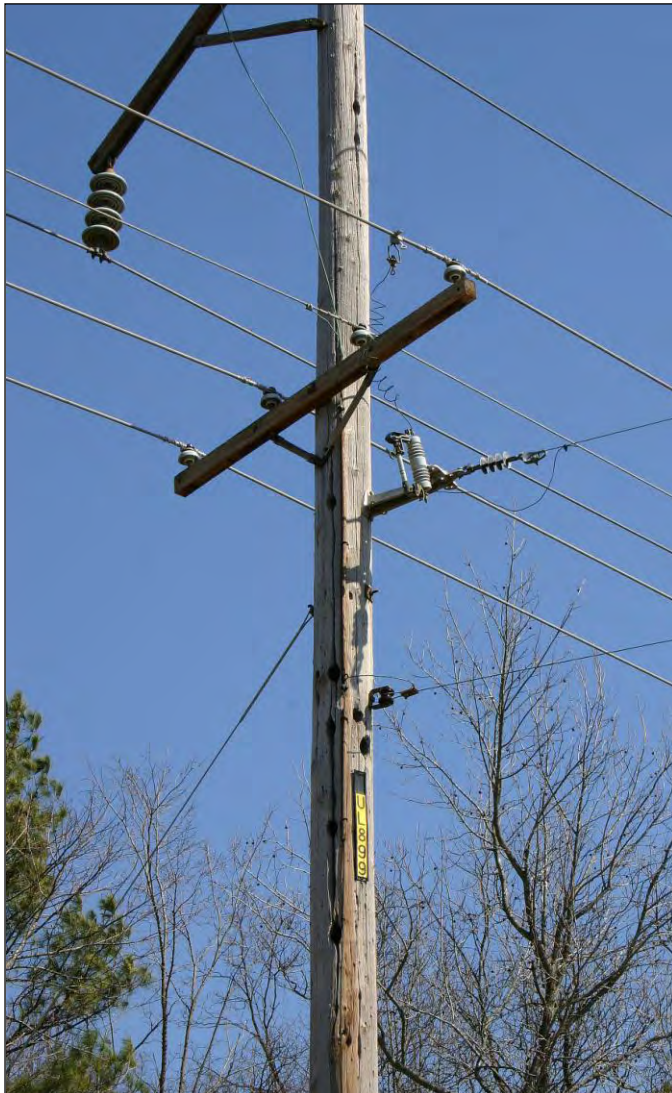
Figure 1 (Photo 07-CIP1282)

**10(+) woodpecker holes in 69 kV structure w/ 12 kV underbuild & tap
Circuit S34527, Str. 230 (69 kV Line 608), east of Gale Substation**

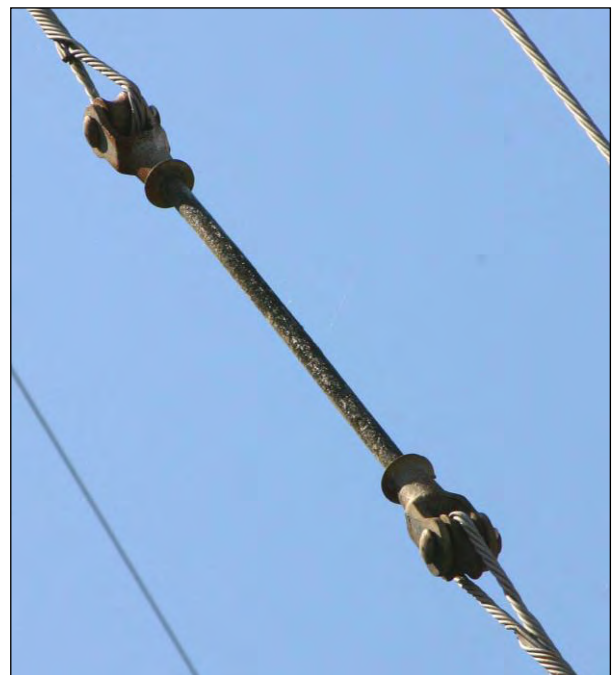
**Figure 2 (Photo 07-CIP1286)
Charred 69 kV strain insulators
(in both lower 69 kV downguys)
Circuit S34527, Pole A3185, east side of
Bean Ridge Rd., east of Gale Substation**

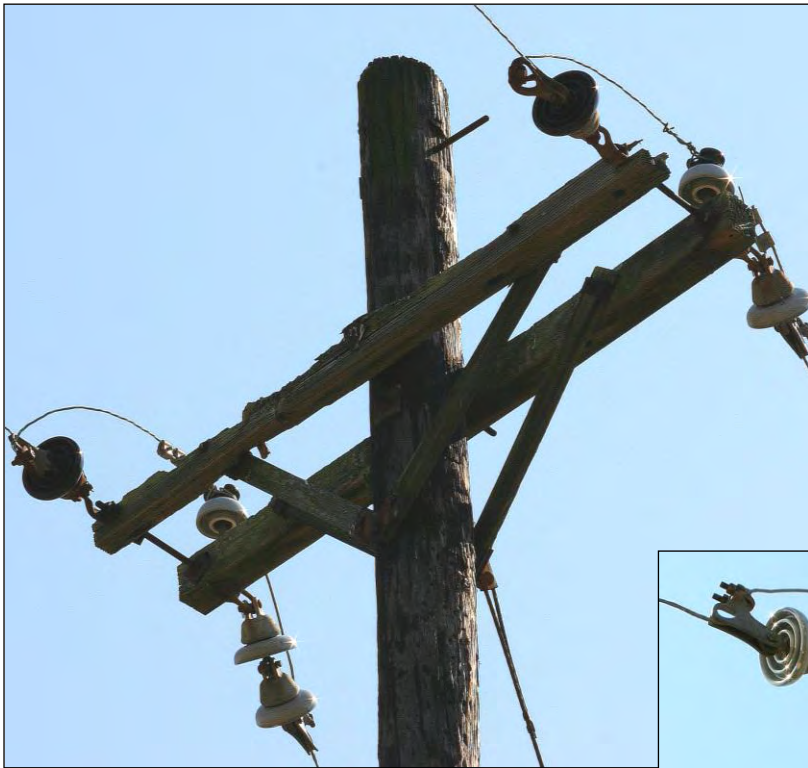
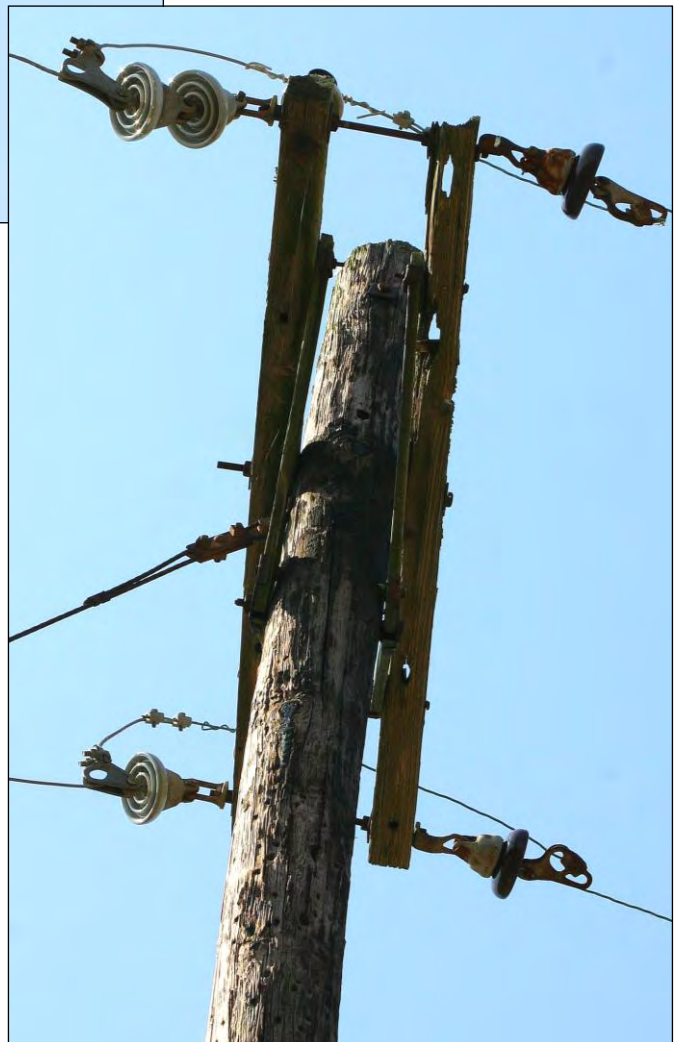
Figures 3 & 4 (Photos 07-CIP1290 & 07-CIP1292)
Badly deteriorated crossarm
Circuit S34527, south of Old Diswood Rd., northeast of Olive Branch

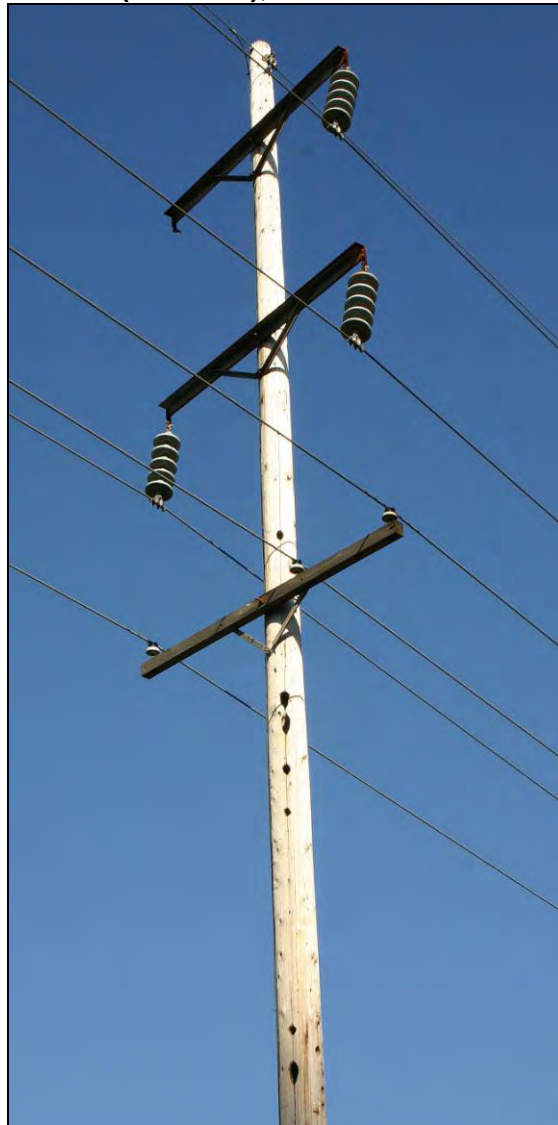
Figure 5 (Photo 07-CIP1298)

**Several (14+) large woodpecker holes in pole
Circuit X03533, Spruce Ln. (Rd. 600E), south of Albion & northwest of Grayville**

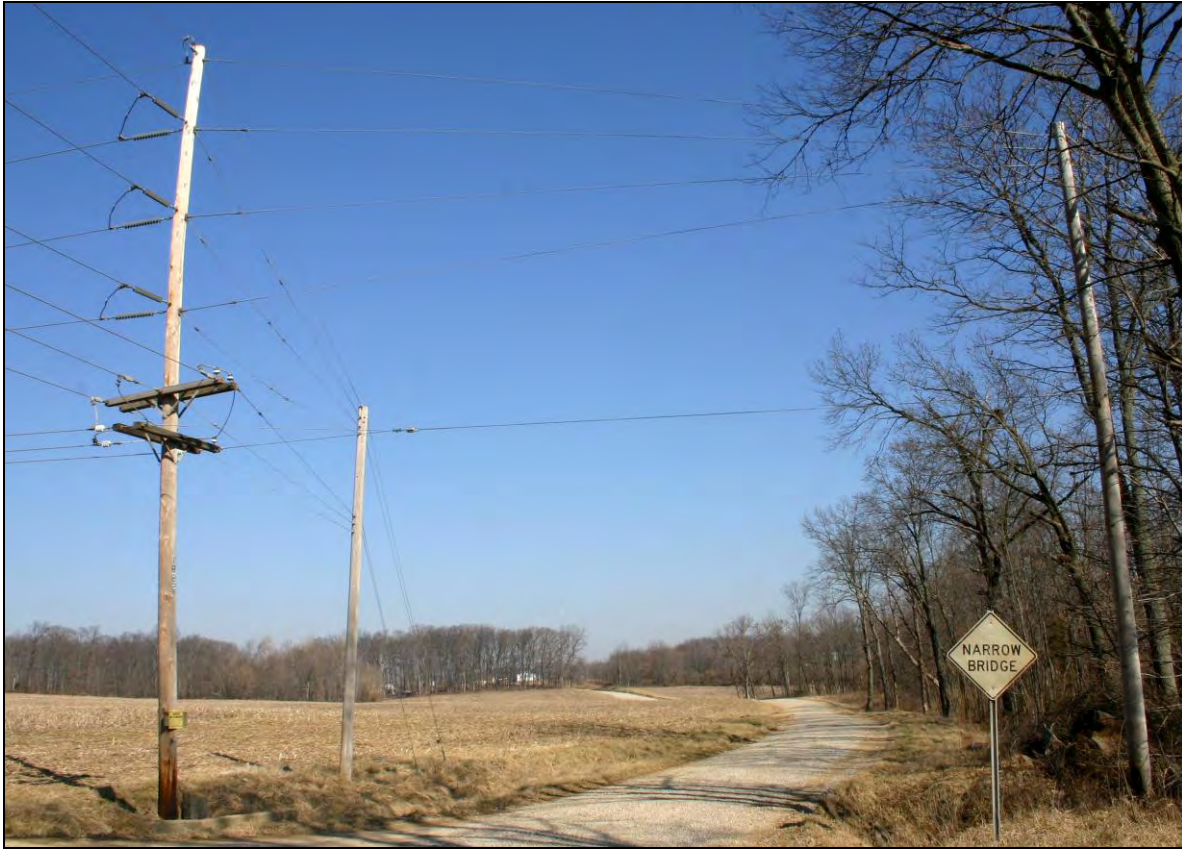
Figure 6 (Photo 07-CIP1302)

**Five ungrounded 69 kV & 3- 12 kV overhead guys without properly placed strain insulators
(NESC Guying Violations)**

Circuit X03533, NW corner of Rds. 600E & 357N, south of Albion

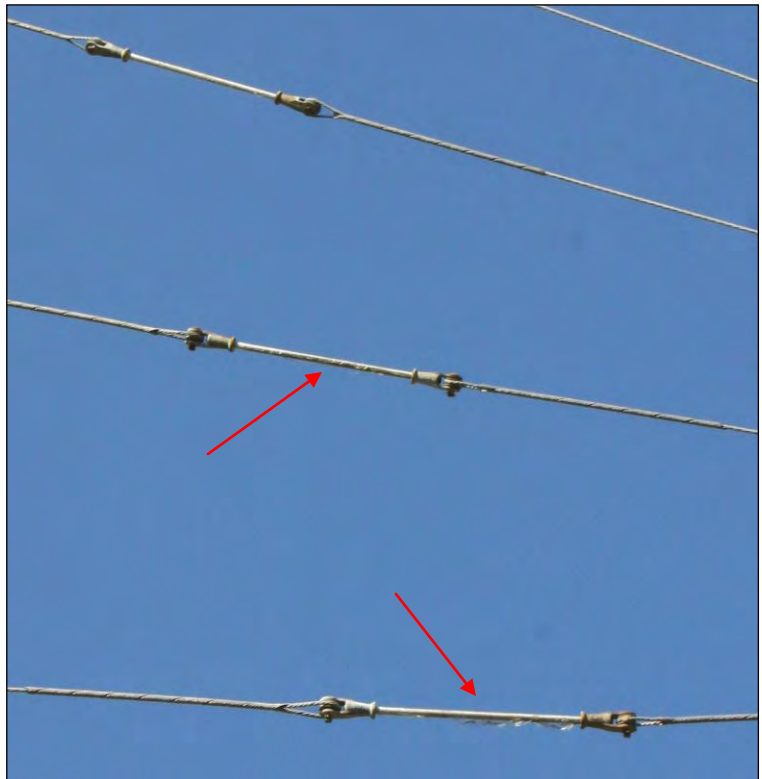
Figure 7 (Photo 07-CIP1301)

**Deteriorated guy strain insulators
in overhead guys**

**Circuit X03533, NW corner of
Rds. 600E & 357N, south of Albion**

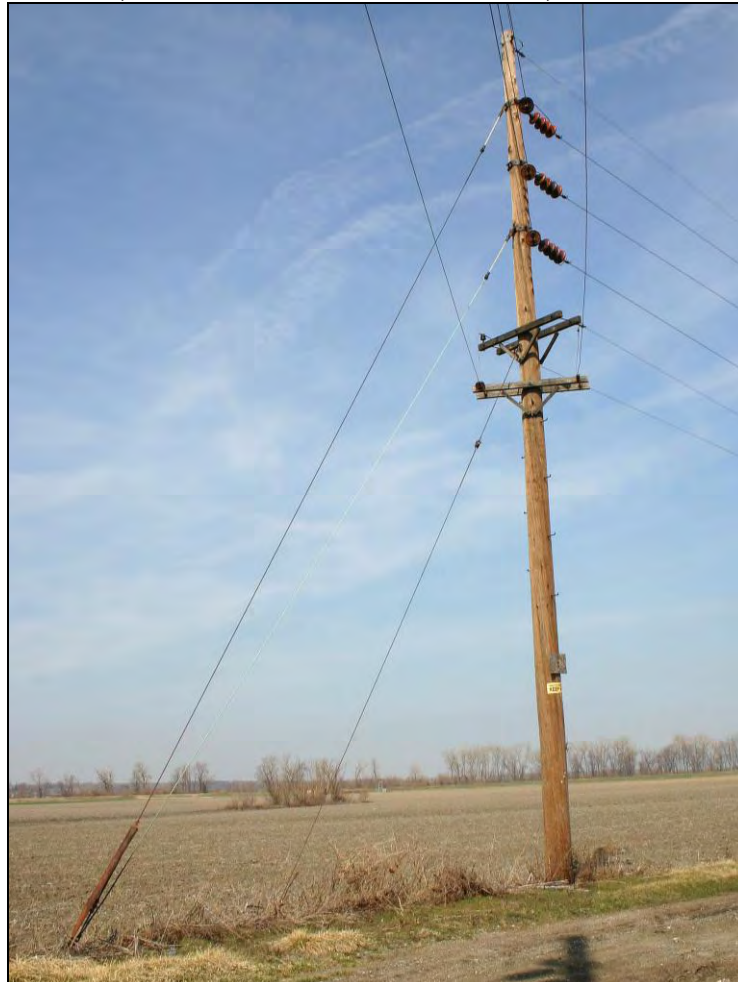
Figure 8 (Photo 07-CIP1319)

**Two ungrounded 34 kV downguys without properly located strain insulators
(NESC Guying Violations)
Circuit 324002, Waterworks Rd. north of I-270, west of Granite City**

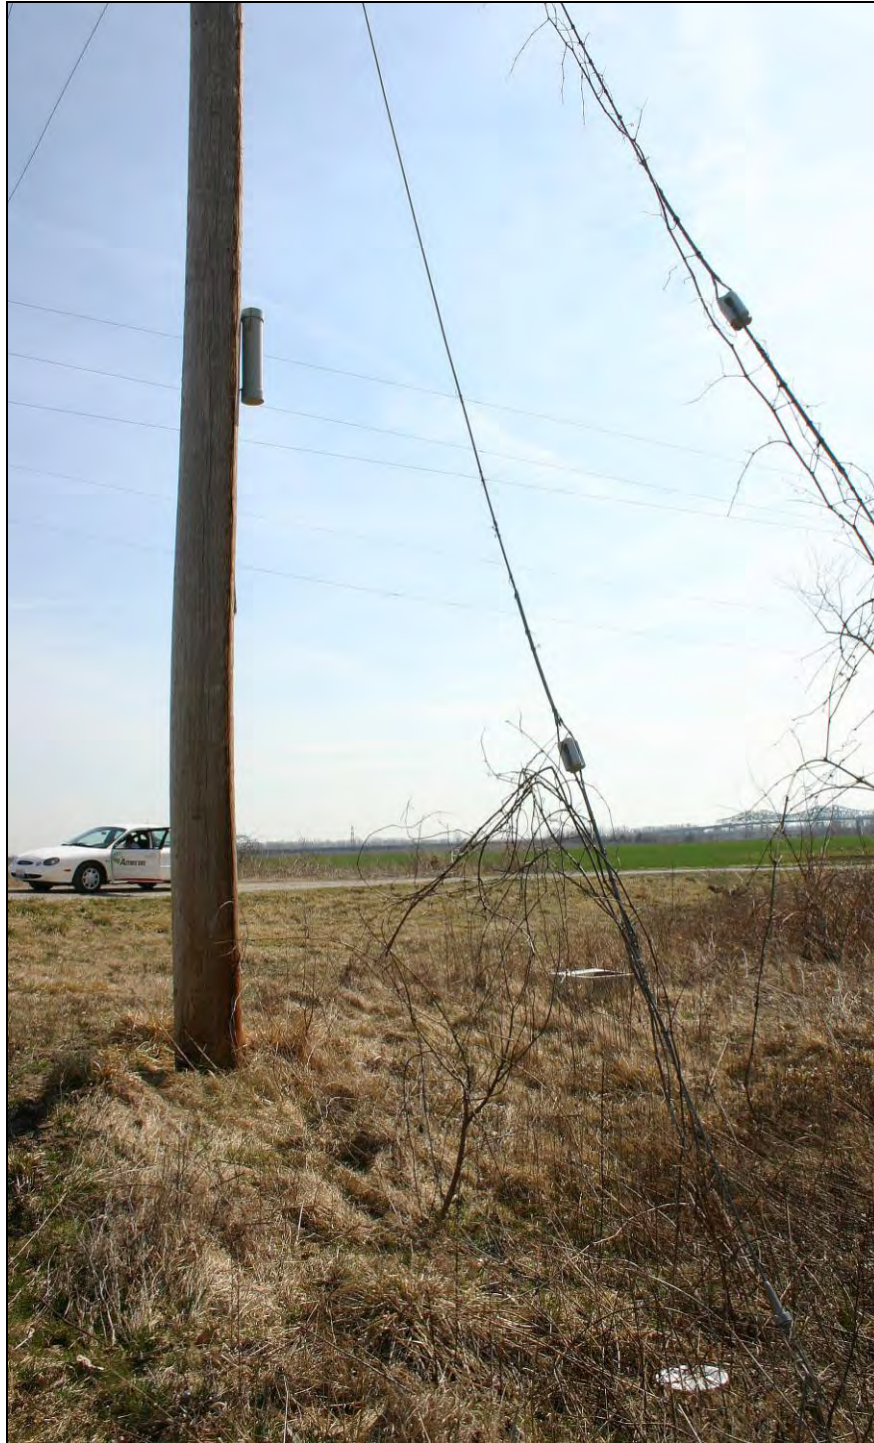
Figure 9 (Photo 07-CIP1320)

**Two ungrounded 34 kV downguys with inadequate height of strain insulators
(NESC Guying Violations)**

Circuit 324002, Waterworks Rd. at Illinois American Water Co., west of Granite City

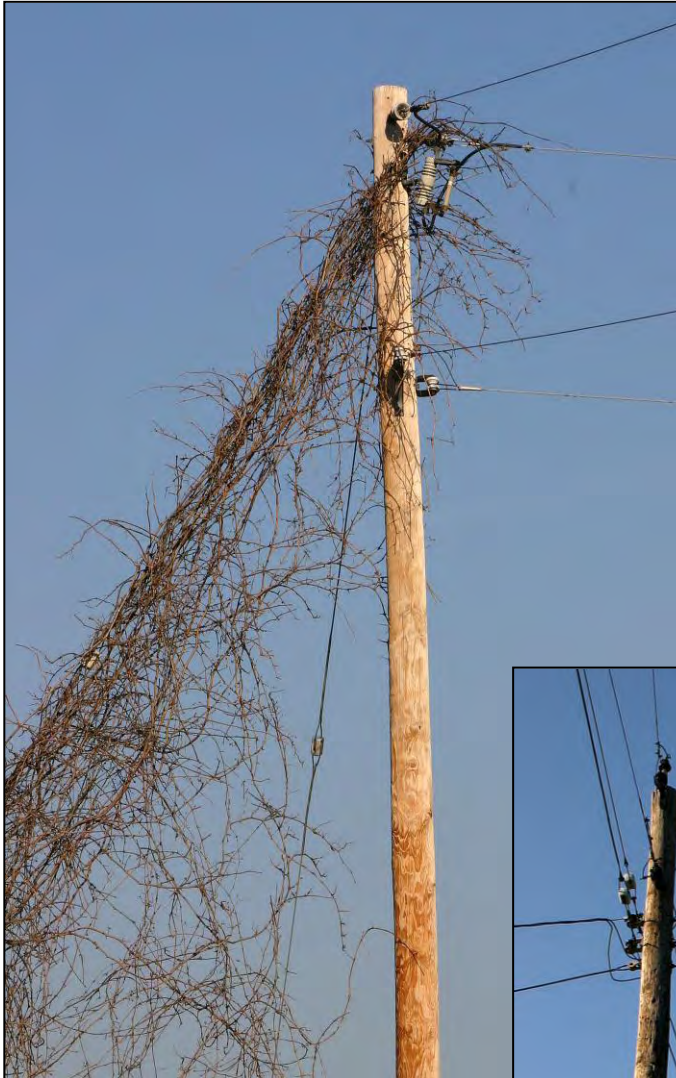
Figure 10 (Photo 07-CIP1308)

**Vines up a downguy & into the primary & fused cutout
Circuit 324002, Chouteau Place Rd., west of Granite City**

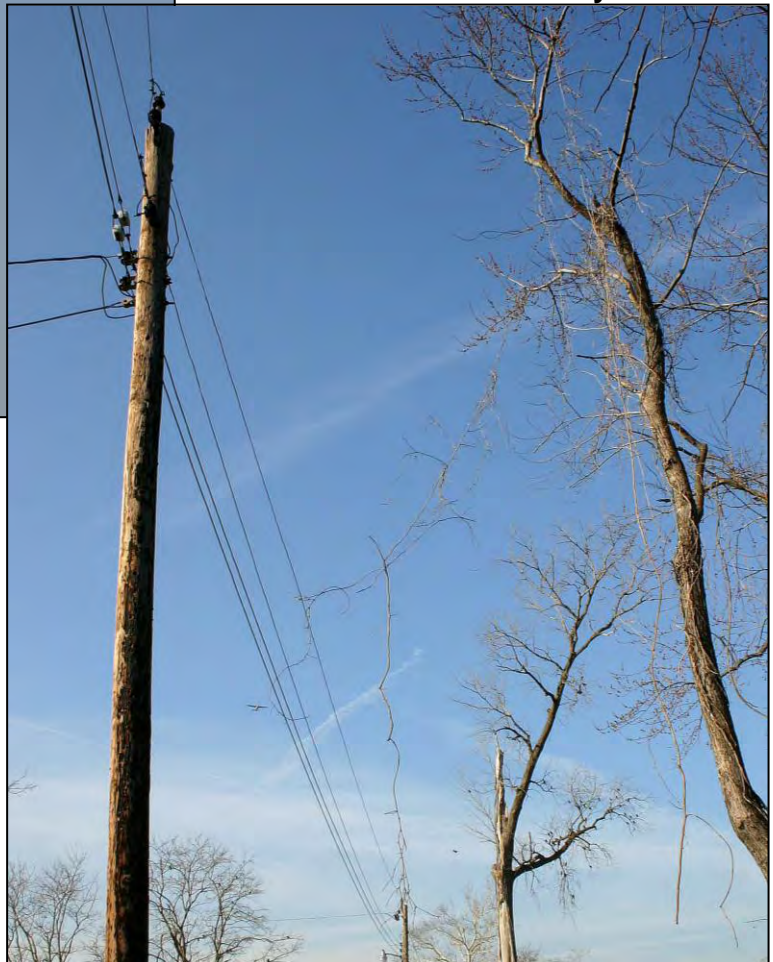
Figure 11 (Photo 07-CIP1311)
**Vegetation hanging from a tree
and into the primary
Circuit 324002, Chouteau Place Rd.,
west of Granite City**

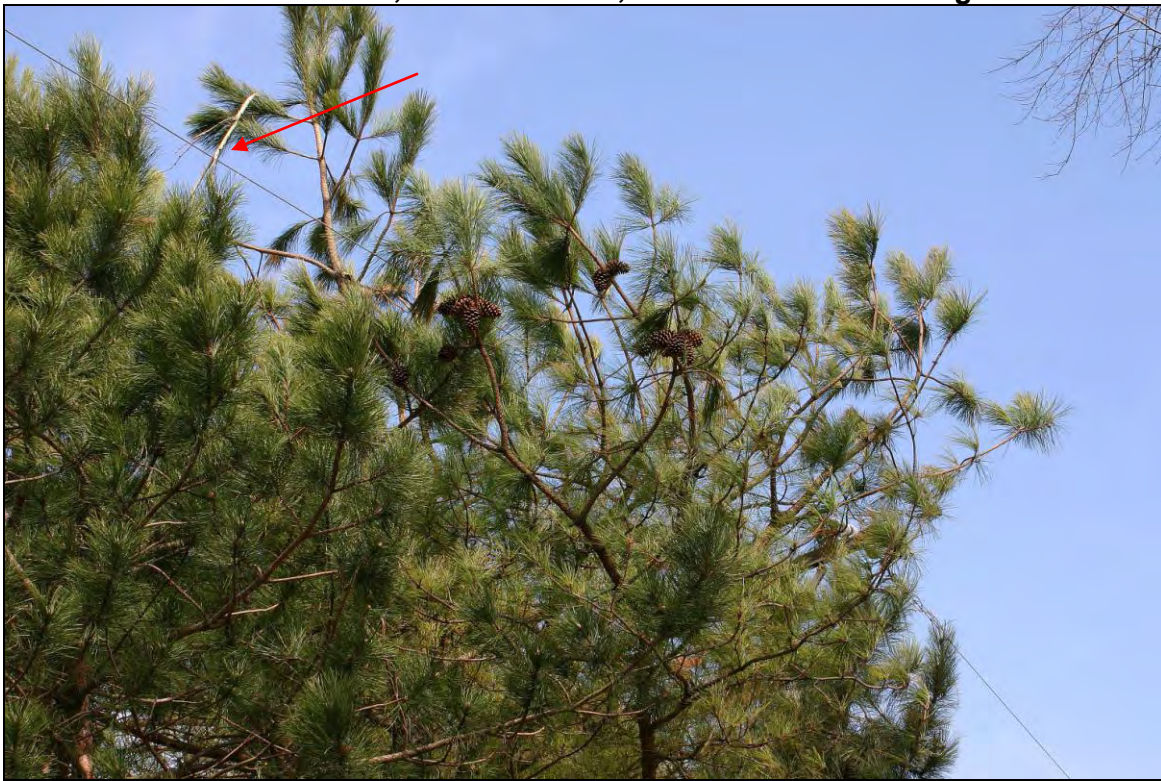
Figure 12 (Photo 07-CIP1325)
Pine trees into primary, with burning, & broken limb on primary
Circuit 310053, Hill Creek Lane, southwest of Fosterburg

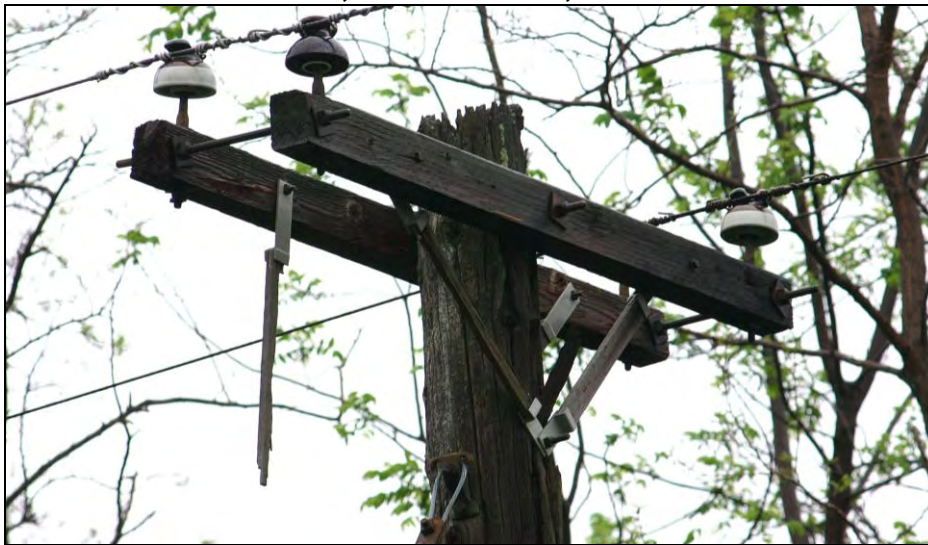
Figure 13 (Photo 07-CIP1440)

**Broken wood brace (second brace split) & bad pole top (noted in 2006 but not corrected)
Circuit V18553, E. Glenarm Rd., east of Glenarm**

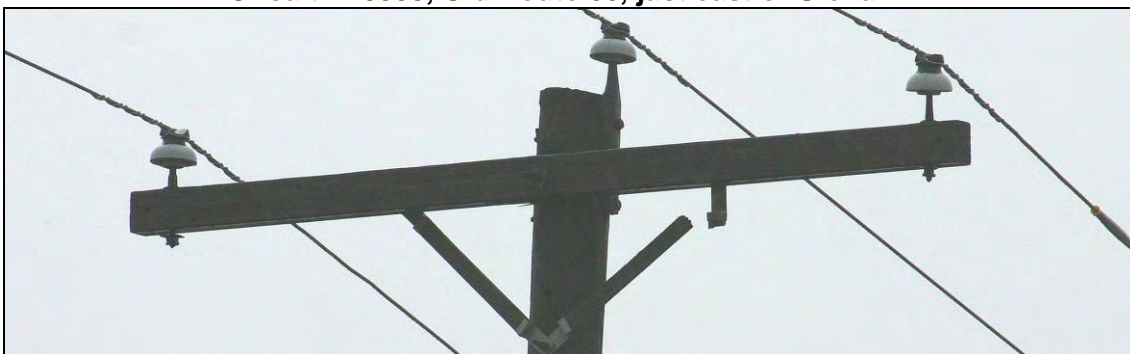
Figure 14 (Photo 07-CIP1437)

**Broken wood brace (road side)
Circuit V18553, Old Route 66, just east of Glenarm**
