Voting System Anomaly Root Cause Analysis Template v2.0

**VV40ECT-76: VxMARK ESD FAILURE AT PAT & ATI
VxSUITE, VERSION 4.0 AND EAC CERTIFICATION #VXS4**

**VOTINGWORKS
548 MARKET ST, STE 53001
SAN FRANCISCO, CA 94104-5401**

APRIL 24, 2025

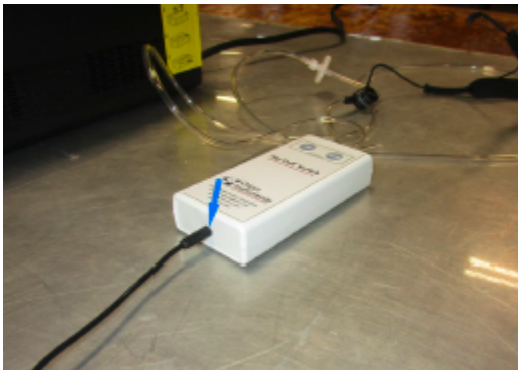
- After discharging ESD onto the sip/puff PAT device connected to the PAT port, the sip/puff device and accessible controller stopped responding.
- All other functions were normal. The scanner would run in a regularly scanning “shoeshine” mode, the printer would regularly print lines, the touchscreen would remain responsive and show updated logs.

- Image VxMark with a hardware test utility software that continuously runs its major components. Connect all VxMark components, including the UPS into mains, the VxMark unit into the UPS, and the non-VotingWorks PAT accessory to be tested: a sip/puff device (AirVoter). Power on VxMark and run the test software utility. Insert a sheet of paper into the scanner to implement shoeshine mode.
- Apply ESD (15kV air discharge, 10 pulses, 1 per 2 sec) according to IEC 61000-4-2 to the PAT accessory where it starts to connect to its phone jack cable, which in turn is plugged into the PAT port on VxMark. This location is indicated by the blue arrow in the photo below, as reported by SLI Compliance:
