Voting System Anomaly Root Cause Analysis Template v2.0

VV40ECT-75: RADIATED RF IMMUNITY FAILURE AT 350-400MHz
VxSUITE, VERSION 4.0 AND EAC CERTIFICATION #VXS4

VOTINGWORKS
548 MARKET ST, STE 53001
SAN FRANCISCO, CA 94104-5401

MARCH 27, 2025

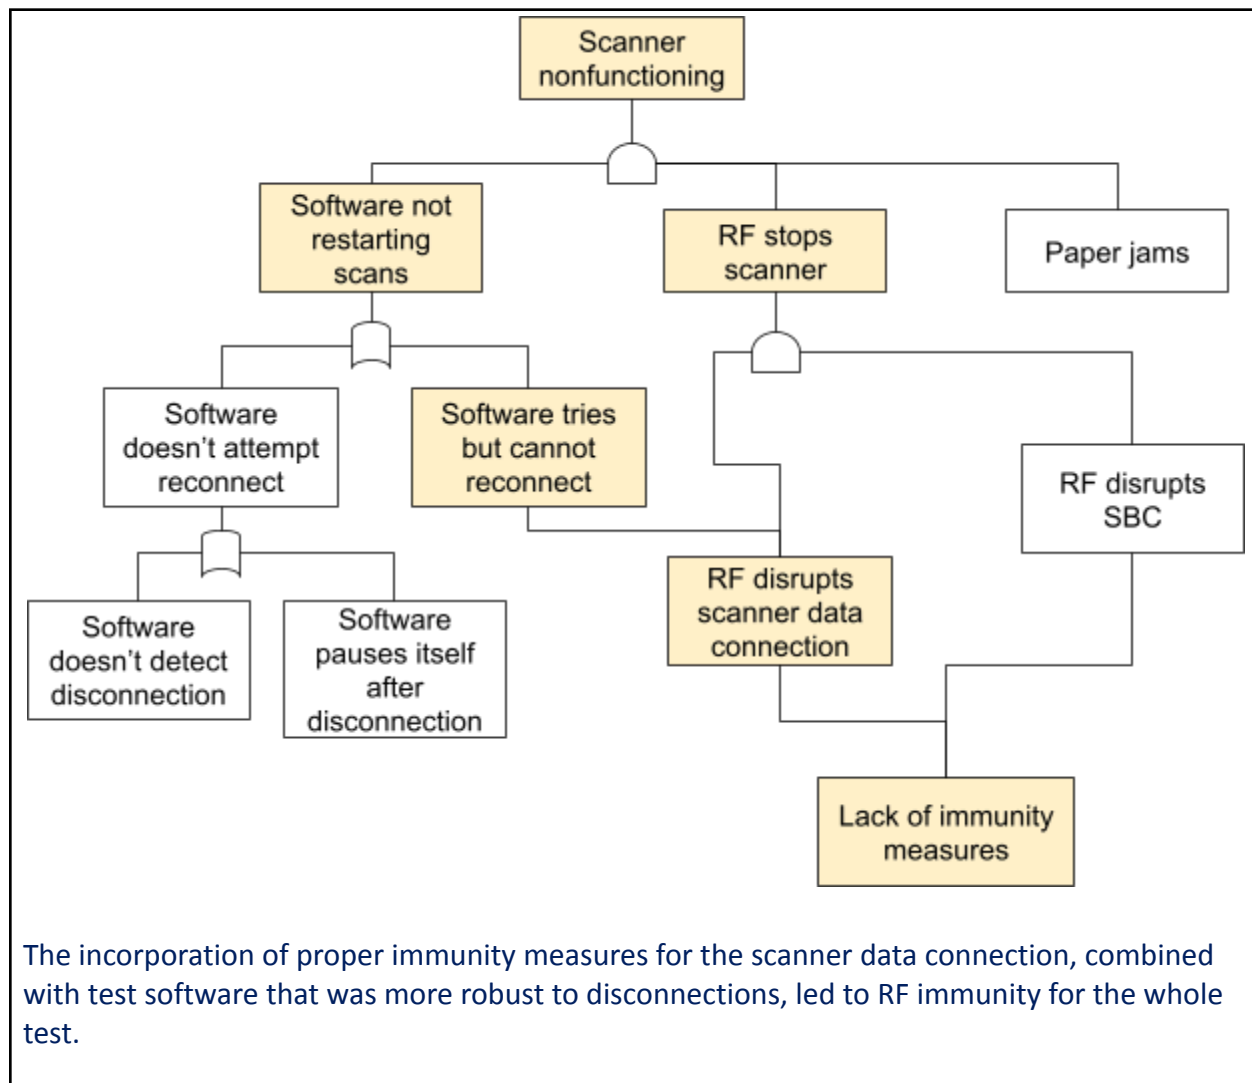
After the test software was identified to have that fault, it was modified to account for it. The new test software did not pause on any disconnection and instead attempted reconnect to the disconnected component. Following that modification to the test software, it was found that hardware issues ultimately also had to be mitigated at the same time. The fault paths highlighted here ended up determining root causes:

1. The scanner data connection, or USB cable joining the scanner to the SBC, was susceptible to disconnection when targeted with an RF field in the front horizontal direction in the range of 350-400 MHz, facing the cable. These signals induced noise in the USB cable (without any chokes or additional shielding) that stopped data transmission and prevented reconnection across it at those frequencies.
2. The test software utility, which is different from the production app for VxScan, was not robustly responding to any scanner disconnections. It would not attempt reconnection after any disturbance.
