# **Voting System Anomaly Root Cause Analysis Template v2.0**

**VV40ECT-75: RADIATED RF IMMUNITY FAILURE AT 350-400MHz - REV. 2**  
**VxSUITE, VERSION 4.0 AND EAC CERTIFICATION #VXS4**

**VOTINGWORKS**  
**548 MARKET ST, STE 53001**  
**SAN FRANCISCO, CA 94104-5401**

**MAY 16, 2025**

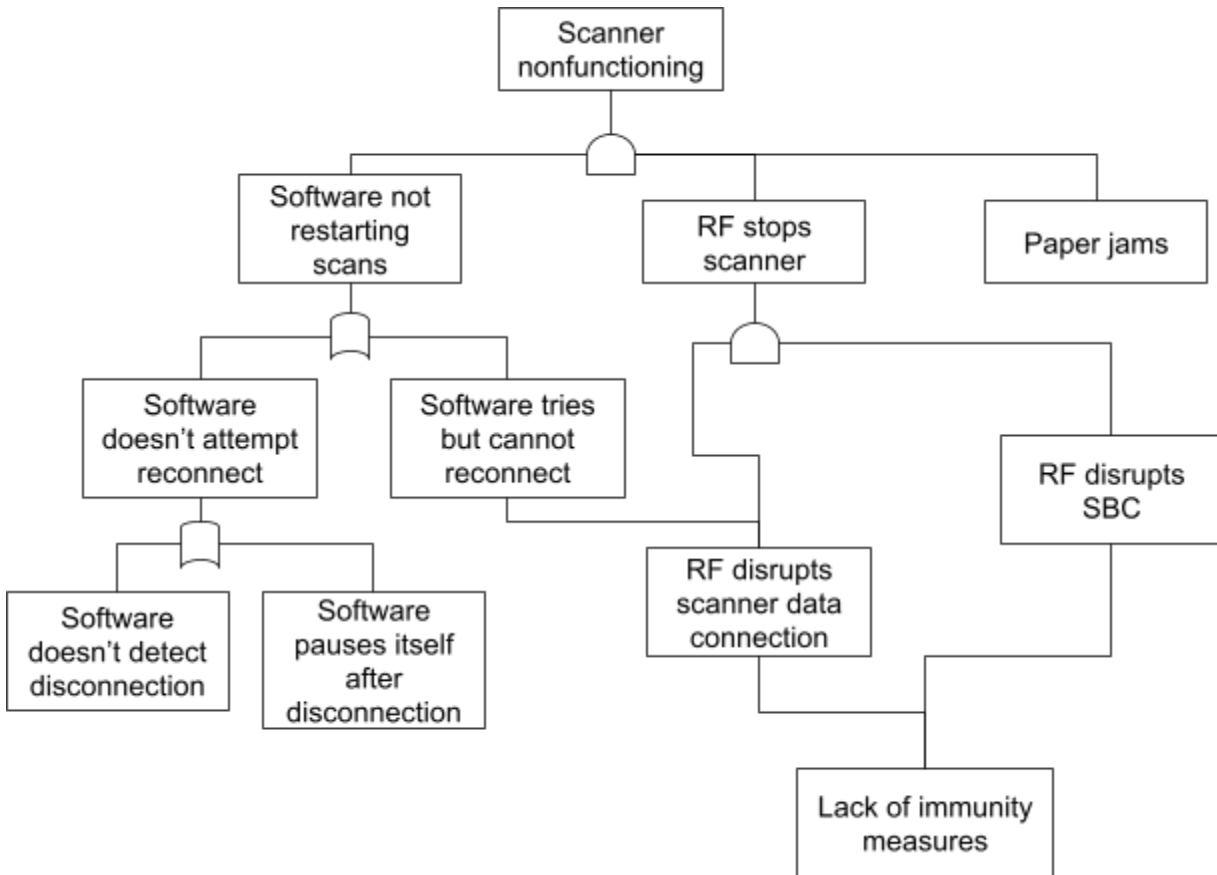
The investigative team used the strategies of Fault Tree Analysis (and similarly 5 Whys) in discussing, narrowing down, and identifying root causes. The Fault Tree initially was broken down into software and hardware causes, and it became more detailed as more data was obtained. Drilldown through the faults led to other potential causes to investigate shown below:

Starting at the top of the tree and working downward, the team would ask of each issue, “Why?” and answer. For example, “Why is the scanner nonfunctioning?” would lead to possibilities of:

- the software not restarting the scanner as evidenced by the onscreen messages
- RF stopping the scanner
- the paper jamming

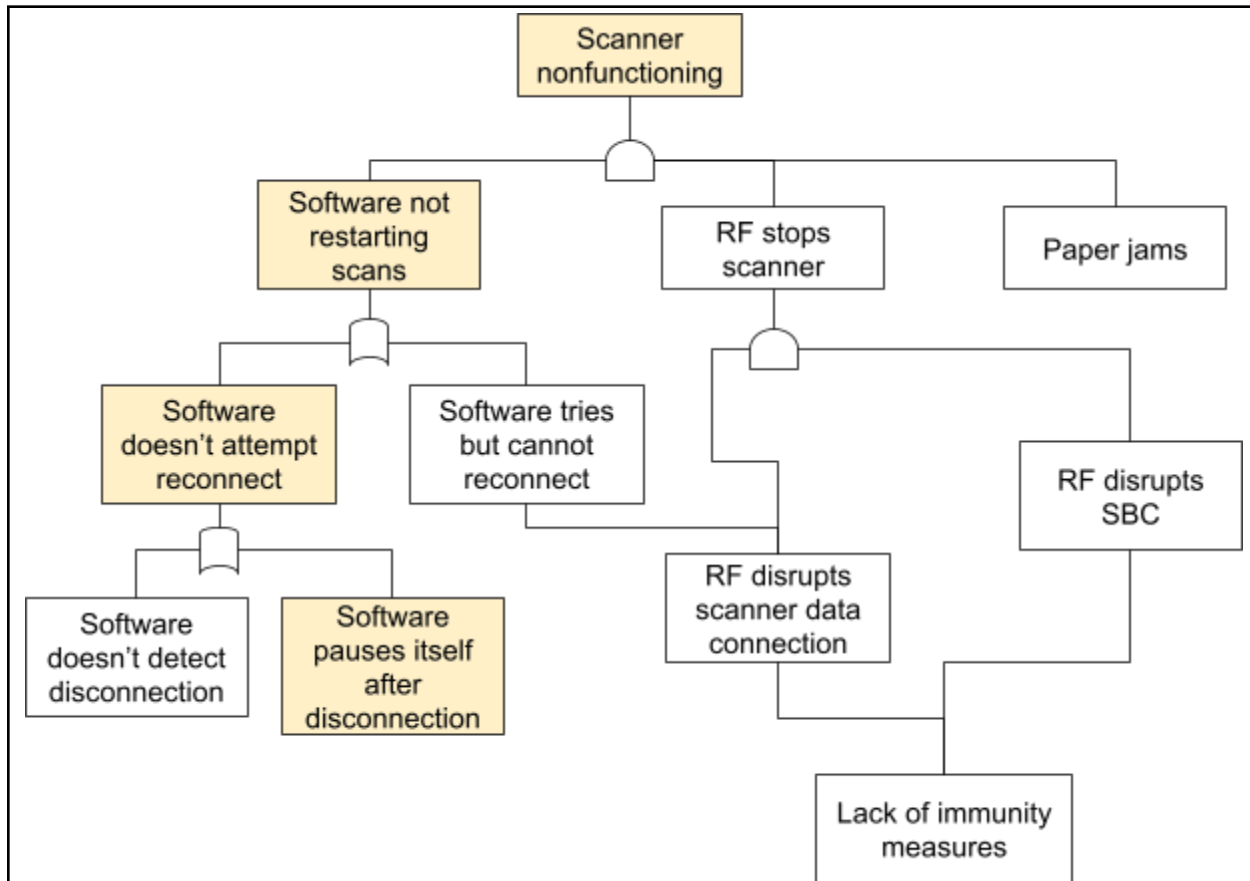
Each possibility was discussed, tested, and/or researched to either rule it out as a fault source or suggest further investigation. As described in the chronology above, an initial investigation followed more of the software fault drilldown, highlighted below:

After the test software was identified to have that fault, it was modified to account for it. The new test software did not pause on any disconnection and instead attempted reconnect to the disconnected component. Following that modification to the test software, it was found that hardware issues ultimately also had to be mitigated at the same time. The fault paths highlighted here ended up determining root causes:

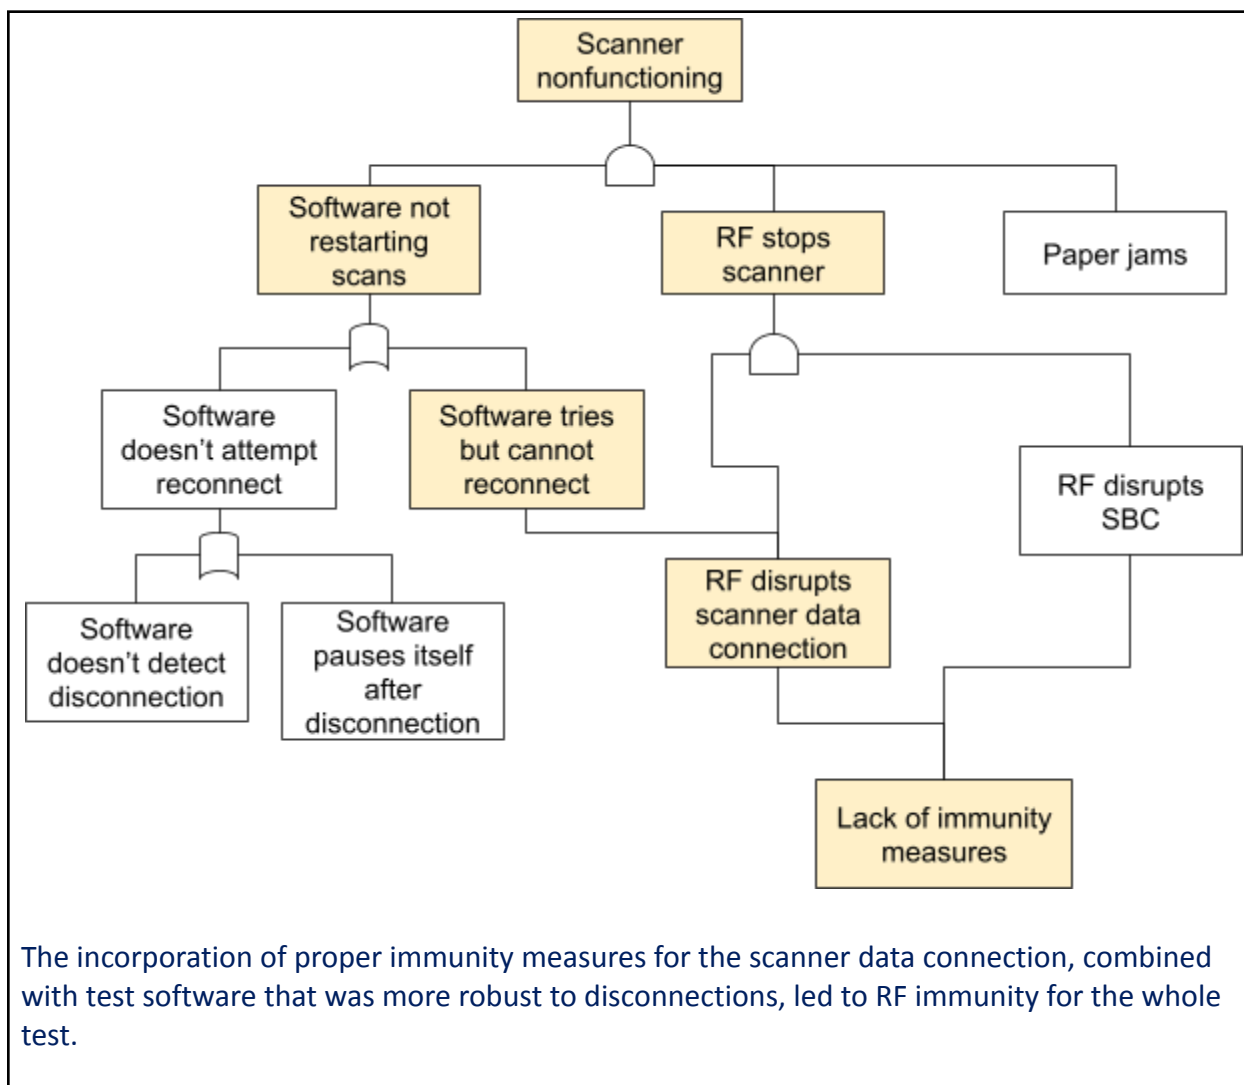
1. The scanner data connection, or USB cable joining the scanner to the SBC, was susceptible to disconnection when targeted with an RF field in the front horizontal direction in the range of 350-400 MHz, facing the cable. These signals induced noise in the USB cable (without any chokes or additional shielding) that stopped data transmission and prevented reconnection across it at those frequencies.
2. The original test software utility (Hardware Test Utility v1), which is different from the production app for VxScan, was not robustly responding to any scanner disconnections. It would not attempt reconnection after any disturbance.

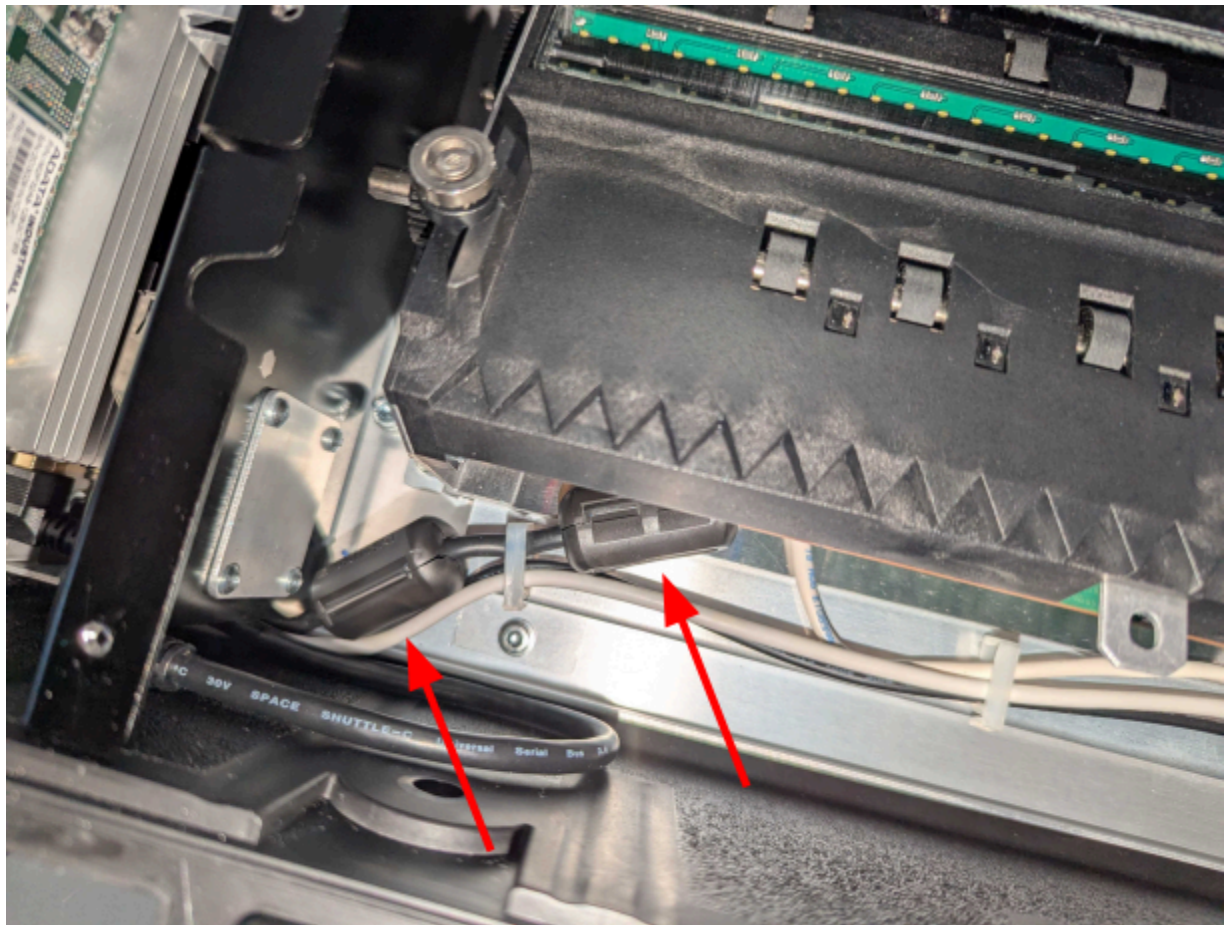
- The scanner data connection is potentially susceptible to RF around 350-400 MHz aimed at the front of the scanner. Before mitigations, that frequency signal consistently disrupted the scanner connection to the SBC in the test software, five times across two devices, and prevented reconnection. This was due to insufficient RF filtering or shielding mechanisms for the USB data cable, which disconnected too frequently for the test software utility.

Two ferrites were clipped onto the internal USB cable running from the scanner to the SBC near the front of the VxScan, as shown in the photo and diagram below. The ferrites have impedance 332 Ohm @250MHz, meant for a 4.9mm maximum diameter cable (Fair-Rite Products Corp, part number 0461164951). They are placed to the left and to the right of the cable clip on the left front of the scanner:
