# Voting System Anomaly Root Cause Analysis Template v2.0

**VV40ECT-76: VxMARK ESD FAILURE AT PAT & ATI  
VxSUITE, VERSION 4.0 AND EAC CERTIFICATION #VXS4**

**VOTINGWORKS  
548 MARKET ST, STE 53001  
SAN FRANCISCO, CA 94104-5401**

**APRIL 24, 2025**

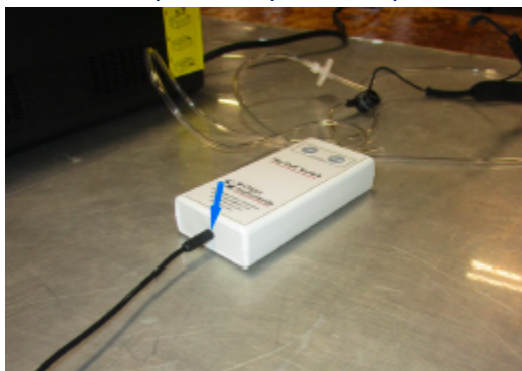
- After discharging ESD onto the sip/puff PAT device connected to the PAT port, the sip/puff itself and accessible controller stopped responding.
- All other functions were normal. The scanner would run in a regularly scanning “shoeshine” mode, the printer would regularly print lines, the touchscreen would remain responsive and show updated logs,

- Image VxMark with a hardware test utility software that continuously runs its major components. Connect all VxMark components, including the UPS into mains, the VxMark unit into the UPS, and the non-VotingWorks PAT accessory to be tested: a sip/puff device (AirVoter). Power on VxMark and run the test software utility. Insert a sheet of paper into the scanner to implement shoeshine mode.
- Apply ESD (15kV air discharge, 10 pulses, 1 per 2 sec) according to IEC 61000-4-2 to the PAT accessory where it starts to connect to its phone jack cable, which in turn is plugged into the PAT port on VxMark. This location is indicated by the blue arrow in the photo below, as reported by SLI Compliance:

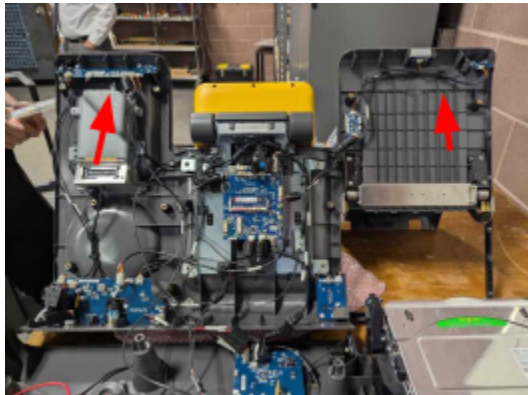
4	3/13/25, 8:09am	Reported that ESD testing was proceeding without issues, then failed when applying 8kV ESD to the sip/puff device itself.	Jessica Myers, Don Chu, VotingWorks	<p>Don Chu opened up the alternate VxMark unit MK-11-005 to plan mitigations. Mitigations were applied to VxMark unit MK-11-005 involving an internal cable running between the PAT and the ATI along the front edge of the system. Ferrites were added on either side of the cable, denoted with arrows in the photo below:</p>

<p>The original unit MK-11-004 was planned to be used for power dip testing.</p>
5	3/13/25, 8:58am	The modified VxMark unit MK-11-005 was put into ESD testing. ESD on the sip/puff device was tested again, leading to the same behavior as before with a nonresponsive ATI and sip/puff device. The components were functional after reboot.	Jessica Myers, Don Chu, Jesse DeWald, VotingWorks	<p>Ground continuity was measured and confirmed to be good (&lt;0.1 ohms) from the grounding strap on both sip/puff PCB and ATI PCB. A ground strap was added on the other side of the ATI PCB to offer a more direct path to discharge.</p> <p>Additional research was done on potential causes. It was noted that one pulse could cause the observed failures, so no plans were made to alter the pulse signal. The public test documents on VSAP hardware were also</p>
