CLIENT: VotingWorks

PROJECT: VXScan

DOCUMENT NUMBER: VWX-001-D010

DOCUMENT TITLE: 4.0 Vibration Test Report

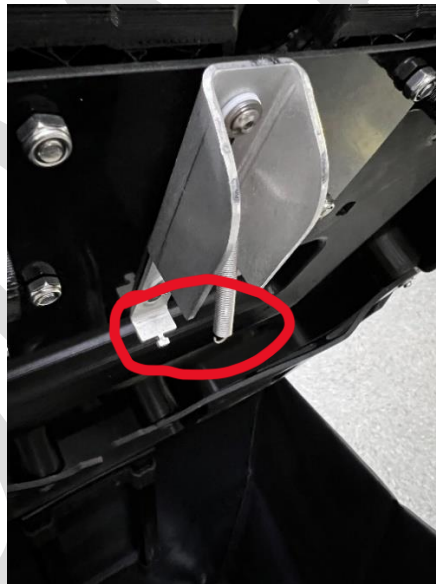
The spring for the latch on the top of the ballot box came loose.

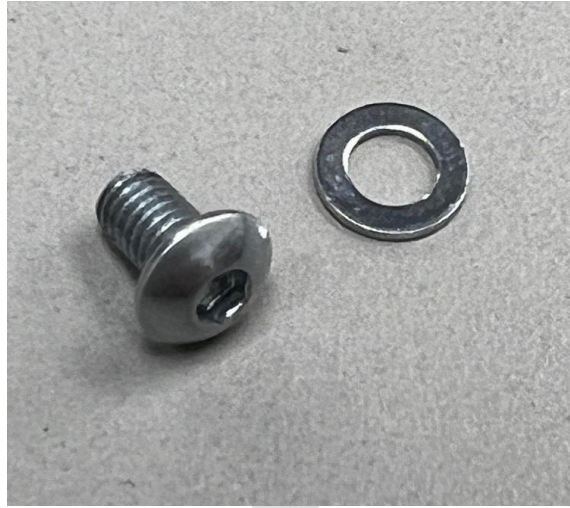
A screw and washer were found in the bottom of the printer. Another screw and washer were found under the bottom plate. The screws and washers were of the type shown below.

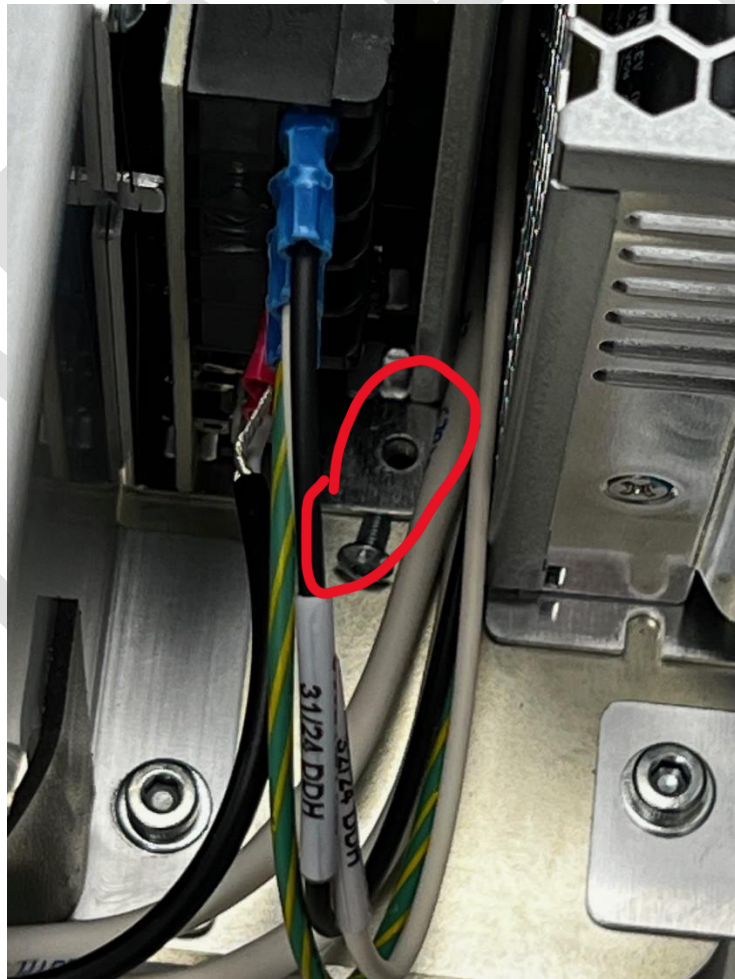
One of the screws and washers appears to have come from where the 5V power supply is screwed to the bottom plate. The source of the other screw and washer is unknown.

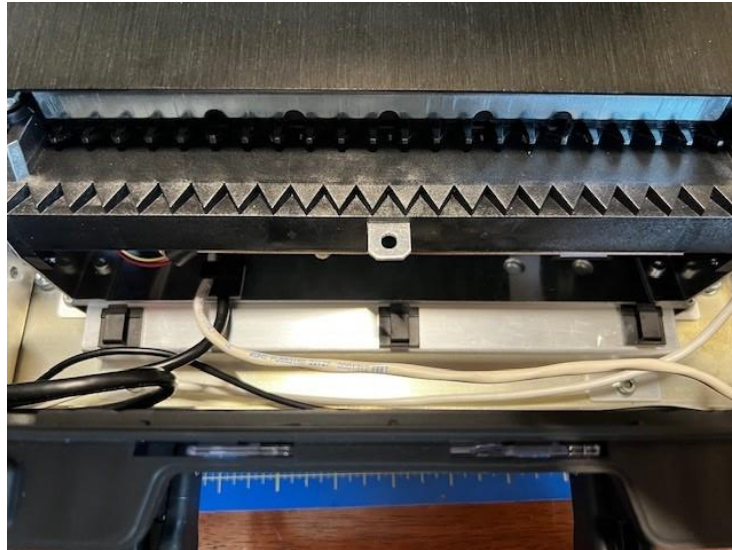
The wires that run along the front of the unit came out of their clips. Nemko did not disassemble the MCM, so the vibration was the cause of the wires coming loose.

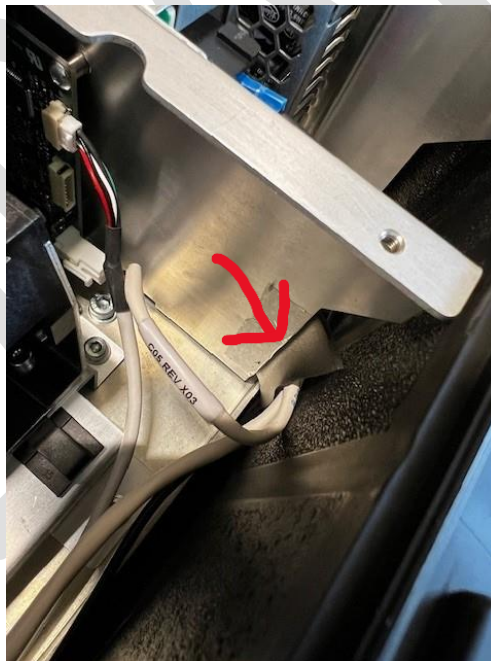
The tape that protects the wires from the sharp edge started coming off. This is probably not due to the vibration test, though. Another method of protecting the wires from the sharp edge should be considered.
