Voting System Anomaly Root Cause Analysis Template v2.0

**VV40ECT-99: UNDERVOTE APPEARED IN VxSCAN
VxSUITE, VERSION 4.0 AND EAC CERTIFICATION #VXS4**

**VOTINGWORKS
548 MARKET ST, STE 53001
SAN FRANCISCO, CA 94104-5401**

APRIL 22, 2025

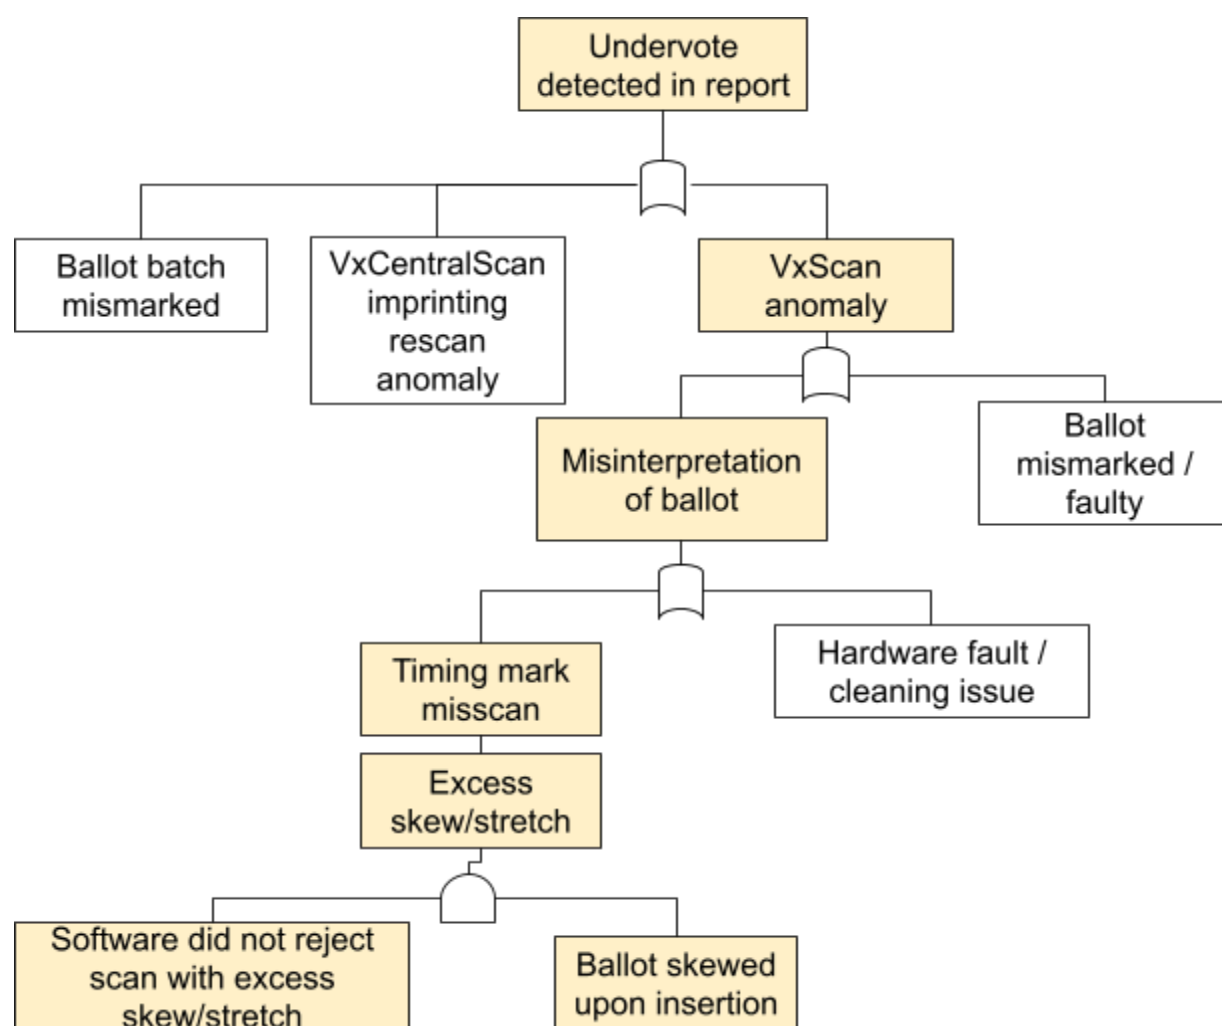
The investigation began with a basic fault tree analysis, analyzing potential fault branches across the different scanner devices under test (VxScan, VxCentralScans). Test methodology was investigated first due to another anomaly previously arising involving test methodology with VxCentralScan, but this was eliminated as a possibility as only VxScan reports were identified as involved. As fault paths were eliminated as possibilities, the logs and CVRs associated with the undervote were analyzed and led to a focus on interpretation of unusually skewed ballots in VxScan. A simplified version of the fault tree analysis diagram is shown below, with the identified root cause fault path highlighted:

Drilldown into these fault paths using the “5 Why’s” technique further led to identifying root causes, detailed in the key findings below. The question “Why did the software not reject a scan with excess skew/stretch?” in this case led to further questions that pointed to a need for more data to better define and identify such ballots with excess skew/stretch.

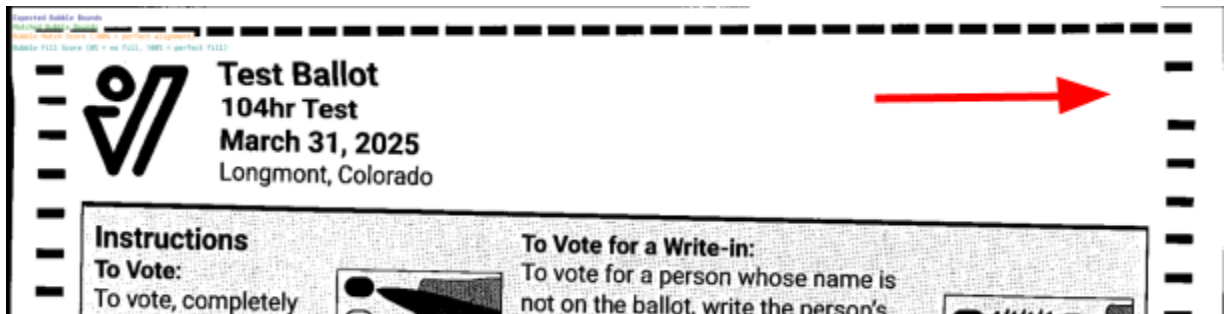
- The underlying problem causing the bubble misalignment was a missing timing mark near the upper right corner of the front side. Note that the 3rd row of timing marks in the image was misscanned with a gap on the right side (see image below). This led to misalignment of the underlying bubble grid interpretation.

- The misscanned timing mark was due to uneven skew and stretching, which can happen rarely when ballots are inserted skewed or gripped unevenly, or if the scanner itself needs mechanical calibration of the infeed gap to grip ballots evenly. The lack of reproducibility rescanning ballots pointed to ballot handling causing the skew.
- Software is expected to reject ballots with excess skew, stretching, or misscanned timing marks.

- Excess skew and stretch of the ballot scan image, due to uneven ballot insertion or ballot handling, and
- Software acceptance of the ballot scan with the misscanned timing mark.

- Prevent the issue at the software level by more reliably rejecting mis-scanned ballots with excess stretch/skew, and logging stretch/skew characteristics for diagnostic or maintenance purposes.
- Prevent the issue at the hardware level by adjusting the bracket holding in the scanner to help prevent the scanner gap falling out of calibration.

The undervote was due to misidentifying the timing mark grid, causing the interpreter to look for the bubbles in the wrong location. The grid was incorrectly identified and accepted as valid because the interpreter will attempt to infer missing timing marks, and inferred a timing mark in the stretch gap between the real timing marks on the right side near the top of the sheet's front side. This essentially caused all the timing marks below the 2nd timing mark on the right side to be off by one, causing greater alignment errors in bubble finding the farther to the right the bubbles were.
