Blockage in Common Drain - 15a/b/c Euston Road, Sandringham

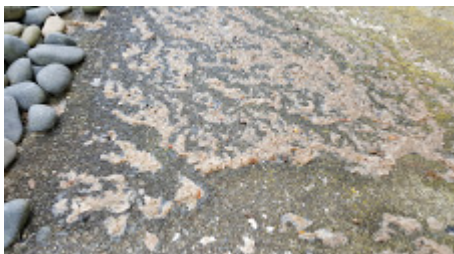
20190209_141820.jpg
7951K

It was obvious to me that the blockage was lower down on the site, as the lowest drainage fittings (gully traps) were overflowing. If the problem/blockage had been above Unit's B and C, the lowest point for waste to flow out of would have been the gully traps of Unit A. Pushing our camera up from the manhole (as per attached Council GIS plan), we found that the main blockage was on the corner of the bottom Unit, and that is why overflows were rising out of those lower gully traps. However, to determine what the blockage was, was very difficult as there was slow seepage of faeces and other wastes pushing through this blockage area. To try and locate the blockage from the upper end of the common drain, I assessed that there would be an inspection/entry to the drain where we cut out a section of the concrete footpath. Why would I have cut this section out? Answer: Because normal practice is to have an inspection point where there is a junction on the drain connecting to a gully trap. This section of the line was 800mm in depth below the ground level. We were able to put our drain cleaning rods down through this inspection point, and try and push through the corner where the main blockage appeared to be. We could not clear enough to place the camera back in to actually see what was happening.....this all happened on Day 1. Removal of spoil/crap/and sewer waste could not be done by wheel barrow, as you know that there are steps up to the car park. Therefore, spoil/waste exiting this site had to be carried out by carrying it in buckets up to our vehicles. Likewise, backfilling and re-concreting also had to be by using material carried up and down by buckets. i.e. extra time/labour involved here.

Finally, we needed to use a very powerful back cutting water blasting unit, and therefore we brought in a specialist unit to carry out these works from the bottom manhole within the lower end of the property, whilst we were probing and camering from the upper end (the inspection point) so as to recognise and understand that we had cleared this blockage. It appeared that there may have been old plaster, and perhaps a greyish sort of paint that may have been washed down this drain years ago, i.e. the corner point blockage of the drain system we are talking about was hard to cut away, and whether it had been oversized plastered jointing of the old pipes or something else, we do not know. I don't believe it was

plastering of the pipe work as blockages would have been more regular than the last couple of years. I have seen this sort of mess in pipe lines before, as sometimes whilst renovating/plastering contractors tend to wash their buckets down gully traps thinking that it will flow away without causing problems. However, we feel that the problem is resolved, but we have informed Bob to keep in contact with us if any other problem evolves as well.
