Accumulation of small changes leads to an explosion

November 2018

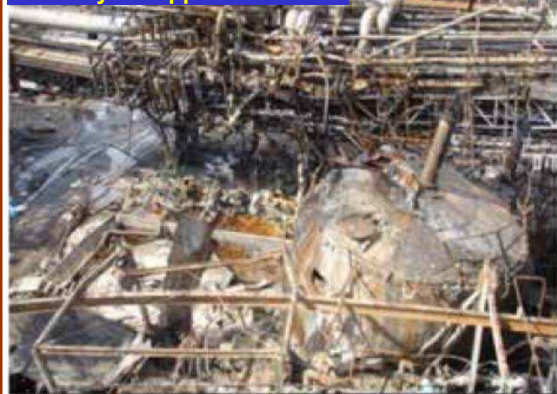
In September 2012, at an industrial site in Himeji, Japan, a 70 cu m (18,500 US gal) fixed roof acrylic acid (AA) tank exploded, and a fire followed. There was one fatality, a fire-fighter. 36 people were injured – 2 policemen, 24 fire-fighters, and 10 plant workers. The tank was destroyed and nearby facilities were significantly damaged (Photo 1). There were no major impacts to the neighborhood and environment.

Photo 1: Destroyed AA Tank

- Never make any changes to your plant, even changes you think are small, without following your plant Management of Change (MOC) procedures.
- When you see any change in your plant, ask if there has been an MOC review. If there has been, and you were not informed of the change, tell your supervisor. You should always be informed of changes in your plant that impact your job.
- If something is different from normal operation, confirm operating procedures or ask your supervisor what to do.
- Accumulation of small changes can cause an incident with a big consequence. All small changes must be identified and the risk to the total system analyzed and adequately managed.

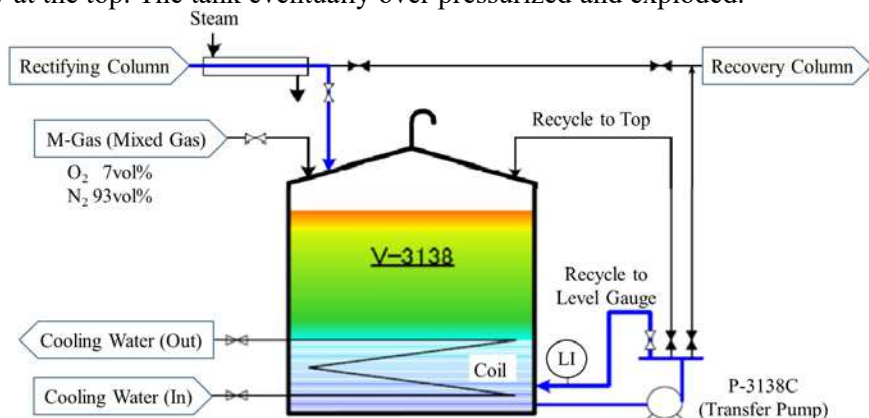
The tank provided intermediate storage between two distillation columns for purifying AA. Originally the tank had been used at full capacity. The contents were cooled and mixed by pumping from the bottom of the tank to the top. Later, the normal operating level was reduced to a level below the cooling coil. The contents were no longer recirculated to the top of the tank, but instead to a nozzle near the bottom that was also used to connect a level gauge (Drawing 2).

At the time of explosion, the plant was conducting a test of the downstream distillation column, which required stopping feed from this tank. The level of the tank gradually increased to its original operating level. Without recycle to the top of the tank, the AA above the cooling coils was not mixed and cooled. The temperature of the incoming AA was believed to be below the onset temperature for polymerization, and the AA contained polymerization inhibitor. However, the temperature in the tank increased, especially at the top. The tank eventually over pressurized and exploded.

Drawing 2: Only the bottom of the tank was cooled, the liquid above became hot

- Originally the pipe feeding the tank was hot water jacketed to provide freeze protection, but this was changed to steam.
- Removal of a steam trap made temperature control unreliable.
- The top layer was no longer mixed with cooler AA, and stayed warm from incoming AA.
- There are two exothermic AA self-reactions – dimerization and polymerization. Polymerization inhibitor does not stop the dimerization reaction. Experiments showed that heat from dimerization raised the temperature sufficiently to start a runaway polymerization reaction.
- The hazard of heat from dimerization was not recognized, so recirculation to the top of tank was not resumed.
- The tank had no temperature indicator. The first indication of a problem was observation of AA vapors escaping from the top vent on the tank.
