UNITED STATES COAST GUARD
U.S. Department of Homeland Security

MARINE SAFETY ALERT
Inspections and Compliance Directorate

Safety Alert 04-19

Confined Spaces: Silent & Invisible Killers

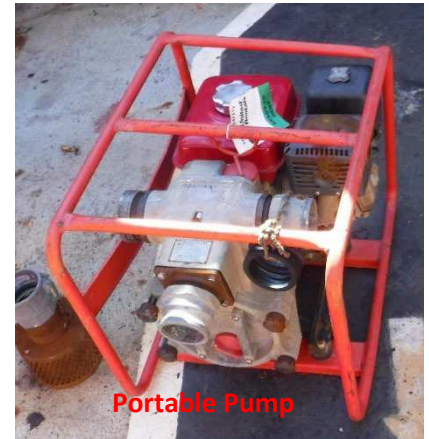
Ten crewmembers were onboard the MODU preparing it for a heavy lift transport to an overseas ship breaking facility. They were successful in dewatering three of the MODU's four legs. However, the de-ballasting system was inoperable in the fourth leg because piping and valves had been previously removed. To continue pumping, the crew rigged a portable diesel engine driven pump to discharge the tanks.

Each leg had six decks. The first two uppermost decks had access hatches that allowed easy transfer of crew and equipment between the decks. The remaining decks were accessed via manhole hatches that were too small to allow passage of the portable pump and had to be enlarged. As each ballast tank was fully discharged, the manhole cover at the bottom of the tank was enlarged and the pump was lowered. Once they reached the lowermost ballast tank, the pump was set up with its suction hose in the tank and discharge hose exiting the leg via a hole torched through its side shell plating. A second smaller hole was also cut to serve as an air supply vent.

- Obtain the requisite level of knowledge and training of confined space entry procedures including emergency and rescue procedures;
- Ensure crews undergo periodic confined space training and participate in routine and practical onboard emergency drills;
- Verify all required confined space entry and rescue safety equipment is onboard, maintained, tested and fully functional; and
- Continually appreciate the dangers involved in confined space entry and educate yourself by further study. A good place to do this are the [reports found on this webpage](#) ¹
