LESSONS LEARNED

LL# 344

Mud/Gas Separator Cleaning Results in Death

Safety Bulletin No. 003
March 8, 2017

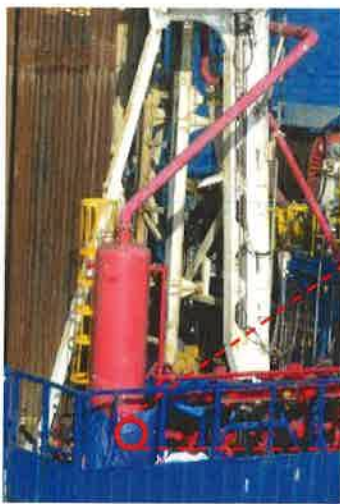
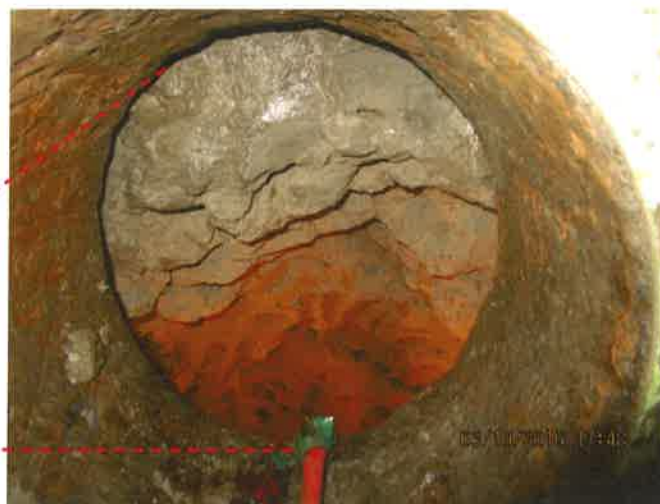
A fatal incident occurred when an Assistant Driller (AD) placed his head and an arm into a platform drilling rig's vertical Mud/Gas Separator (MGS) through its inspection hatch, while performing the assigned, but non-routine task of removing built up and hardened material from inside the MGS.

A BSEE Panel investigation identified a number of established Safe Work Practices (SWPs) that, if followed, should have prevented the task from proceeding in the manner in which it occurred. The contaminating material, believed to be cement, had already begun to cure and harden inside the MGS when it was discovered. The decision was made to attempt to remove the material, and supervisors authorized the task without understanding of the extent of the buildup.

the overhead material from falling. Despite some of the workers having expressed individual concerns about the task conditions, stop work authority was not invoked. Personnel were not provided a stopping point short of total task completion. The AD was working with the provided equipment, and with a portion of his upper body inside the MGS, when material broke free and/or dislodged and entrapped him causing the traumatic injury that ultimately resulted in his death.

- Ensure that authorizing personnel take an active role in task planning and verify that all required task authorization documents are complete, accurate and meaningful.
- Ensure that hazard analyses are updated or revised to reflect all impactful changes in task conditions, and/or the working environment.
- Ensure that equipment approved and made available for each assigned task is adequate to perform the task-work safely and in accordance with safe work practices and work instructions.
- Clarify through initial and/or recurrent training how "confined space" and "entry" are defined.
- Evaluate emergency response plans and supporting response organization agreements to ensure everything is adequately in place to support your emergency response plans and strategies.
