From: Wellington Chun
Sent: Friday, July 11, 2014 9:32 PM
To: greg.hayes@densitron.com
Subject: Beagle Bone Black USB communication very slow;RipDraw - Beagle Board Black Development
Attachments: smallbutton_BBB.zip; smallbuttonswindows.zip

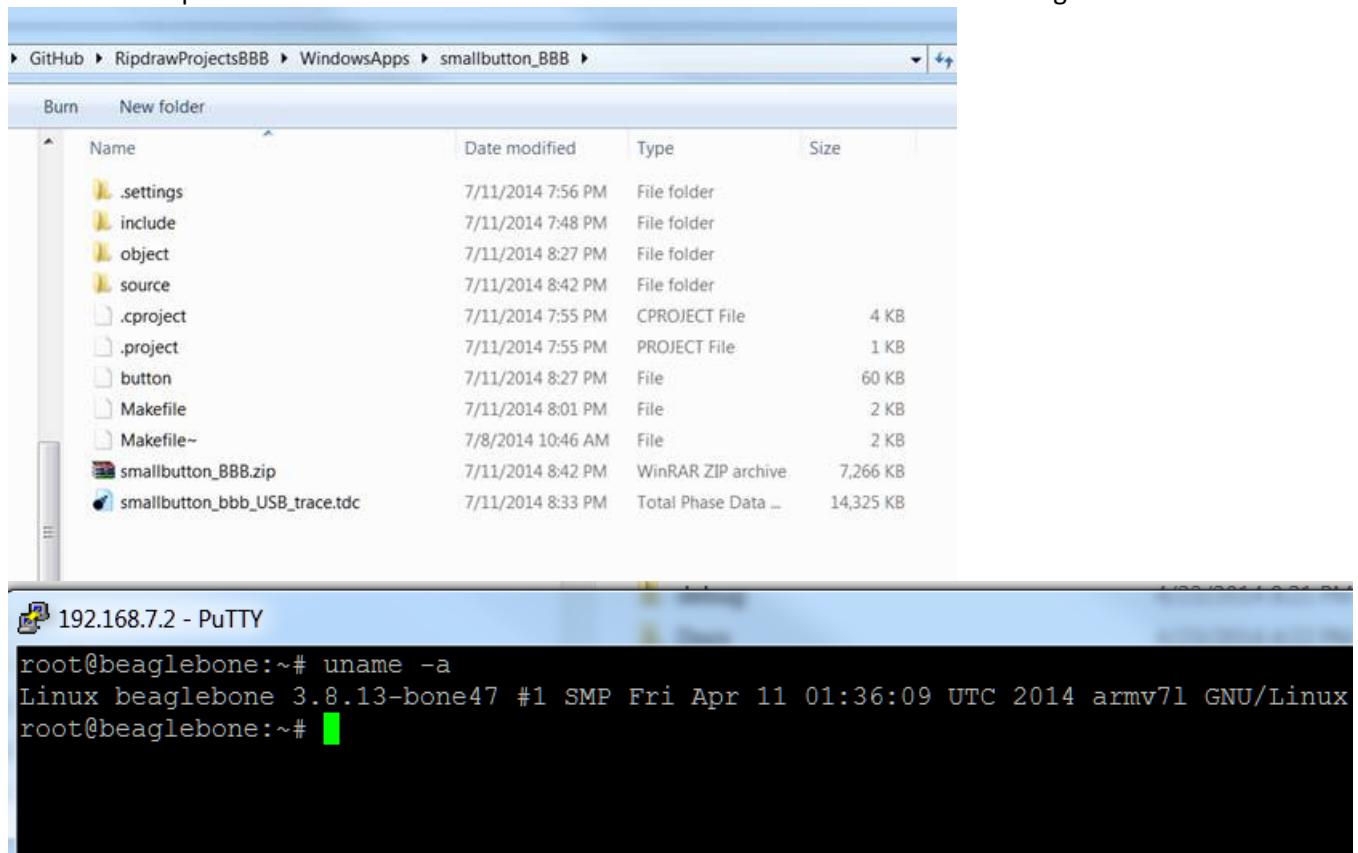
The smallbuttonBBB.zip has all the source for the test routines and the USB sniffer trace for Beagle Bone Black.

But if you look at the BBB USB trace, the time 0x3131 SetLayer command and 0x3138 ComposeLayersToPage is about 3 to 4 seconds. Please have a look at why the BBB and Ripdraw board is having this communication delays. Please note that the data is moving, but between each Ripdraw out/Ripdraw response, the USB port seems to loses connection and needs 3-4 seconds to reconnect.

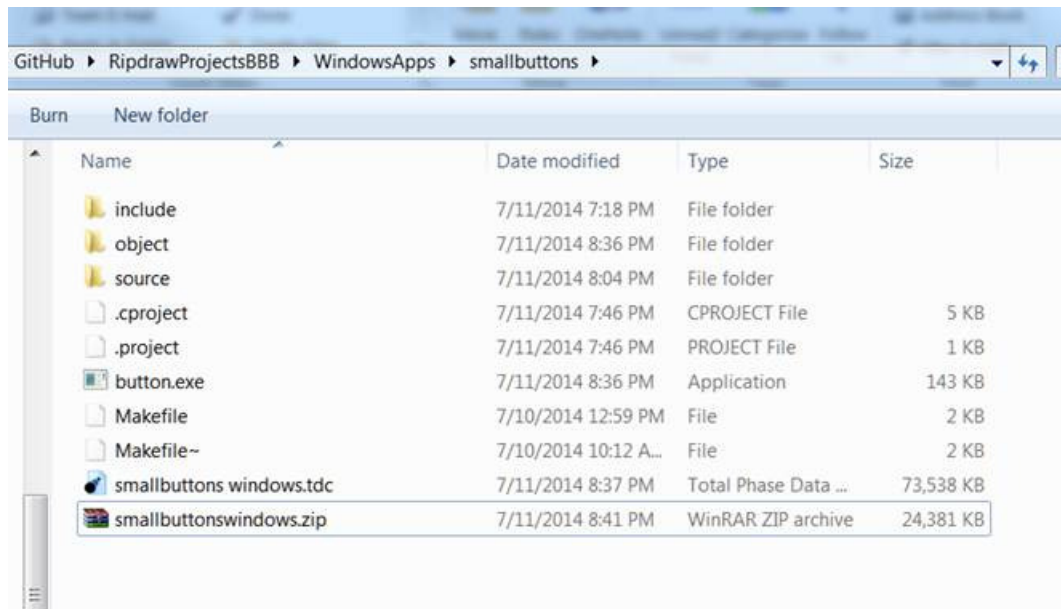
The smallbuttonwindows.zip contains the same application but run under windows, which is fine. This also contains the USB trace for between the ripdraw and windows system

If you look at the windows trace the time between the 0x3131 SetLayer command and 0x3138 ComposeLayersToPage is short
