Date of Report: September 19, 2023

BURNED-AREA REPORT**PART I - TYPE OF REQUEST****A. Type of Report**

PART II - BURNED-AREA DESCRIPTION**A. Fire Name:** Ridge Creek**B. Fire Number:** ID-IPF-000447**C. State:** Idaho**D. County:** Kootenai**E. Region:** Northern**F. Forest:** Idaho Panhandle**G. District:** Coeur d'Alene River Ranger District**H. Fire Incident Job Code:** P1QG9D (0104)**I. Date Fire Started:** 08/03/2023**J. Date Fire Contained:** 10/31/2023 (ICS-209)**K. Suppression Cost:** \$24,000,000 (ICS-209)**L. Fire Suppression Damages Repaired with Suppression Funds (estimates):**

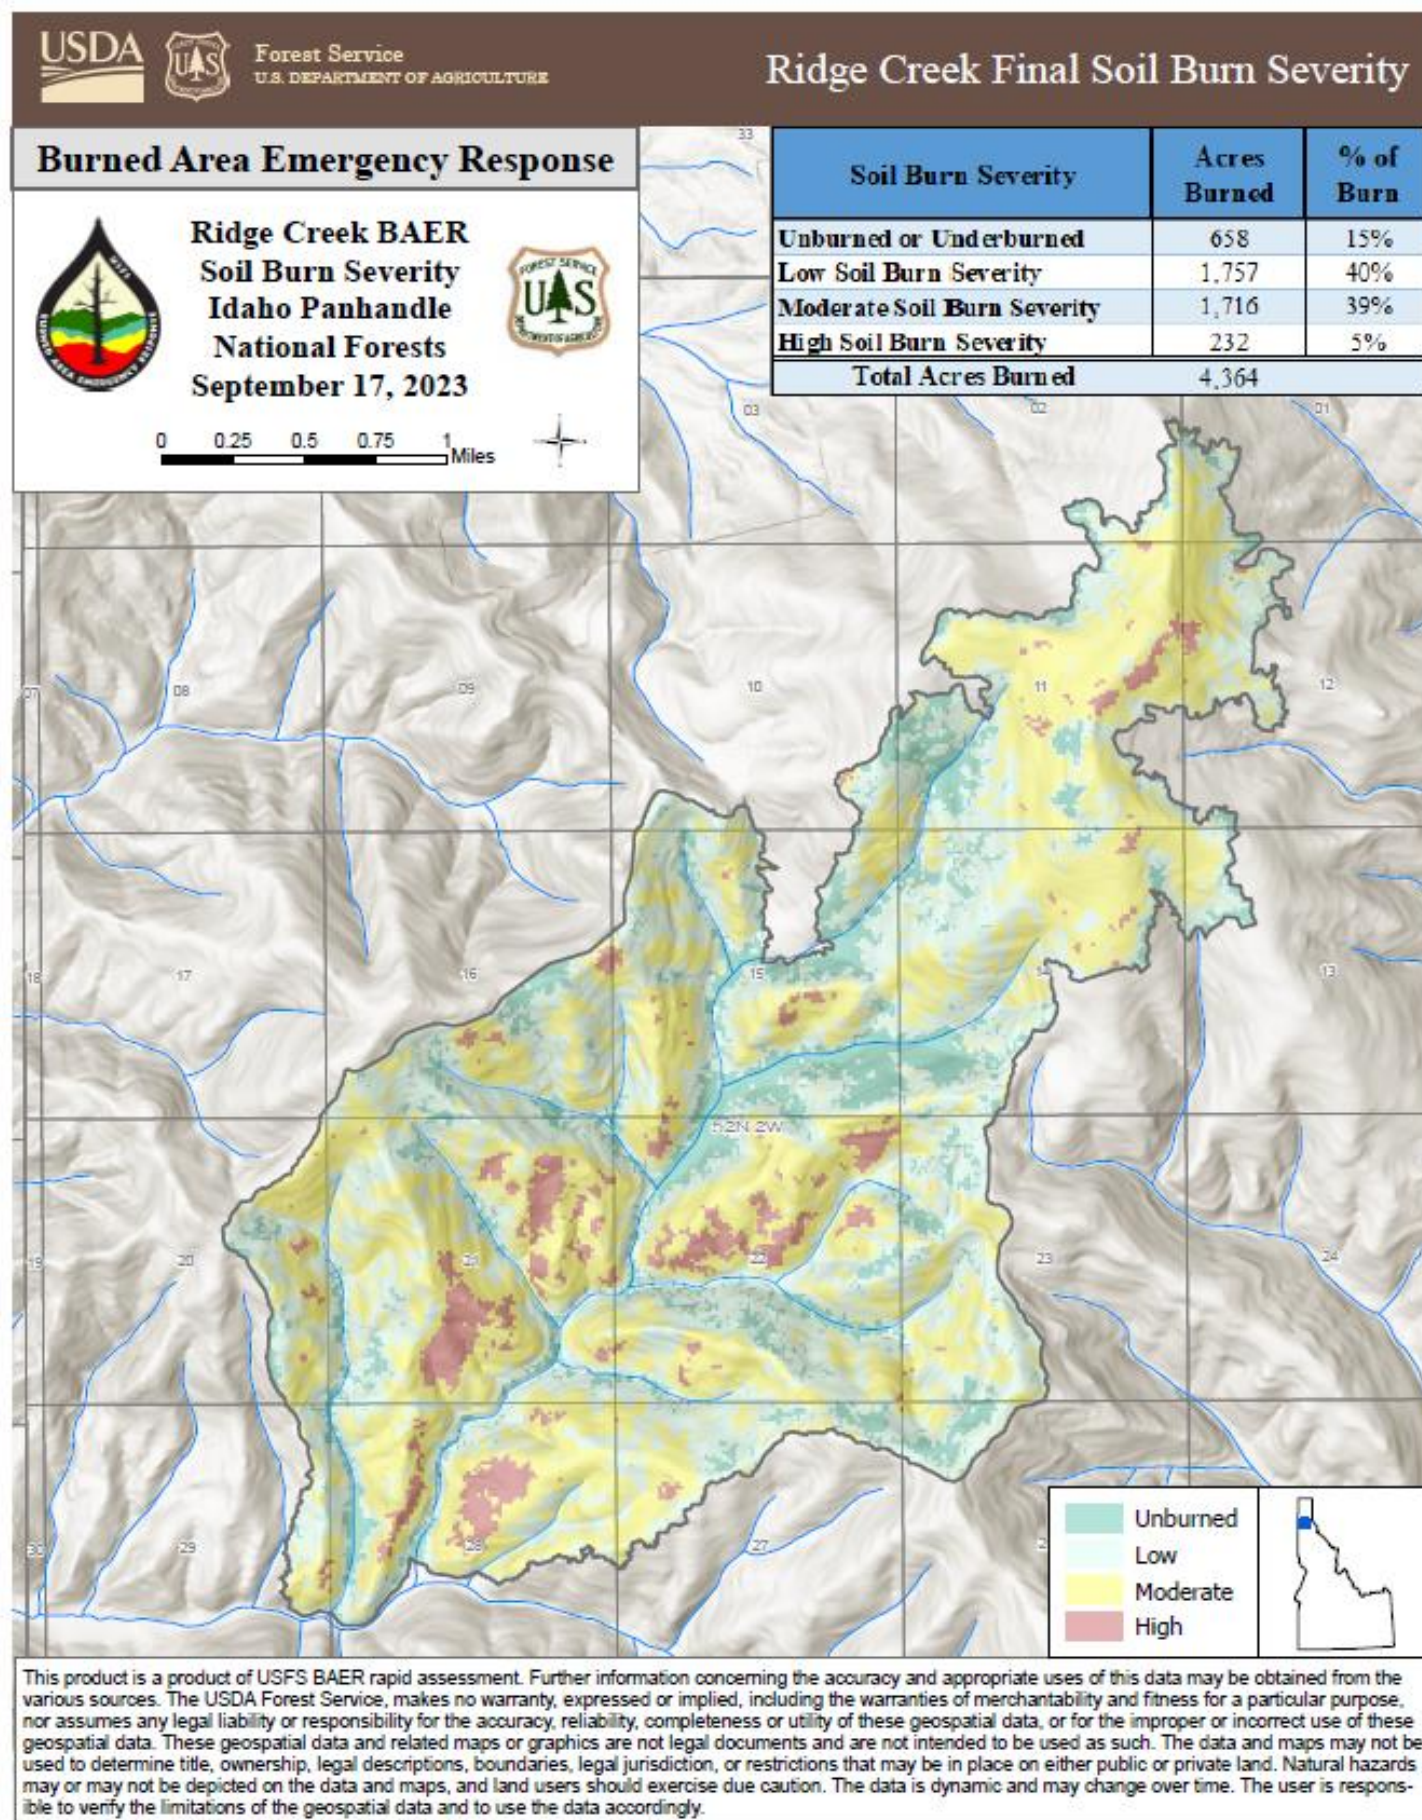
APPENDIX – SOIL BURN SEVERITY MAP

(BARC) map using methods described in RMRS-GTR-24. This resulted in a field validated SBS map (Figure #). The two vegetation types supported very different fire behavior; when combined with weather and fire progression help interpret post-fire conditions, such as patterns for resulting SBS. Additional field reconnaissance and identification of threats to human life and safety, NFS transportation system, recreation features, soils, water quality, native vegetation communities and cultural resources was completed by the BAER survey team.
