Date of Report: 10/12/2022

BURNED-AREA REPORT

Gifford-Pinchot National Forest

A. Fire Name: Goat Rocks
Kalama

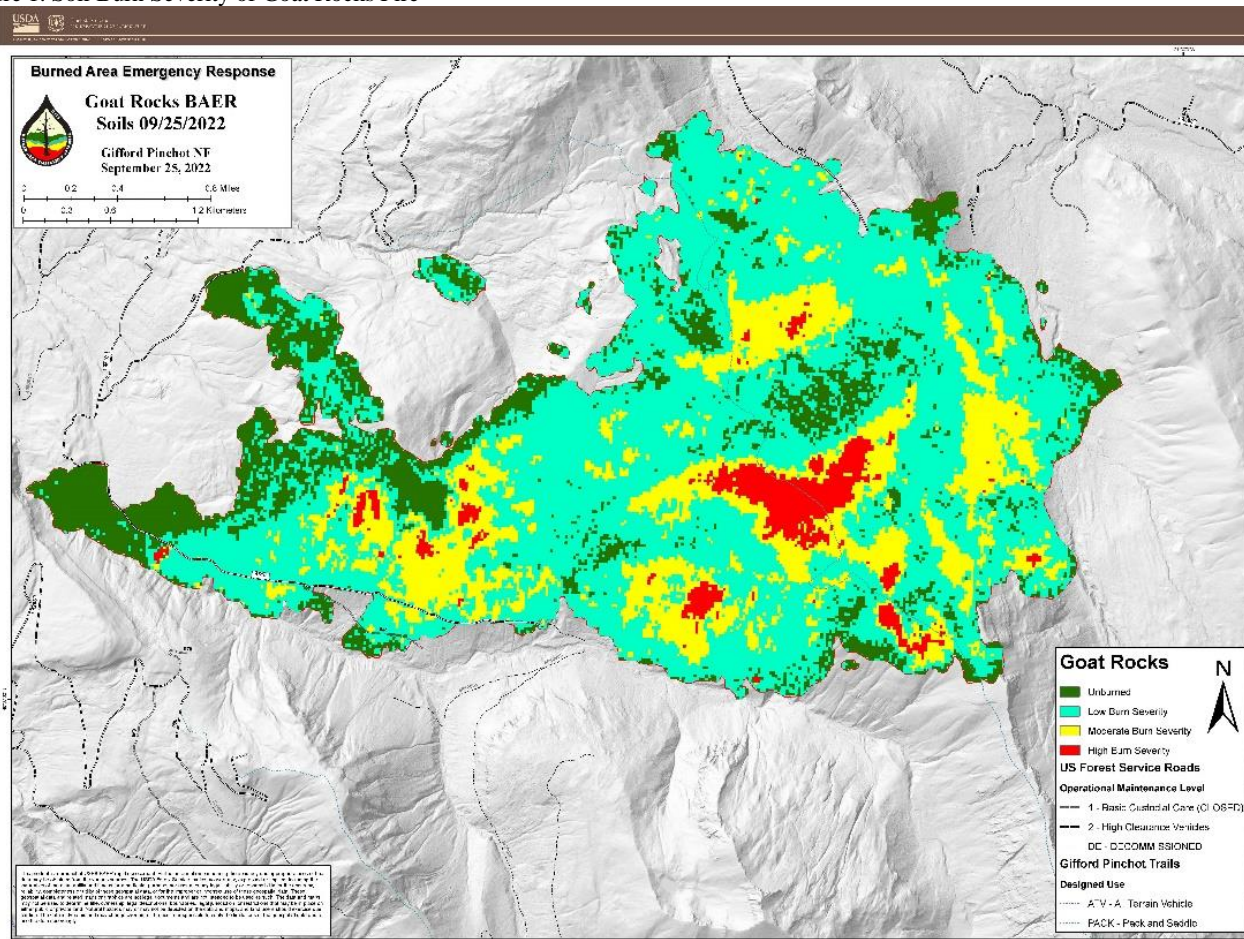
Figure 1. Soil Burn Severity of Goat Rocks Fire

Soil Burn Severity	GPNF Goat Rocks	GPNF Kalama	State	Private
Unburned/ Very Low	617	105	0	0
Low	2,127	169	0	0
Moderate	719	25	0	0
High	144	2	0	0
Total	3,608	352	0	0
