## Stellaris® LM3S9B92 RevC Errata

This document contains known errata at the time of publication for the Stellaris® LM3S9B92 microcontroller. The table below summarizes the errata and lists the affected revisions. See the data sheet for more details.

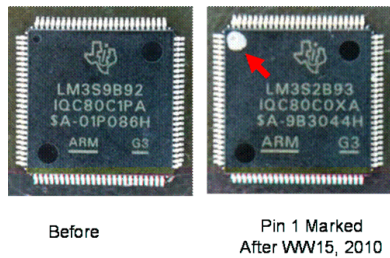
### Part Marking Examples

Note that two versions of the patch code have been released. Devices that have the patch code pre-programmed in Flash memory have a silver metallic dot located on the pin1 indicator. Devices that have the patch code plus a UART-only flash loader pre-programmed in Flash memory (see

The silver metallic dot on the part indicating that the patch code was pre-programmed in Flash memory looks like the following:
