## Failure Analysis Report

<b>Coherent RMA Number</b>	987360 - 1.1	<b>Customer</b>	JABIL CIRCUIT SDN BHD (IPC)
<b>Coherent Part Number</b>	FTLF8518P4BNL-C1 (Cisco P/N: 10-2626-01)	<b>End Customer</b>	CISCO SYSTEMS
<b>Failure Analysis Report Date</b>	02/07/2023	<b>Customer Reference</b>	3908620-CISCO
<b>Analysis by</b>	Liau Jian Yang	<b>Received Date</b>	02/01/2023

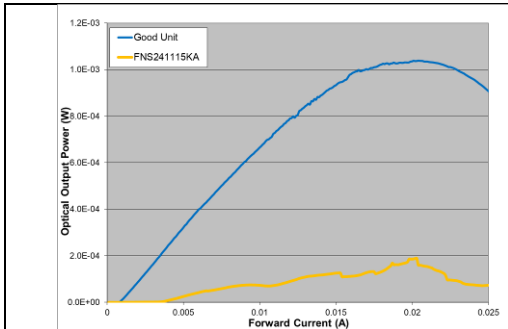
</div> <div>Fig. 1 - Forward LI Traces</div>

Condition	LDI (mA)	Diagnostic Tx power (dBm)	Measured Tx power (dBm)	Before Shipment	-	-4.48	-4.36	Upon Return	11.928	-12.35	-12.68
Condition	LDI (mA)	Diagnostic Tx power (dBm)	Measured Tx power (dBm)										
Before Shipment	-	-4.48	-4.36										
Upon Return	11.928	-12.35	-12.68										
Internal inspection	No anomaly could be observed on the PCBA and OSA assembly.												
Electrical probing	Probing on the components of PCBA up to Tx hotbar area along the Tx path did not show any abnormality. This suggests the fault was internal to the TOSA.												
TOSA light current voltage curve (LIV)	<div>TOSA was then removed and tested separately. LI sweep showed low optical output power (Fig. 1). This confirms the failure was due to a faulty VCSEL within the TOSA.</div> <div>

RC analysis	Module failed with high laser bias current. Failure was isolated to a faulty VCSEL within the TOSA.
Failure mechanism	A faulty VCSEL within the TOSA caused the module to fail.
Containment/ Corrective action(s)	N/A
Risk Assessment	<p>Wafer#: 180105-70</p> <p>Coherent has been shipping this product in high volume for more than 4 years and the failure rate is less than 100 DPPM.</p>

Customer reported failure was confirmed. Module failed with low Tx power. The failure was isolated to faulty VCSEL within the TOSA.
