## Failure Analysis Report

Coherent RMA Number	987359 – 1.1	Customer	JABIL CIRCUIT SDN BHD (IPC)
Coherent Part Number	FTLF8536P4PCL-C2 (Cisco P/N: 10-3227-03)	End Customer	CISCO SYSTEMS, INC.
Failure Analysis Report Date	02/07/2023	Customer Reference	3908618-CISCO
Analysis by	Liau Jian Yang	Received Date	02/01/2023

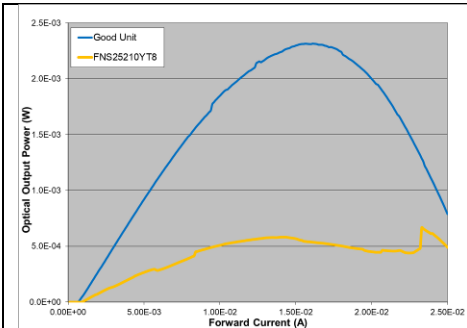
<p>Table. 1: Tx parameters</p>	Condition	LDI (mA)	Diagnostics Tx Power (dBm)	Actual Tx Power (dBm)	Before shipment	7.994	-0.50	-0.70	Upon return	8.054	-3.28	-4.42
Condition	LDI (mA)	Diagnostics Tx Power (dBm)	Actual Tx Power (dBm)										
Before shipment	7.994	-0.50	-0.70										
Upon return	8.054	-3.28	-4.42										
Internal Visual Inspection	No abnormalities were observed on PCBA and OSA of the module.												
Electrical Probing	Probing on the components of PCBA up to Tx hotbar area along the Tx path did not show any abnormality. This suggests the fault was internal to the TOSA.												
TOSA/VCSEL Analysis Results	<p>TOSA was then removed and tested separately. LI sweep on the TOSA showed low laser output power (Fig. 1). Reverse bias IV trace (Fig. 2) revealed excessive reverse bias leakage current compared to a known good unit. This confirms the failure was due to faulty VCSEL within TOSA.</p> <div><div>

</div></div> <div><div>Fig. 1: Forward LI Trace</div><div>Fig. 2: Reverse Bias IV Trace</div></div>
