## EE371 Debug Examples

Intel Corporation  
jstinson@mipos2.intel.com

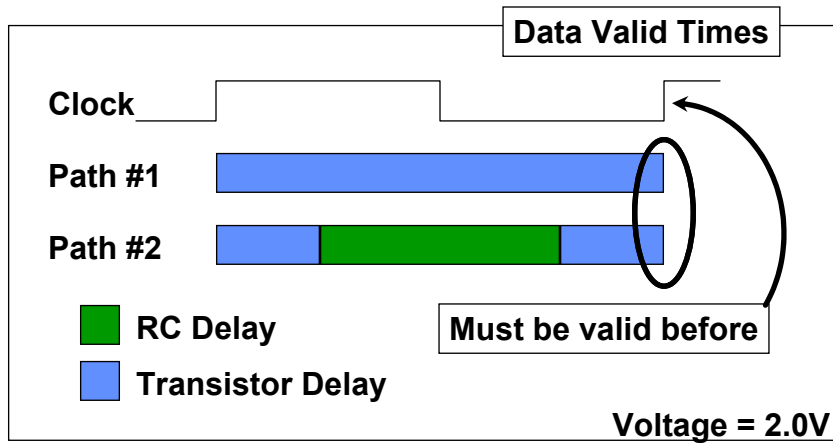
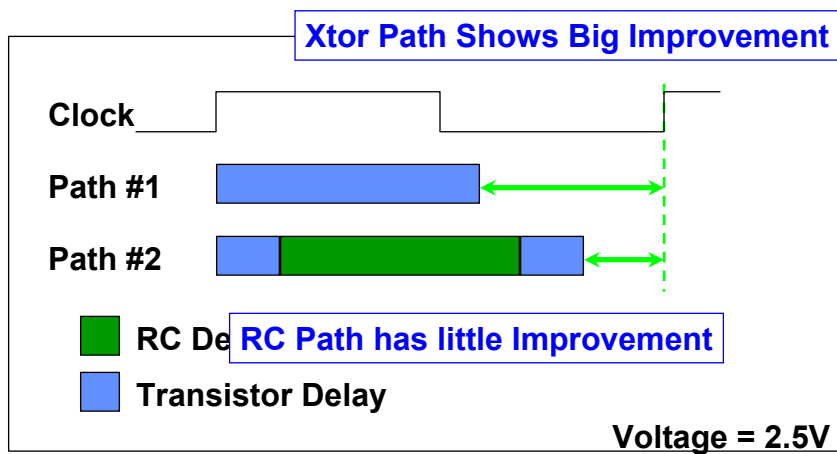
## Interconnect Effect

- Long Interconnect Line
  - RC Delay less sensitive to driver strength
  - Voltage/process only improve driver

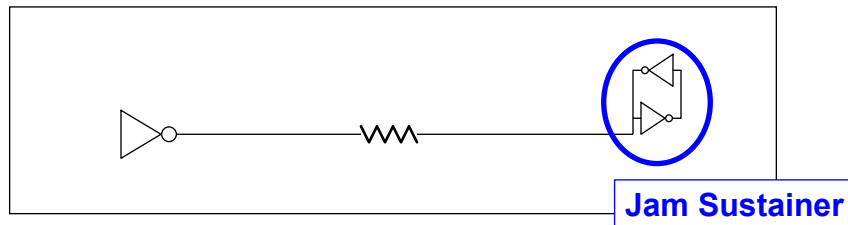
- Jam sustainer at end of the line
  - Fights transition of signal
  - Sustainer gets stronger with voltage/skew
  - Adds to “wall” characteristics

- Two FIB experiments
  - Driver speedup – wall moved
  - Cut sustainer – wall “leaned”

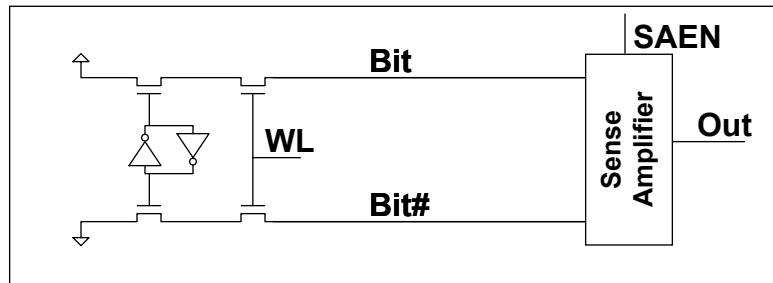
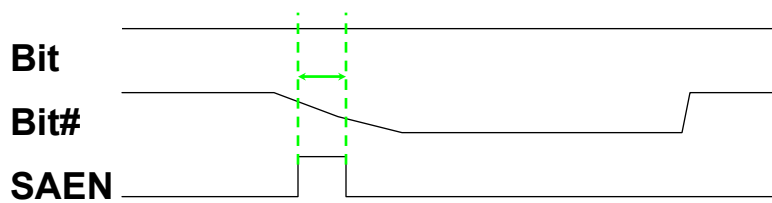
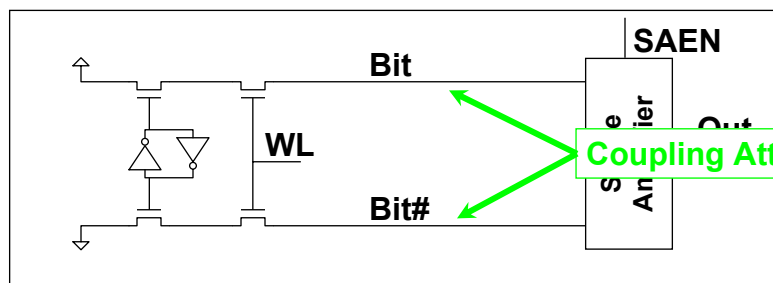
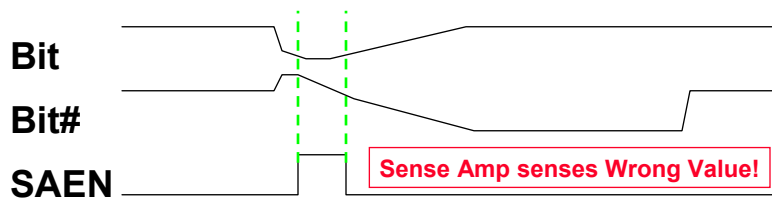
## Coupling Schematics

- EBeam confirmed branch array read
  - Visibility limited in array
- Bit 4 resolved later than other bits
  - Based on EBeam waveforms
- Signals on either side of read lines transistioned in opposite direction
  - Suspected coupling problem

- Parameters data checked at problematic FAB
  - M2 CD's wider than normal
  - ILD1 and ILD2 thicker than normal
  - More sensitive to coupling
- Audit of original design
  - Simulations ignored some coupling
  - New simulations showed failure

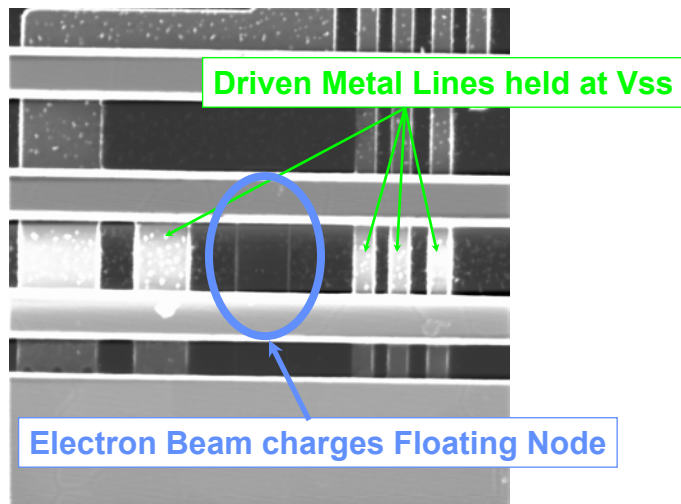
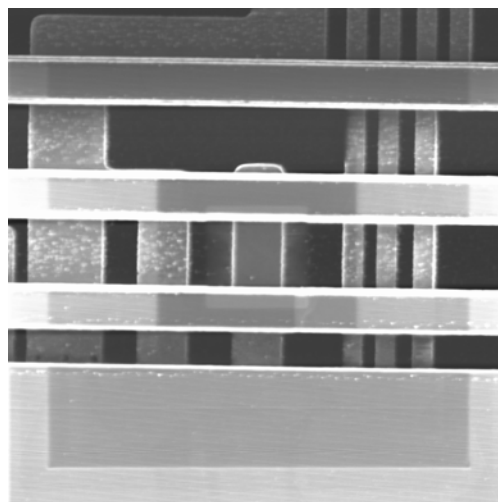
## Floating Node

- Noticed a floating node in EBeam scope

- Node should NOT have been floating
- A0 and A1 layout compared
  - Via1 or M1 could cause error
- FIB strip back focused on this node

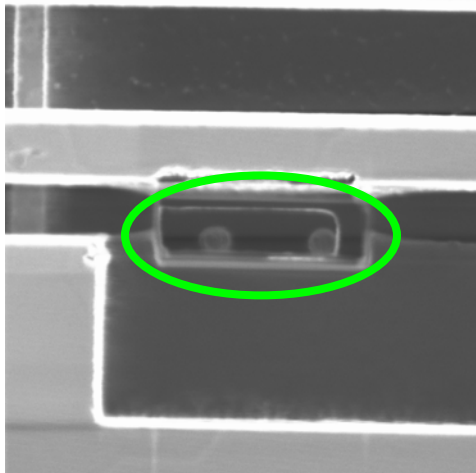
## FIB Stripback Results

- **Should be 3 via1's**
- **FAB contacted**
  - Accidentally used A0 via1 mask
- **Problem fixed**
  - New silicon arrived shortly

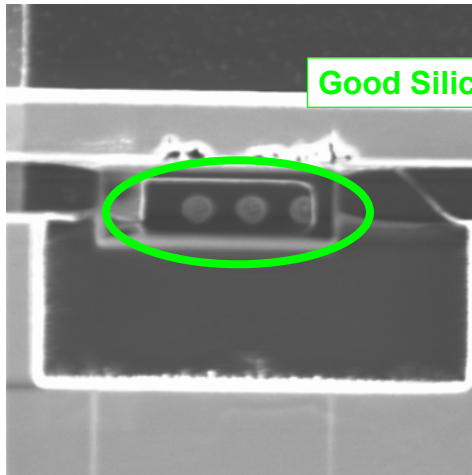
Good Silicon has all 3 via1's

- Fully functional with correct via1 mask

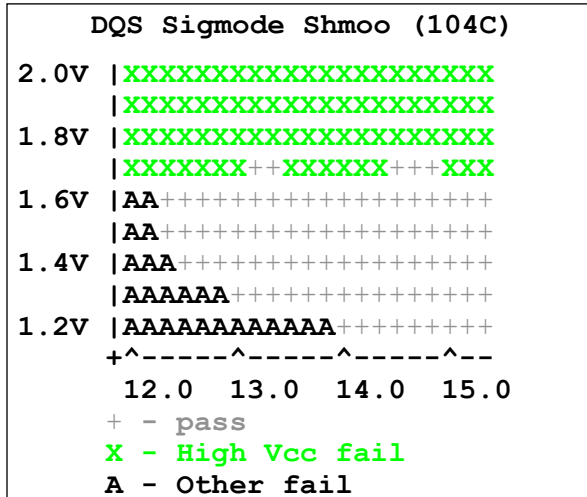
## High Vcc Shmoo

- Observed High Vcc failures
  - Frequency Insensitive
- TDO only failure
  - All signature mode tests were failing
  - Turning off signature mode allowed test to pass

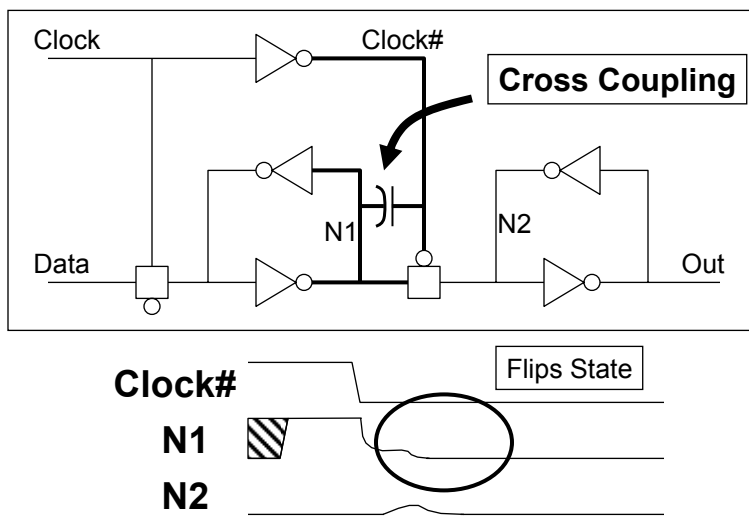
## MSFF Problem #3

- Slave “backwrites” value into Master
  - Combination of three mechanisms to cause failure
- Re-simulated all standard cell MSFF’s
  - Two other cells flagged with same problem
- Circuit was a direct “shrink” from a previous process
  - Discovered same issue on prior process—but at a MUCH higher voltage

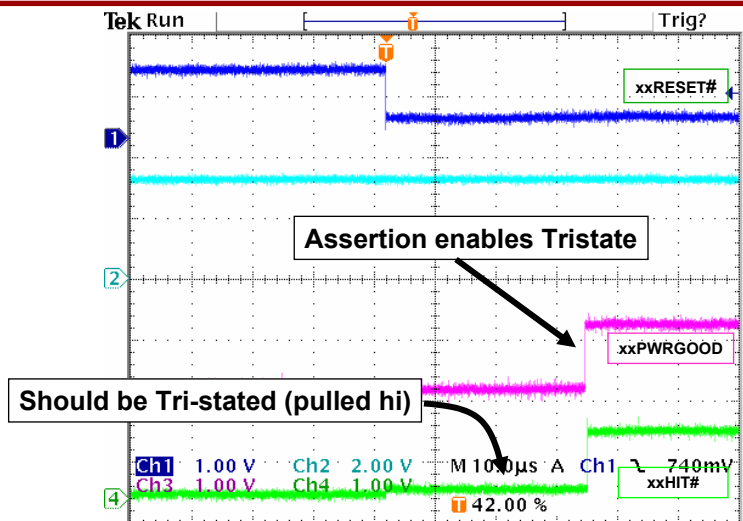
## Oscope Waveforms

- Observed *\*some\** systems wouldn't boot
  - Toggling RESET always enabled boot
  - Toggling power did not guarantee boot
- Nasty problem to debug
  - System level issue (not seen on tester)
  - Intermittent failure (occurred 1 out of 100 times)
  - Debug tools not enabled (part hasn't booted)
- Started with oscilloscope waveforms...

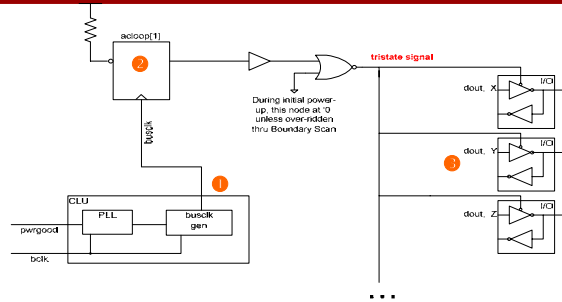
## Why is TriState determined by PWRGOOD?

- Discovered busclk dependency @ 2
  - ACLOOP[1] directly controls I/O tristate signal
    - Depends upon busclk for proper initialization
  - While !PWRGOOD, busclk is not generated
    - Power-up initialization @ 1 may generate a busclk → no issue
    - Otherwise, must depend on power-up initialization of ACLOOP[1] (2)
    - “Driven value” on I/O pins will depend on power-up initialization at 3

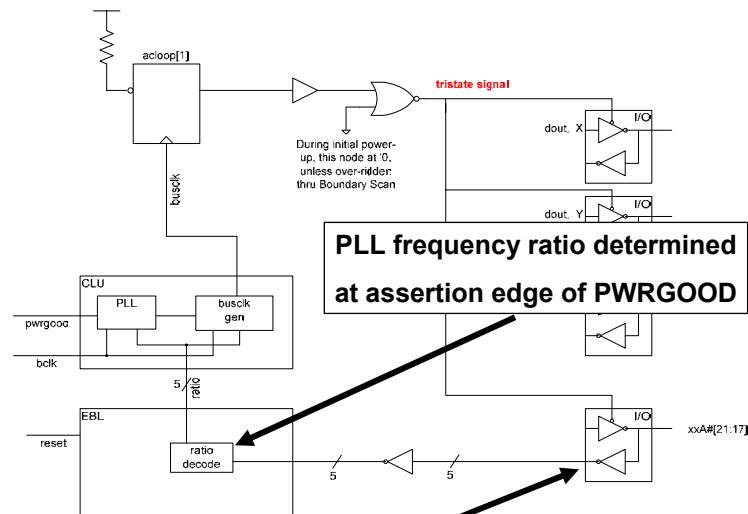
## PLL Ratio Depends on PWRGOOD

- PWRGOOD will always clear the ACLOOP
  - Eventually the pins should tristate
  - So, why was the part still not booting?
- Further characterization: Power levels were very low
  - When the part failed to boot, the power was very low
  - Potentially indicated that the PLL wasn't running
  - Discovered secondary effect of ACLOOP initialization problem

- System drives address pins at PWRGOOD assertion
  - Sets internal PLL frequency
  - Address pins are \*supposed\* to be tristated by the processor
- If ACLOOP powers up incorrectly, contention can occur
  - Processor is driving a '0' on address pin; system is driving a '1'
  - The processor will always win
- PWRGOOD assertion tristates the address bus
  - Too late! It's already been sampled by PWRGOOD assertion
  - Only "illegal" bus fractions will cause failure
    - Only 7 out of 32 possible bus fractions are "illegal"
- Failure requires a confluence of diff't events
  - ACLOOP powers up "on"
  - Bus clock does NOT glitch during power up
  - Address pins power up driving an "illegal" bus fraction

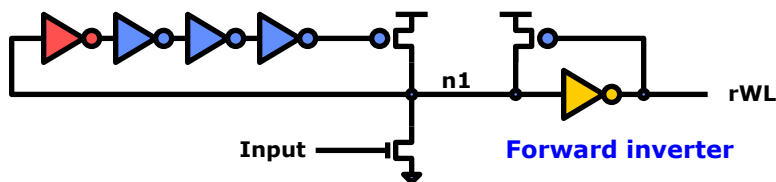
- Used a fancy self-resetting mechanism
  - Self-reset WL prevented read→write min-delay
  - Pulsed WL read array for short period of time

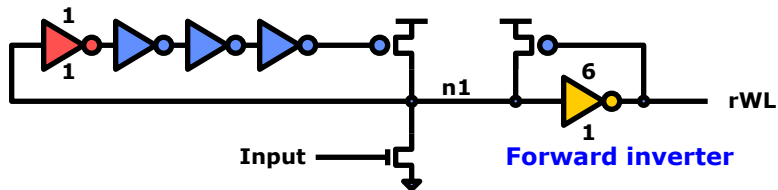
## Wordline Driver: Problem

- Self-reset sized diff't than forward path
  - Initial state could flip forward inverter but not feedback (pseudo-metastable state)
- Resolving pseudo-meta state
  - Access WL
  - High temp
  - Low temp
