Section : Woldiya
Road Segment: Woldiya-Dilb
Bridge No B22 -1 -003 (Tikur Wuha)

15.1 Brief Description of the Structure

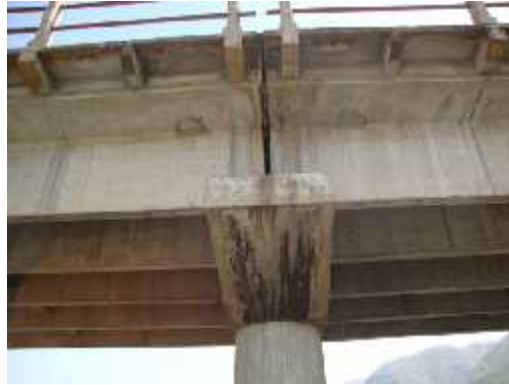
Water leakage

The damage observed due to the mentioned structural distresses are to proceed with the **repair & maintenance for Water Leakage, and Drainage Pipe Damage** as per the designed specification and working drawings for such construction activities

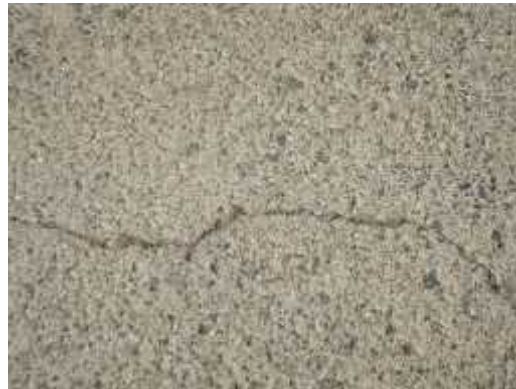
Surface Crack

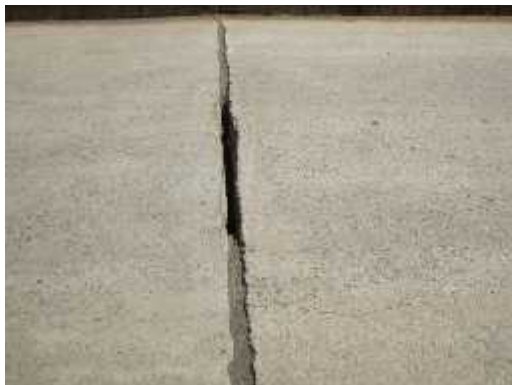
Expansion Jpint Missing
