# FAILURE ANALYSIS OF WELD-REPAIRED B-1900 TURBINE BLADE SHROUDS

Erik M. Mueller<sup>1</sup>, Luis Carney<sup>1</sup>, Sun Tai Ngien<sup>1</sup>, John L. Yadon<sup>1</sup>

<sup>1</sup>NAVAIR, ISSC Code 4341, Building 793, NAS JAX, Jacksonville, FL 32212-0016

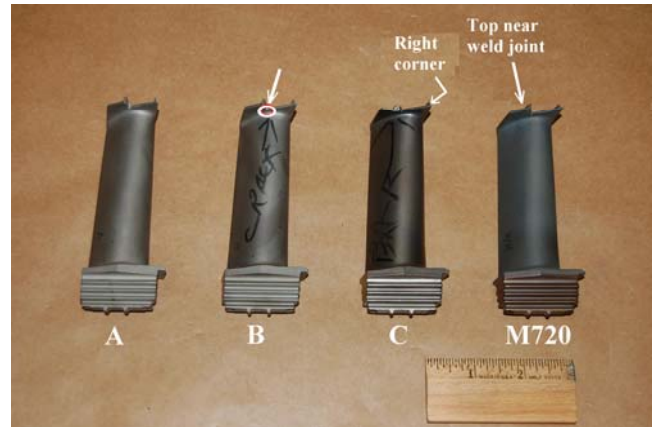
- Blade A: Underneath shroud at concave side
- Blade B: At center of Z-notch on both the convex and concave sides
- Blade C: Above the far right corner on the convex side
- Blade M720: On top of the shroud at weld joint near the fractured Z-notch (see Figure 3)

Figure 1. Image of the convex side of the turbine blades with showing the cracks observed through FPI.

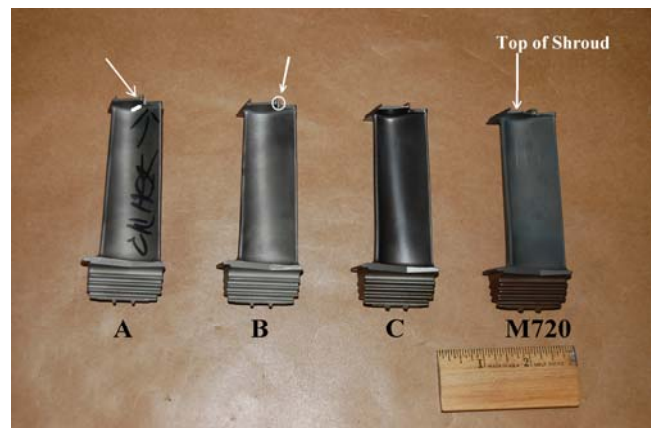
Figure 2. Image of the concave side of the turbine blades with showing the cracks observed through FPI.

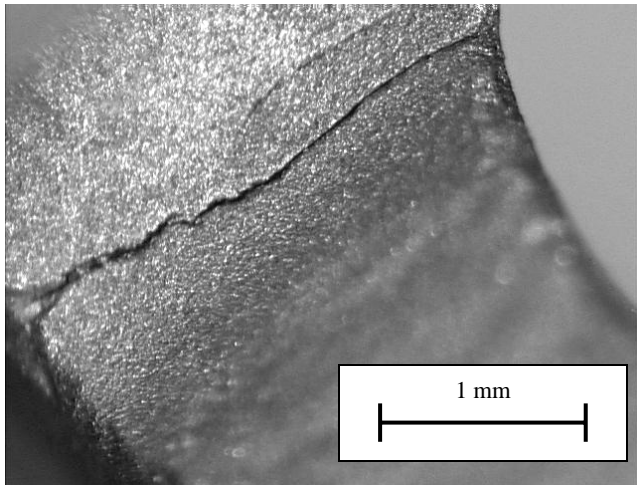
Figure 4. Photograph of the Z-Notch cracks on Blade B on the convex side. The crack was later found to have penetrated into the weld material.

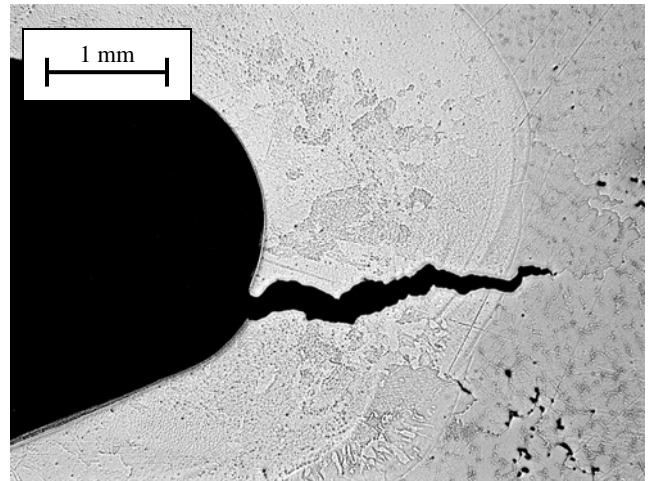
Metallographic inspection of the blades revealed cracks that appeared to emanate on the surface and interior of the blade perpendicular to the top shroud surface. These flaws were found in the weld material as well as the substrate. Figure 6 shows an example one of the cracks identified from FPI. These surface

Figure 6. Image of Z-notch surface crack in Blade B (25X).

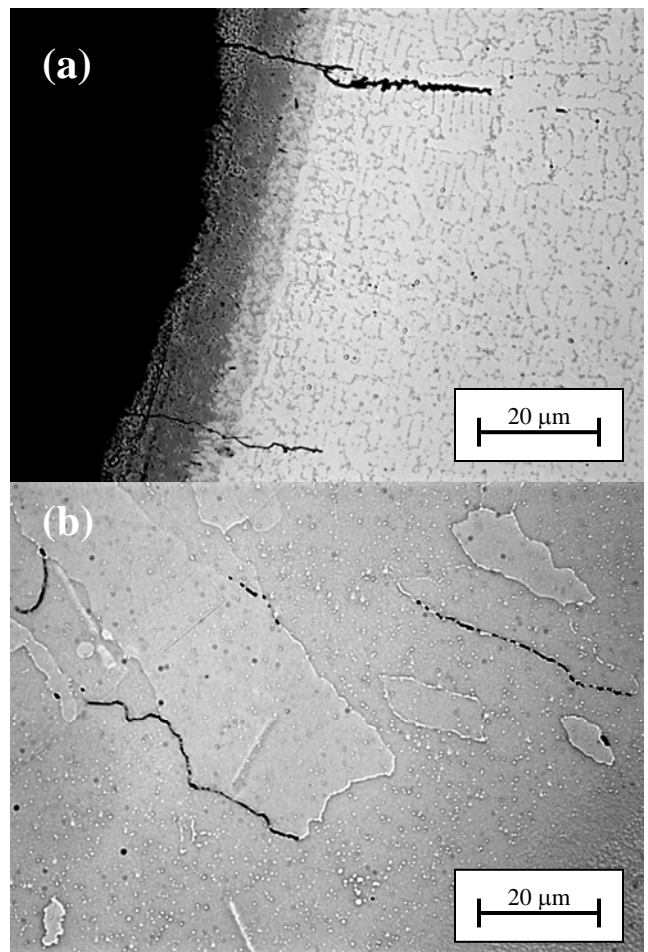
Figure 7. Images of cracks in blade B (a) along the interdendritic regions of the hardface and (b) along the grain boundaries in the filler material (1000X).

cracks were found to penetrate through the filler material as well as into the casting substrate. The cracks appeared to preferentially propagate along the grain boundaries in the base alloy, and along the interdendritic regions in the hardface welds (see Figure 7).

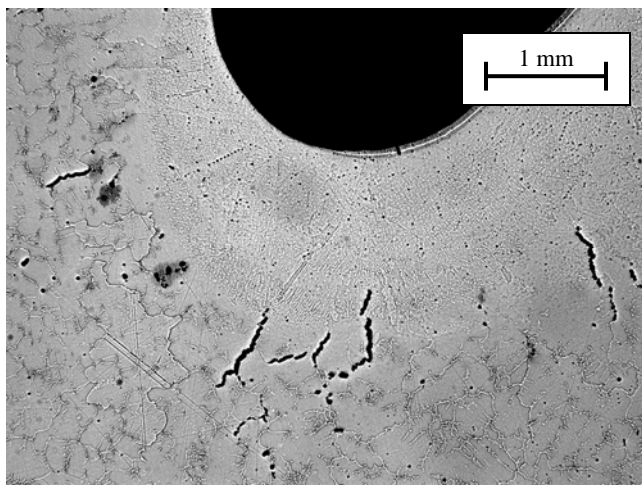
Figure 8. Optical image of hot cracks at the weld-alloy interface in the Z-notch of blade A (25X).

At the weld-alloy interface, hot cracks were observed (see Figure 8). These cracks were always along the alloy grain boundaries (see Figure 9) or interdendritic regions of the hardface, which were generally normal to the surface direction. At the interdiffusion zone between the coatings and the weldments, small microcracks were observed (see Figure 10).

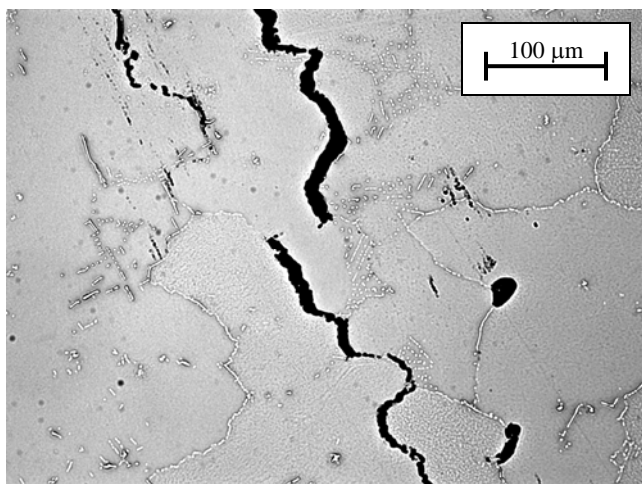
Figure 9. Image of hot cracks along grain boundaries in the heat-affected zone. Carbides are present at the grain boundary (200X).

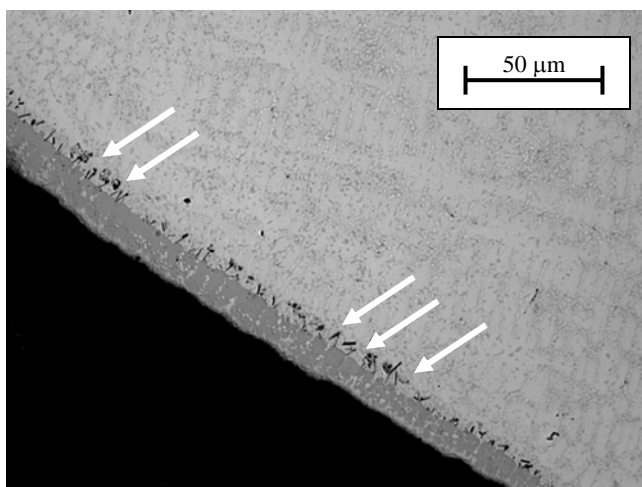
Figure 10. Image of the microcracks in the interdiffusion zone between the coating and the hardface in Blade B (500X). The microcracks are labeled (arrows).

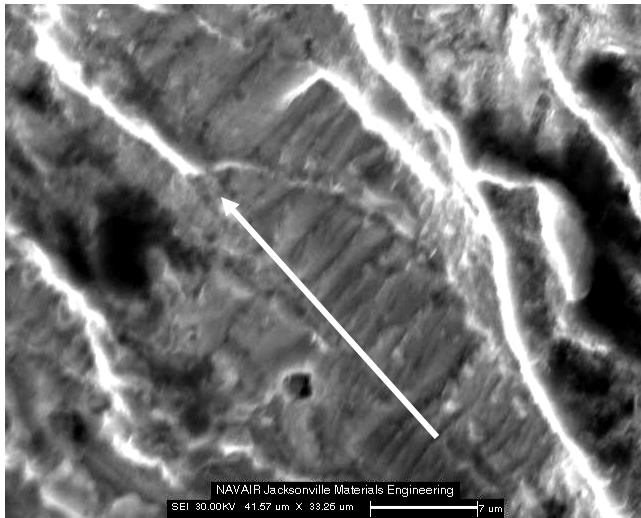
Analysis of the fracture surface of blade M720 suggested failure from fatigue. Figure 11 shows fatigue striations identified on the fracture surface. The initiation site appears to be located, as shown in Figure 6, in the lower inner corner of the fracture surface (see Figure 12). No oxide inclusions or signs of corrosion pitting were found. At the ends of the fracture surface, away from the coating, dimple rupture was observed where the material overloaded. Near the surface, at the interdiffusion zone between the diffusion coating and weld material, signs of intergranular cracking and cleavage were observed (see Figure 13).

Figure 11. Secondary electron (SE) micrograph of the fracture surface of blade M720. The surface shows fatigue striations that propagate from lower right to upper left (arrow).

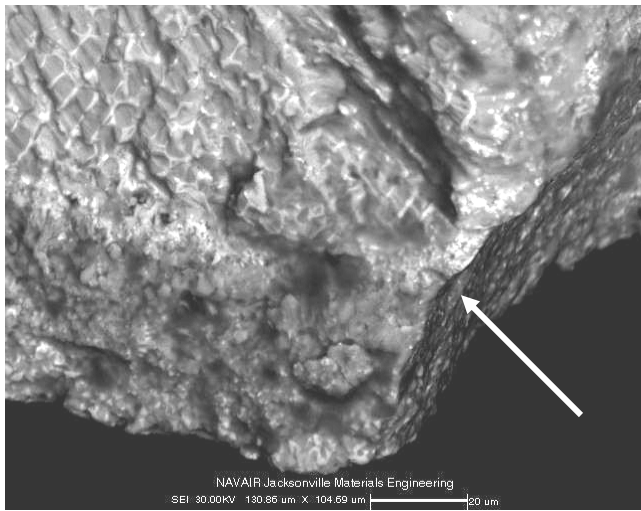
Figure 12. Backscattered electron (BE) micrograph of the fatigue crack initiation site on blade M720 (see arrow).

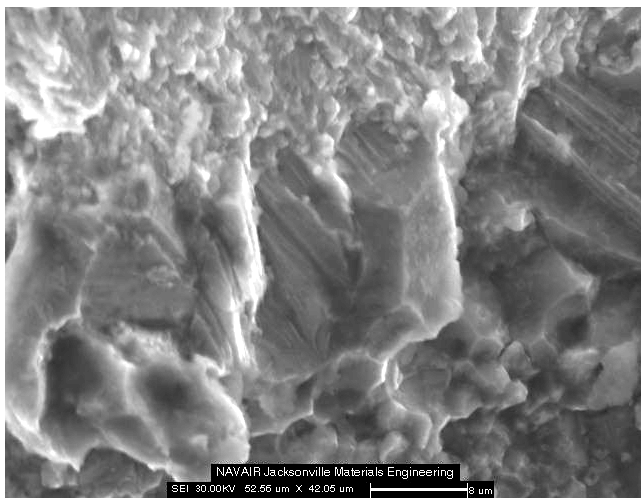
Figure 13. SE micrograph of the fracture surface of blade M720 at the interdiffusion zone between the weldment and coating.

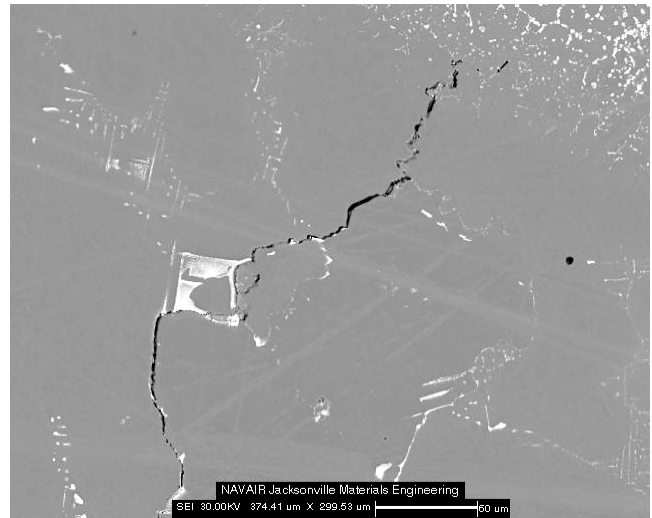
Figure 14. BE micrograph of a blade A hot crack in the HAZ below the weld-alloy interface (upper right). The hot crack proceeds along a grain boundary containing a blocky MC carbide (light phase) and other carbides.

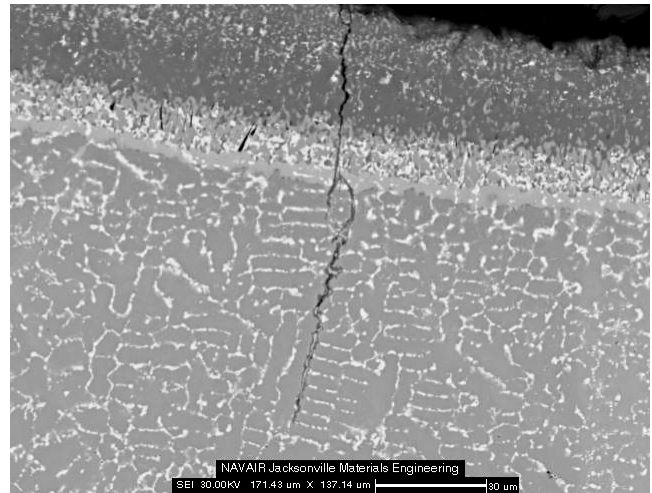
The hot cracks, surface cracks, and porosity discovered through metallographic examination were analyzed using the SEM and EDS. The microstructure of the base metal, as well as the filler, showed blocky TaC and TiC carbides present at the grain boundaries and interdendritic regions. In addition, carbides made from Cr, Mo, and W (either MC,  $M_{23}C_6$  or  $M_6C$ ) were present as well (see Figure 14). Hot cracks propagated along these carbide-rich boundaries in the substrate HAZ, and along the carbide-rich interdendritic regions in the hardface (see Figure 15).

Figure 15. BE micrograph of a blade B surface crack that propagated into the hardface along the carbide-rich boundaries.

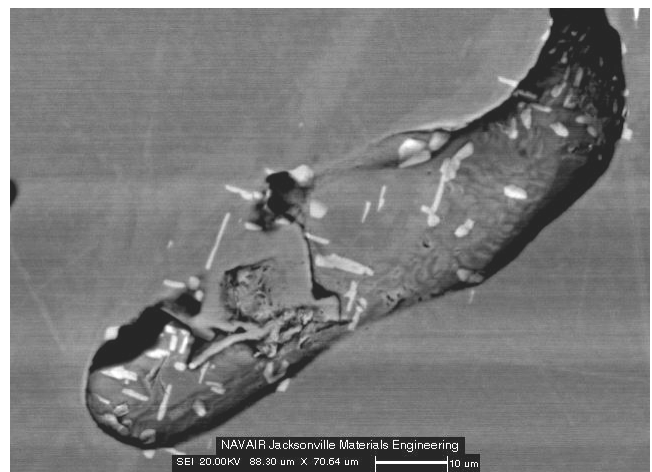
Further inspection of the pores observed previously showed that they had a ruffled internal roughness and multiple blocky carbides on the surface (see Figure 16). EDS confirmed these to be MC (M being Ta or Ti) carbides. Since MC carbides solidify from the melt, these pores were likely present in the original casting before welding.

Figure 16. BE micrograph of a pore in blade A. Light phases are carbides present inside the pore.

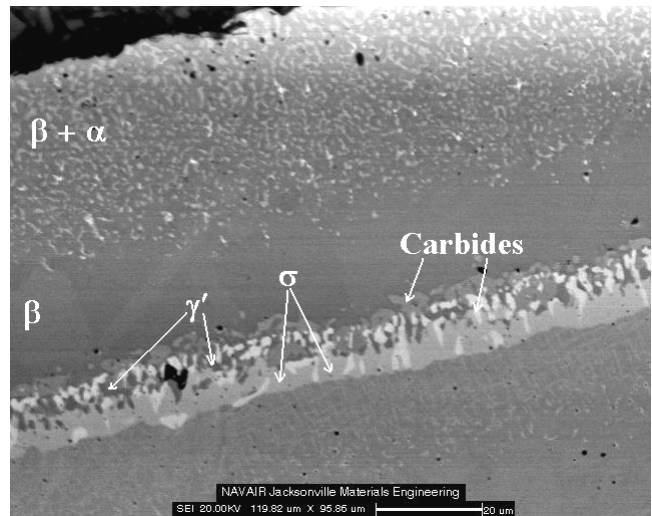
Analysis of the surface at the diffusion coating revealed a multi-layered structure as expected from two diffusion coatings. Figure 17 illustrates this microstructure. The phases were identified using a combination of EDS and WDS. The outermost layer is a  $\beta$ -NiAl layer with some excess  $\alpha$ -Cr throughout. The amount of

Figure 17. BE micrograph of the interdiffusion zone layers between the diffusion coatings and the hardface in blade A.

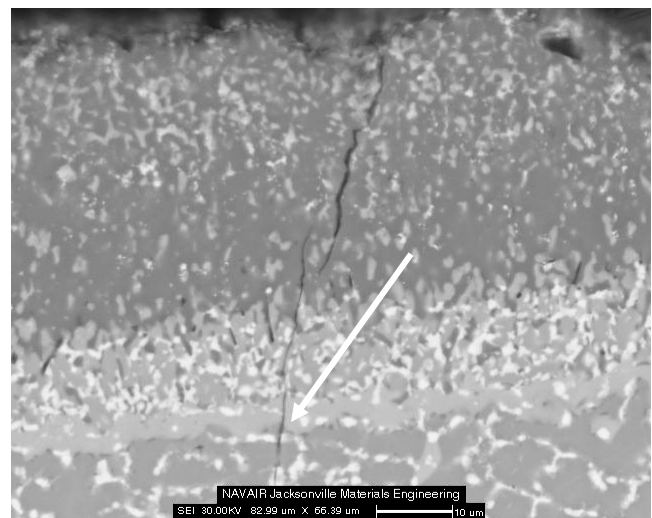
Additionally, a topologically-close packed (TCP)  $\sigma$  phase, with an (Ni,Mo),Cr composition, was detected. No carbon or aluminum was detected in this phase. Multiple pores and cracks were found in this middle layer as well (Figure 18). The innermost layer is a Cr-rich area of the  $\gamma$ -Ni matrix. The Cr content decreases away from the interdiffusion zone until it is the same as the base alloy.

Figure 18. BE micrograph one of the interdiffusion zone cracks (arrow) is found in the  $\sigma$  phase (light grey phase near arrow).
