ANALYSIS OF SURFACE CHEMICAL CONTAMINATION ON EX-SERVICE INDUSTRIAL GAS TURBINE COMPONENTS

Keywords: "Thermal Barrier Coatings, Surface Deposits, Iron Oxide, Industrial Gas Turbine"

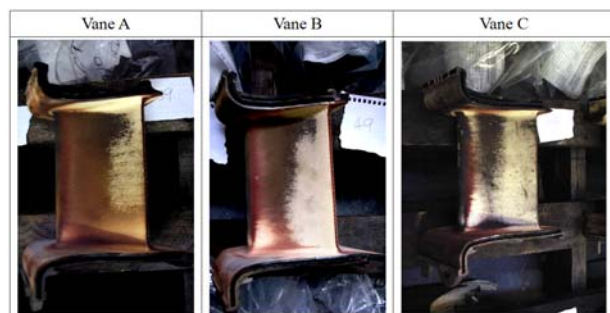
Pressure side images of Vanes A, B, and C are shown in Figure 2. The TBC coatings on these vanes were prepared by air plasma spraying method. The TBC surface discoloration as monitored by visual inspection varies dramatically between the vanes: Vane A had most of its surface covered (approx 75 % surface area) by the deposit, Vane B 50% and Vane C had the least (approx 35 %). The discolored areas reveal dark / light brown, red and black deposits on all three vanes. Dark / light brown deposits tend to cover most of the area on the pressure side. Red deposits can only be seen near the pressure side leading edge. Lastly, black deposits are observed on both pressure side leading edge and trailing edge. Vane C, which reveals the highest ratio of black deposit has TBC coating spallation observed at its pressure side leading edge, as shown in Figure 3.

Figure 2 Pressure side surface images of Vane A, B, and C

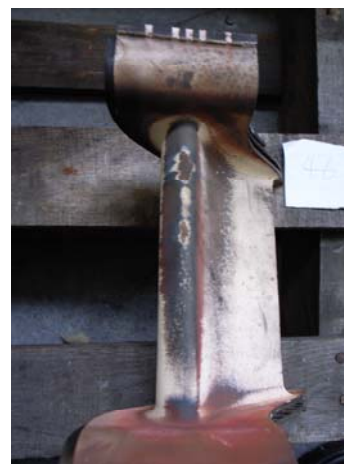
Figure 3 Spallation of Vane C on the pressure side leading edge

From the visual inspection, darker deposits (black and dark brown) were normally found near the pressure side leading edge and trailing edge of the vanes observed. However, in some cases, black deposits were also observed on the pressure side face such as Vane C which had coating spallation at the pressure side leading edge. The pressure side leading edge and trailing edge of the nozzle guide vanes are the potential sites for coating spallation. XRD analyses at the surface of the deposits across the pressure side have discovered co-existence of magnetite and hematite phases. The $\text{Fe}_2\text{O}_3/\text{Fe}_3\text{O}_4$ pressure-temperature phase diagram adapted from Chiang et al. [9] (Figure 20) is used to correlate the range of TBC surface temperature. The predicted TBC surface temperature in these regions could be reaching as hot as 1365°C .

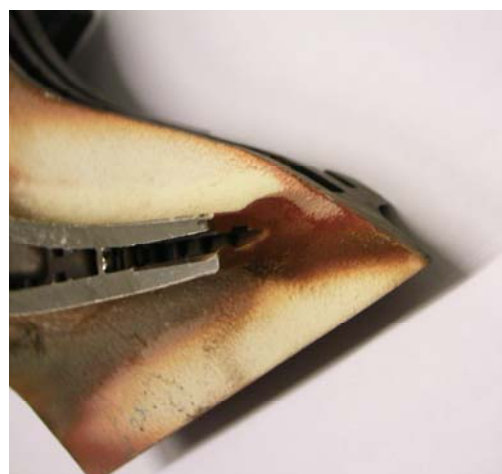
The vane platforms were also examined and have a notable discoloration pattern. One of the interesting observations is that the distribution of red deposits tends to align with the path of cooling air from the trailing edge as shown in Figure 4. Unlike the hot gas exits from the combustor, this internal cooling air contains much higher oxygen content (close to atmospheric pO₂).

Figure 4 Red deposit near the cooling duct

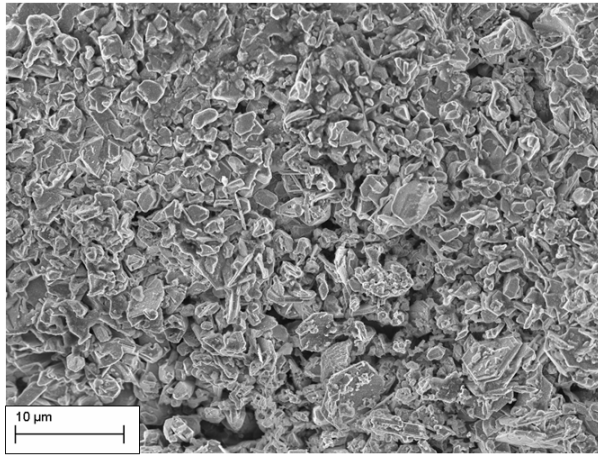
Surface SEM imaging on the deposit has revealed several surface morphologies across the pressure side vane surface. The most commonly observed surface structures were granular and flagstone-like plates (Figure 5 and Figure 6). The size of the granular particles was relatively uniform ranging from 2 to 4 μm . The flagstone-like plates on the other hand had much more variation in size with typical plate sizes ranging from 3 to 10 μm . For the larger plates, a horizontal ridged surface was also observed. Consolidated region (Figure 7) and needle-like structures (Figure 8) were also observed; however, these microstructural features occupied only a minor fraction of the total surface area analyzed.

Figure 5 Granular structures on the commonly observed on the lighter colour deposit surface

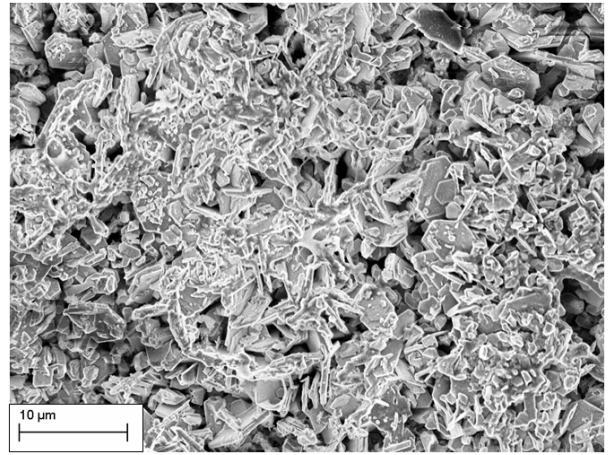
Figure 8 Needle-like structure surface observed in lighter colour deposits

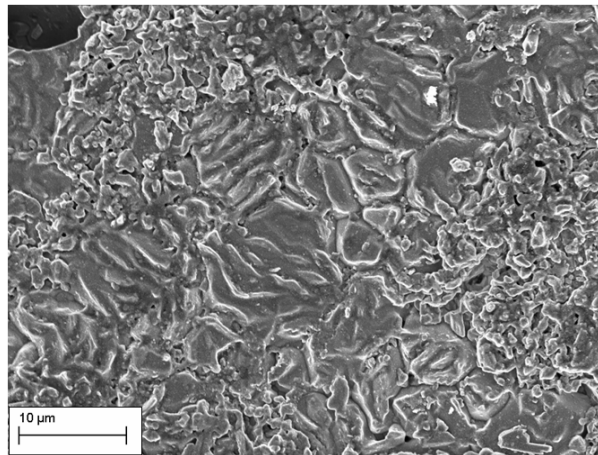
In general, regions with brighter surface deposits (light brown, bright red) tend to have uniform granular macrostructures. Regions with darker surface deposits (dark brown, black) reveal flagstone-like plates. The black deposits in particular, have almost the complete surface dominated by large plates whereas dark brown deposits have mixtures of granular and plate surfaces.

Figure 6 Flagstone-like plates commonly observed on darker deposit surface

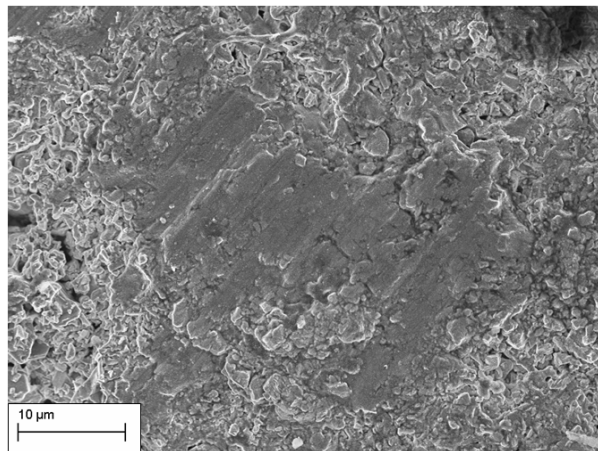
Figure 7 Large area of consolidated region on top of granular layer

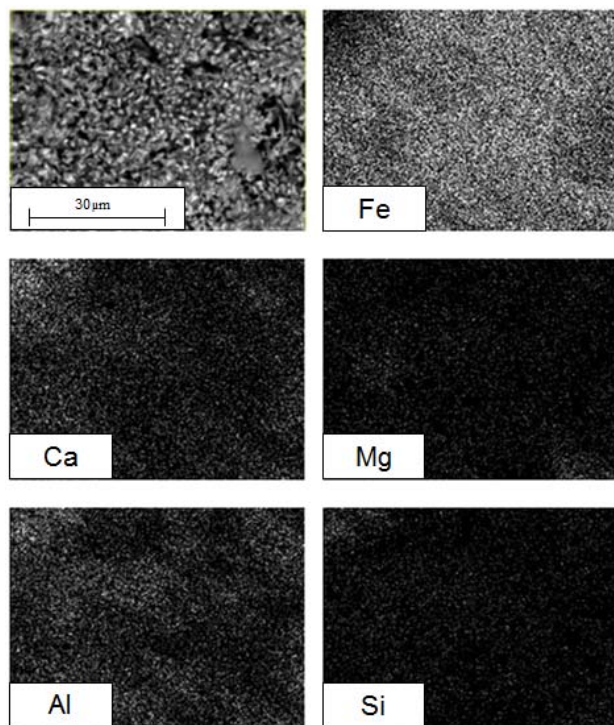
Figure 9 shows the EDS mapping of a granular surface from a light brown coloured surface. Results indicate signals of calcium, magnesium, aluminium, and silicon in combination with much larger iron signals. The flagstone surface structure shows high intensity of iron and oxygen. Figure 10 is the EDS mapping of the flagstone plate from a region covered by black deposit. Signals of calcium, magnesium, aluminium, and silicon come from the gaps and openings of the flagstone-like plates. It is therefore believed the flagstone plates are iron oxide and granular particles are either a mixed Fe-oxides or multiphase grains.

Figure 9 EDS Mapping on granular surface reveals the chemical composition and distribution of Fe, Ca, Mg, Al, and Si

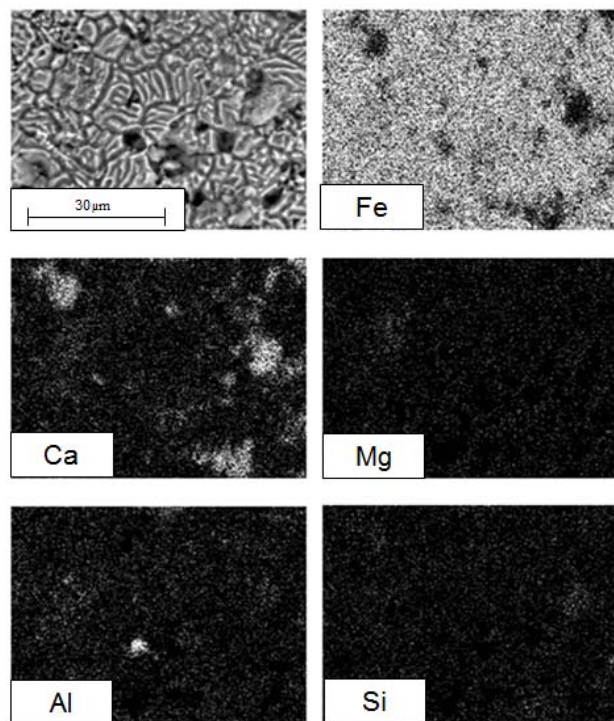
Figure 10 EDS Mapping on Flagstone plate surface reveals mostly iron on the surface

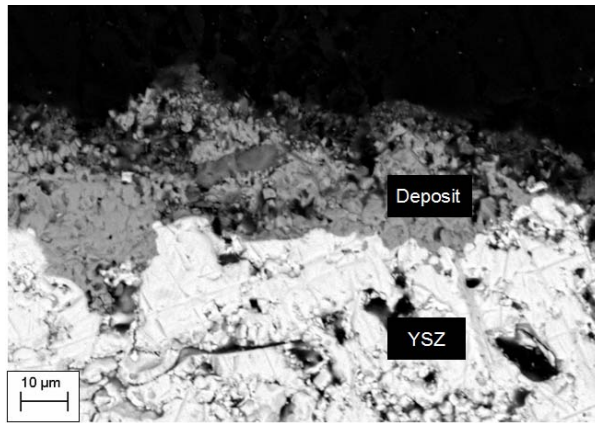
Cross-sectional analyses have been conducted on the various deposits. Figure 11 and Figure 12 show the light brown and red deposits respectively. A large amount of voids were observed within these deposits. The back scattered electron mode (BSE) images also revealed multiple phases within the deposit layer such that a dense, high atomic number layer exists at the outer most layer of the deposit. This outer layer is not uniform in thickness and has a granular structure. It is confirmed from the surface SEM that granular structure dominates the surfaces of lighter colour deposits (light brown and red). These cross-section images revealed that the granular layer is only a thin layer on the surface while a compact layer lies underneath. The granular layer shows high BSE - contrast, indicating the presence of high atomic number elements.

Figure 11 Cross-sectional SEM of light brown deposit

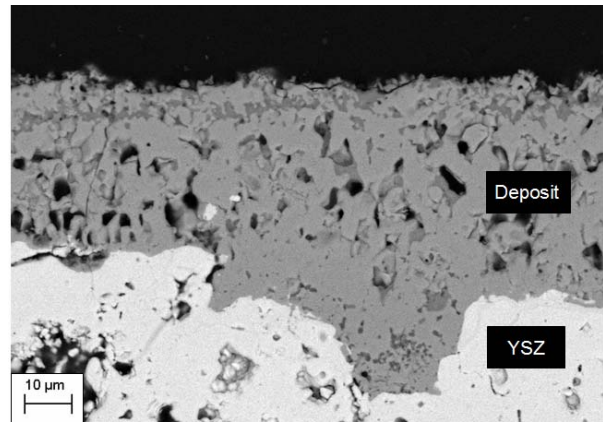
Figure 13 and Figure 14 show the cross-section SEM images of dark colour deposits (black and dark brown). From these microstructures, the dark colour deposits are clearly more consolidated than those light colour deposits. The denser deposit layer reveals less porosity which suggests a sintering effect may have taken place at these sites. Multiple phases are also identified from these SEM images. Recall from the surface EDS mapping of flagstone-like plates, calcium and aluminium signals were also identified. Signals of these elements came from the calcium and aluminium containing layer right under the flagstone-like plate surface; however, this denser phase is only a thin layer ($\sim 5 \mu\text{m}$) and is not representative of the bulk of the deposit.

Figure 14 Cross-sectional SEM of dark brown deposit revealing a dense layer near the surface

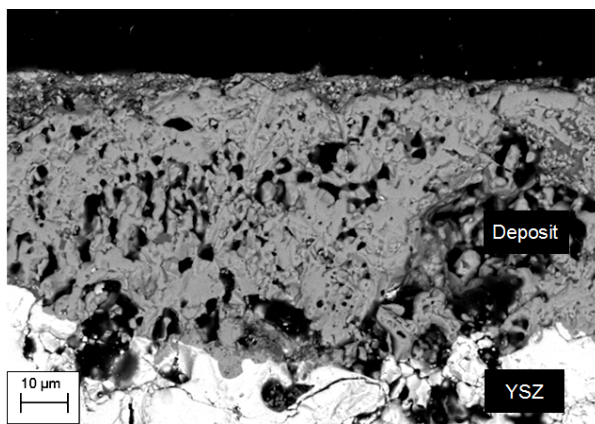
Figure 12 Cross-sectional SEM of red deposit

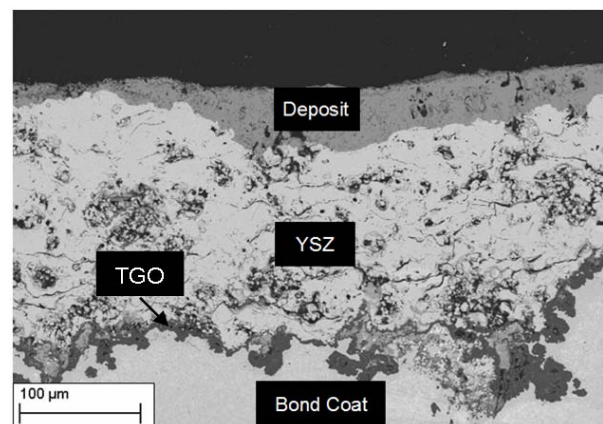
Growth of the thermally grown oxide (TGO) can also be measured from the cross-sectional SEM images. The thickness of the TGO layer under the black deposit surface (Figure 15) is considerably thicker than that of light brown deposit site (Figure 16). The growth rate of the TGO between a TBC and a MCrAlY bond coat is dependent upon temperature [4, 5]. Formation of TGO therefore provides evidence about the relative temperature experienced at these two sites. *i.e.* these data imply that the black deposit covered area had experienced a relatively higher temperature than the region with light brown deposit. Further analytical work will be performed to quantify this.

Figure 15 Cross-section SEM image of black deposit

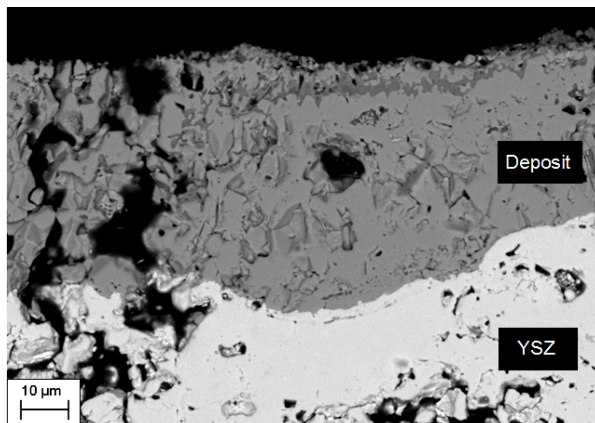
Figure 13 Cross-sectional SEM of black deposit revealing a dense layer near the surface

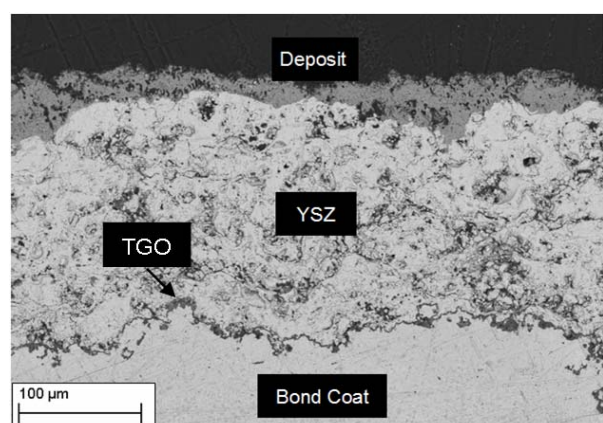
Figure 16 Cross-section SEM image of light brown deposit covered TBC

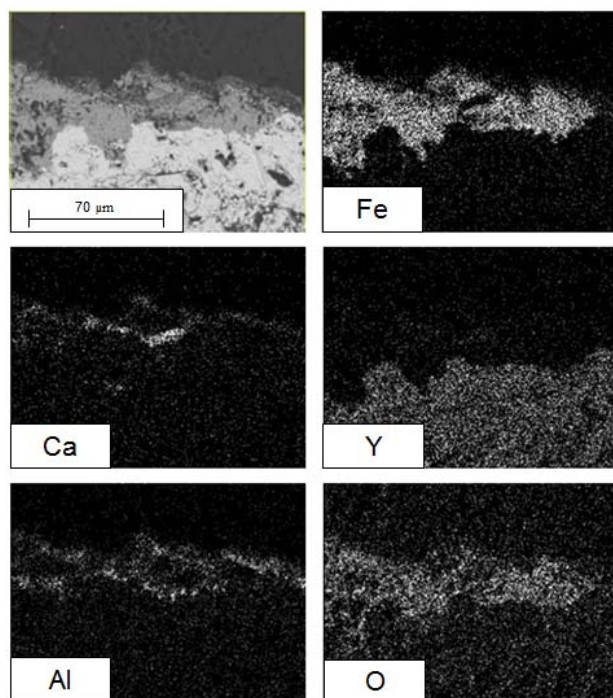
Cross-sectional EDS analysis examined the chemical composition and distribution of the contamination deposit. EDS mapping again reveals heavy iron content ($\sim 30 \text{ at}\%$) with minor trace of calcium ($\sim 2 \text{ at}\%$) and aluminium ($\sim 5 \text{ at}\%$). Figure 17 shows the EDS mapping of a light brown deposit site. Calcium and aluminium were observed near the surface and the deposit / YSZ interface, whereas the bulk of the deposit is primarily iron oxides. The calcium and aluminium appear to be inhomogeneous, suggesting the existence of two different compounds. As comparison, EDS mapping of dark brown deposit is shown in Figure 18. Minor calcium and aluminium signals were again detected from these dense regions. In the study of other environmental degradation, yttria extraction was reported. Stott et al have shown that in the case of CMAS attack, yttria content could be extracted from the YSZ top coat [6, 7, 8]. However, as for this particular iron oxide deposits, EDS mappings reveals no sign of yttria extraction (at least within the sensitivity of this measurement).

Figure 17 EDS mapping on the cross-section of light brown colour deposit site

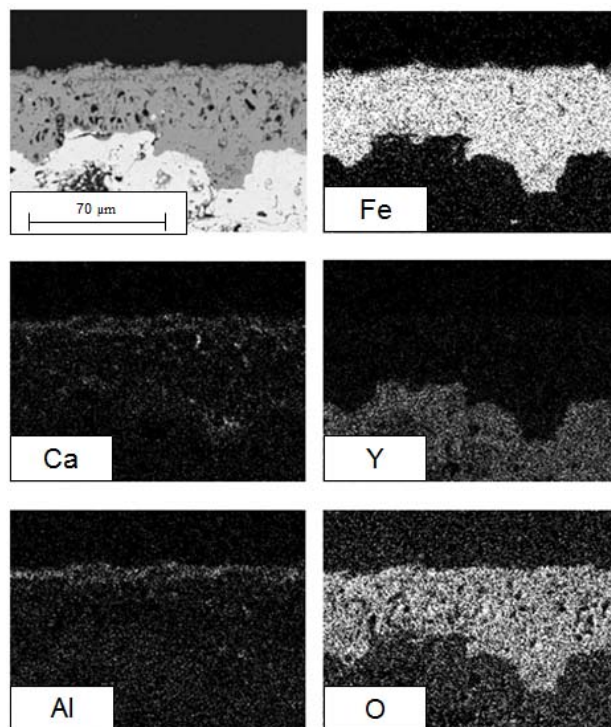
Figure 18 EDS mapping on the cross-section of dark brown colour deposit site

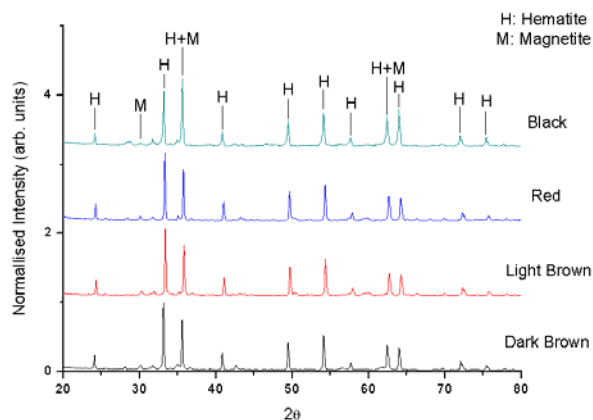
From the EDS analyses, various elements have been confirmed. It is our interest to know the correct phases of the primary contaminant present in this system, iron. XRD has been conducted at four different positions on the pressure side vane surface, covering both light and dark coloured deposits. Figure 19 shows the XRD spectra of black, red, light brown, and dark brown colour deposit surfaces. Since the deposits layers are generally thick (greater than 30 μm in most surfaces) the XRD could only reveal the elemental phases near the surface. A mixture of hematite (Fe_2O_3) and magnetite (Fe_3O_4) phases have been identified.

Figure 19 XRD traces of black, red, light brown, dark brown colour deposit surfaces
