An Investigation of the Therac-25 Accidents

Nancy G. Leveson, University of Washington

Clark S. Turner, University of California, Irvine

A thorough account of the Therac-25 medical electron accelerator accidents reveals previously unknown details and suggests ways to reduce risk in the future.

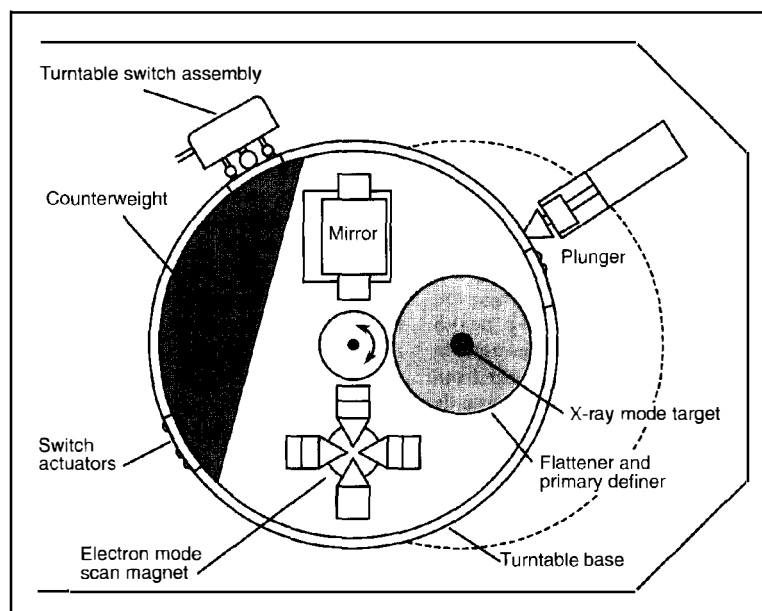
hazard of dual-mode machines: If the turntable is in the wrong position, the beam flattener will not be in place.

No accelerator beam is expected in the field-light position. A stainless steel mirror is placed in the beam path and a light simulates the beam. This lets the operator see precisely where the beam will strike the patient and make necessary adjustments before treatment starts. There is no ion chamber in place at this turntable position, since no beam is expected.

Figure B. Upper turntable assembly.

cate turntable position that tolerated a 1-bit error. The code would still unambiguously reveal correct position with any one microswitch failure.

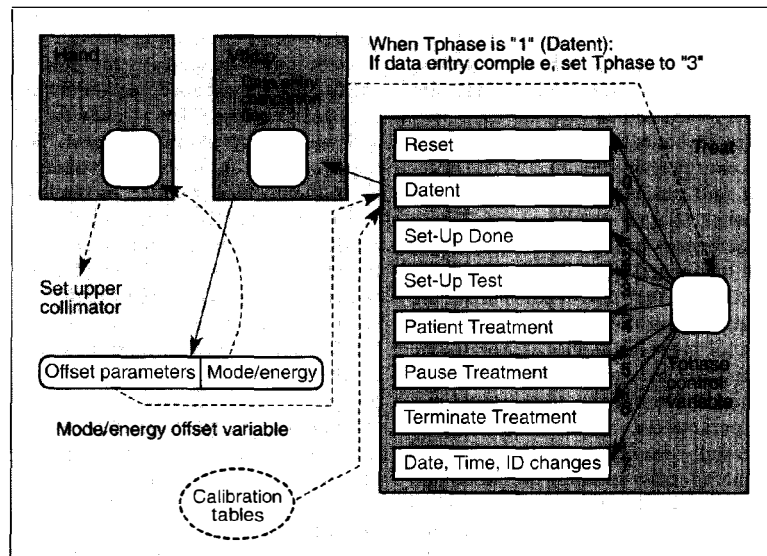
As described in the sidebar on Therac-25 software development and design, **the treatment monitor task (Treat) controls the various phases of treatment by executing its eight subroutines** (see Figure 2). The treatment phase indicator variable (Tphase) is used to determine which subroutine should be executed. **Following the execution of a particular subroutine, Treat reschedules itself.**

One of Treat's subroutines, called **Datent (data entry), communicates with the keyboard handler task (a task that runs concurrently with Treat) via a**

Figure 2. Tasks and subroutines in the code blamed for the Tyler accidents.

shared variable (Data-entry completion flag) to determine whether the prescription data has been entered. The keyboard handler recognizes the completion of data entry and changes the Data-entry completion variable to denote this. Once the Data-entry completion variable is set, the Datent subroutine detects the variable's change in status and changes the value of Tphase from 1 (Data Entry) to 3 (Set-Up Test). In this case, the Datent subroutine exits back to the Treat subroutine, which will reschedule itself and begin execution of the Set-Up Test subroutine. If the Data-entry completion variable has not been set, Datent leaves the value of Tphase unchanged and exits back to Treat's main line. Treat will then reschedule itself, essentially rescheduling the Datent subroutine.

Upon exit from the Magnet subroutine, the data-entry subroutine (Datent) checks the data-entry completion variable. If it indicates that data entry is complete, Datent sets Tphase to 3 and Datent is not entered again. If it is not set, Datent leaves Tphase unchanged, which means it will eventually be rescheduled. But the data-entry completion variable only indicates that the cursor has been down to the command line, not that it is still there. A potential race condition is set up. To fix this, AECL introduced another shared variable controlled by the keyboard handler task that indicates the cursor is not positioned on the command line. If this variable is set, then prescription entry is still in progress and the value of Tphase is left unchanged.
