### STM32H742xI/G, STM32H743xI/G, STM32H750xB, STM32H753xI device errata

This document applies to the part numbers of STM32H742xI/G, STM32H743xI/G, STM32H750xB, STM32H753xI devices and the device variants as stated in this page.

It gives a summary and a description of the device errata, with respect to the device datasheet and reference manual RM0433.

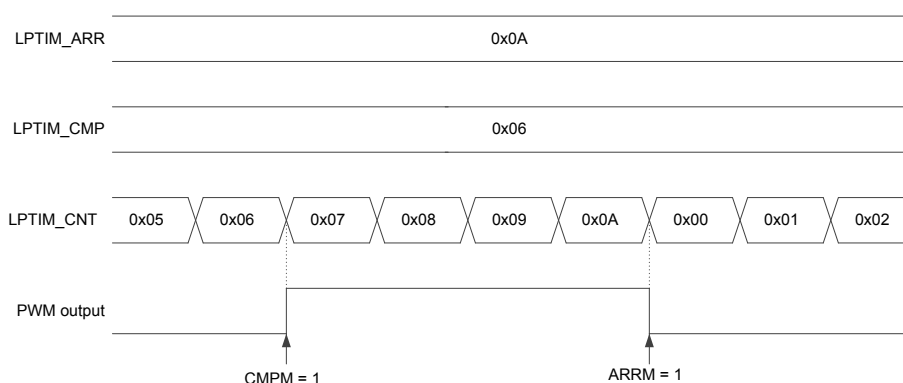
**Figure 1. Example of PWM output mode**

The following waveform gives the example of PWM output mode and the effect of the delay:

Set the compare value to the desired value minus 1. For instance in order to generate a compare match when `LPTIM_CNT = 0x08`, set the compare value to 0x07.

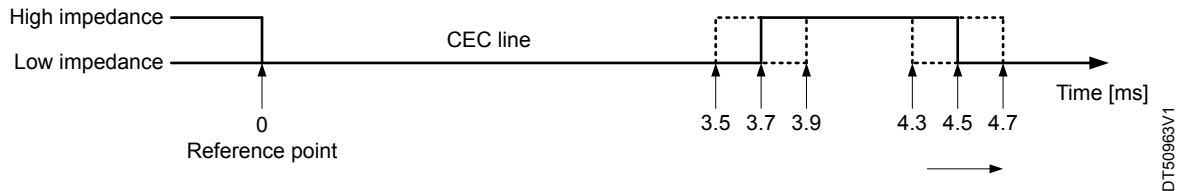
**Figure 3. CEC start bit format with tolerances**

If one of these conditions is not met, the transmission is aborted and never automatically retried. No error flag is set and the TXSOM (Tx Start Of Message) bit is not cleared.

The only way to detect this error is for the application software to start a timeout when setting the TXSOM bit, restart it upon ARBLST or any RX event (as the transmission can be delayed by interleaved reception), and stop it upon TXBR (proof that the start bit was transmitted successfully) or TXEND event, or upon any TX error (which clears TXSOM). If the timeout expires (because none of those events occurred), the application software must restart the CEC peripheral and retransmit the message.
