MICROCHIP dsPIC33EPXXXGM3XX/6XX/7XX FAMILY

dsPIC33EPXXXGM3XX/6XX/7XX Family Silicon Errata and Data Sheet Clarification

The dsPIC33EPXXXGM3XX/6XX/7XX family devices that you have received conform functionally to the current Device Data Sheet (DS70000689D), except for the anomalies described in this document.

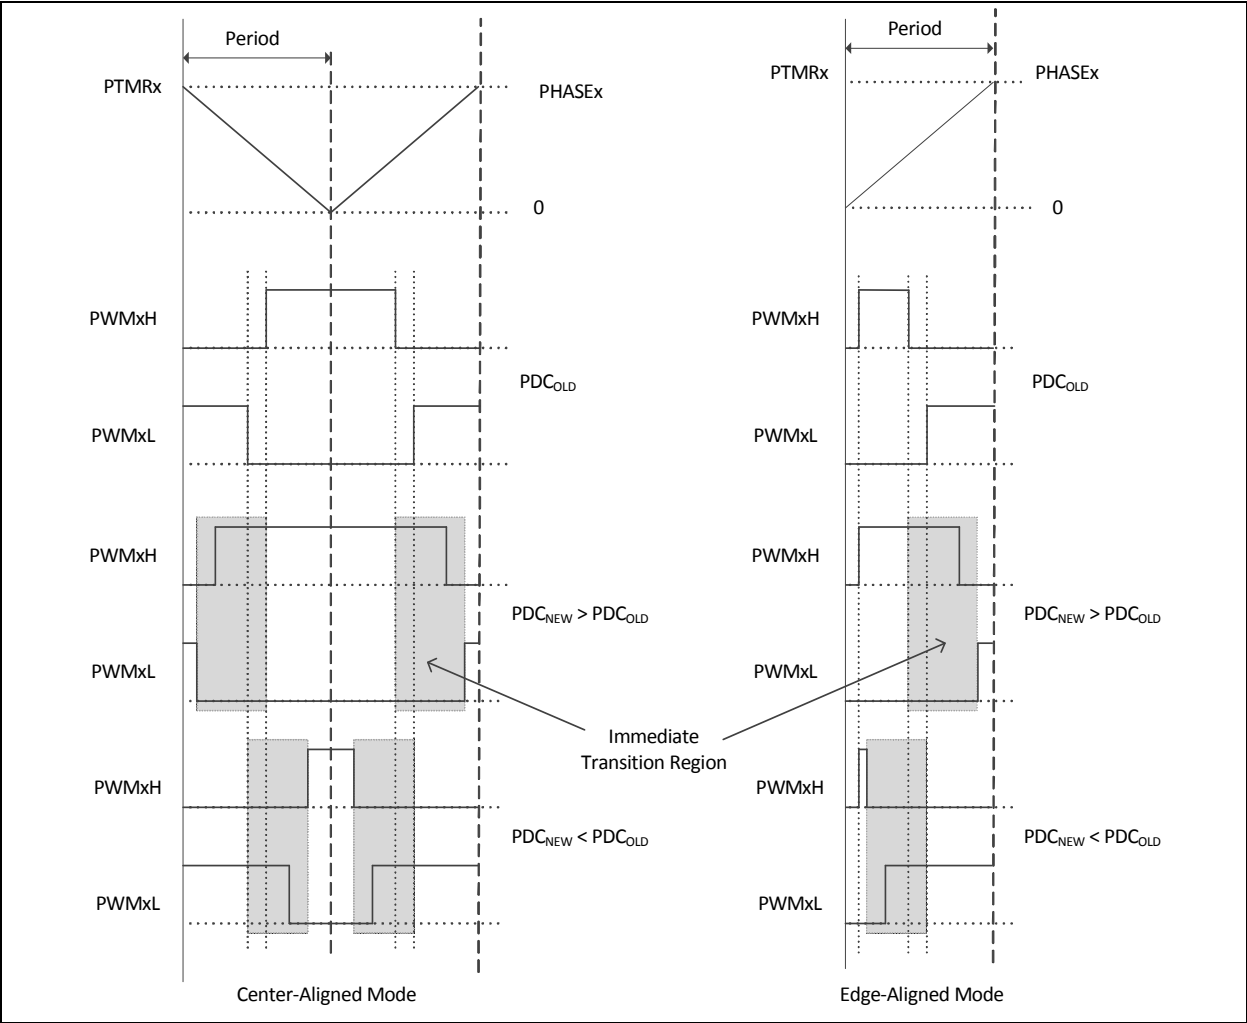
FIGURE 1: TIMING DIAGRAMS FOR CENTER-ALIGNED AND EDGE-ALIGNED MODES

The PWM generator may not assert dead time on the edges of transitions. This has been observed when all of the following conditions are present:

- The PWM generator is configured to operate in Complementary mode with Independent Time Base (ITB) or master time base;
- Immediate update is enabled; and
- The value in the PDC register is updated in such a manner that the PWMxH and PWMxL outputs make an immediate transition.

time base, will determine if the PWMxH and PWMxL outputs make an immediate transition. PWMxH and PWMxL outputs make an immediate transition if the Duty Cycle register is written with a new value, PDC_{NEW}, at a point of time when the PWM time base is counting a value that is in between PDC_{NEW} and PDC_{OLD}. Additionally, writing to the Duty Cycle register, close to the instant of time where dead time is being applied, may result in a reduced dead time which is effective on the PWMxH and PWMxL transition edges.

In Figure 1, if the duty cycle write occurred in the shaded box, then PWMxH and PWMxL will make an immediate transition without dead time.

In most applications, the duty cycle update timing can be controlled using the TRIGx trigger, or Special Event Trigger, such that the above mentioned conditions are avoided altogether.

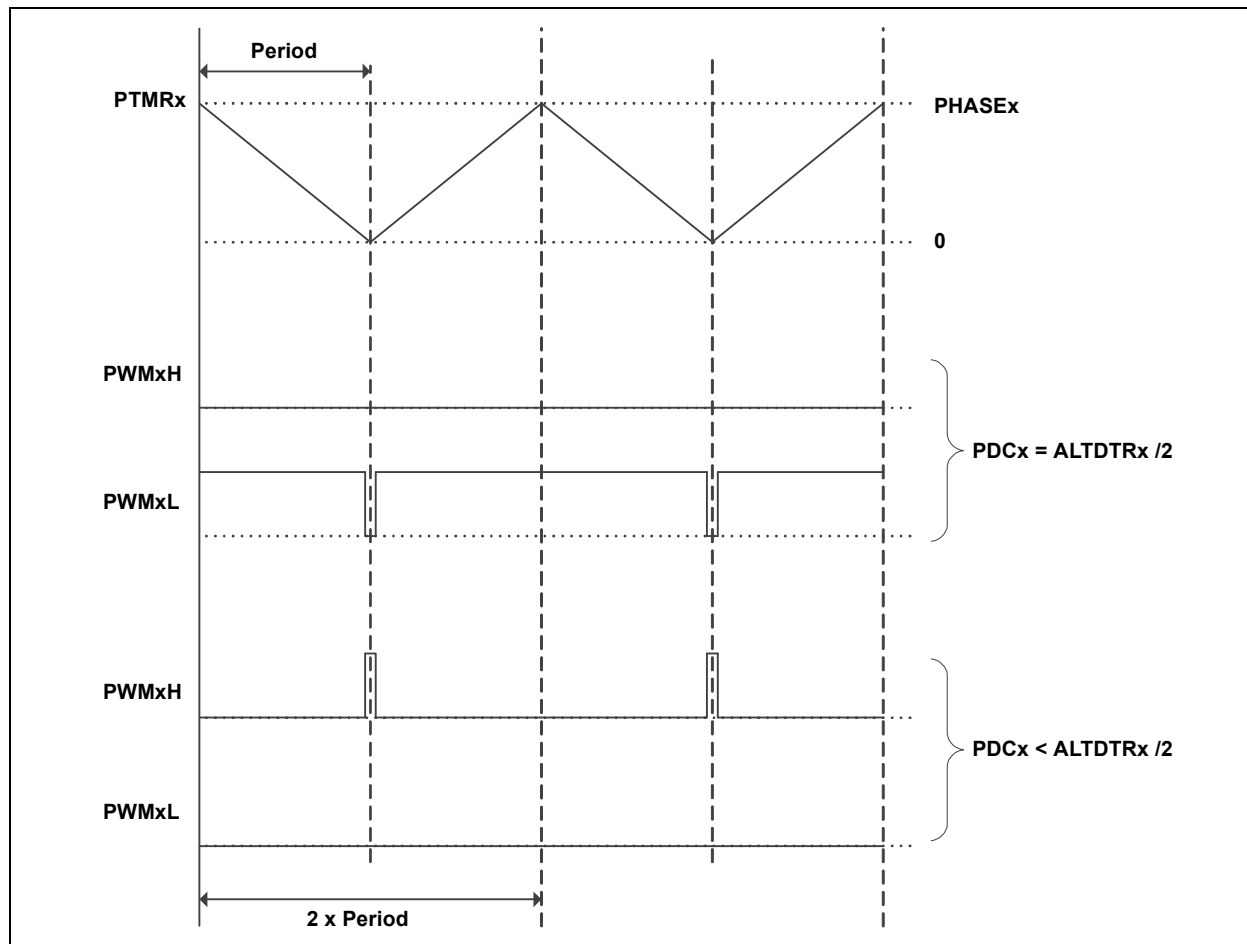
FIGURE 2: PWM GENERATOR TIMING DIAGRAM

In Center-Aligned Complementary mode with Independent Time Base, if the value in the PDCx register is less than one-half the value in the ALTDTRx register, the PWM generator will force the PWMxL to low, and on the PWMxH, generates pulses of a width less than twice the dead time, as shown in Figure 2.

Include a software routine to ensure that the duty cycle value written to the PDCx register is at least one-half of the value in ALTDTRx. Example 1 shows one method, with PDCtemp representing the variable which has the value to be written to the PDCx register. Alternatively, for duty cycle values less than half the desired dead-time value, zero out the ALTDTRx register or dynamically reduce the value in the ALTDTRx register, such that ALTDTRx is always equal to $2 * PDCx$, as shown in Example 2.

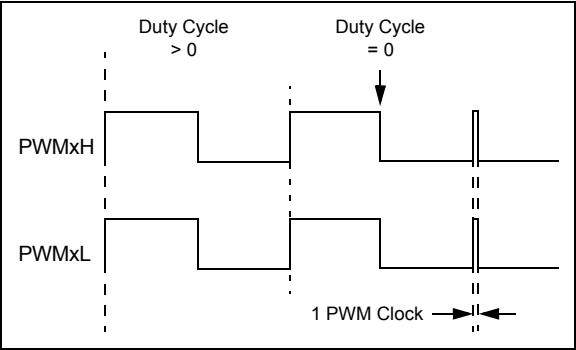
FIGURE 3:

In certain output modes, the PWMx module produces a pulse glitch of one PWM clock in width (Figure 3). This has been observed only when all of the following are true:

- Either Redundant or Push-Pull Output mode is selected ($\text{IOCONx}\langle 11:10 \rangle = 10$ or 01);
- Immediate Update is disabled ($\text{PWMCONx}\langle 0 \rangle = 0$); and
- The value of the current Duty Cycle register (either the PDCx or MDC register, as determined by $\text{PWMCONx}\langle 8 \rangle$) is updated to zero from any non-zero value.

The pulse glitch has been observed to occur at the beginning of the following PWM boundary period.

If the application requires a duty cycle of zero, two possible work arounds are available.

1. Use the PWM overrides to force the output to a low state, instead of writing a '0' to the Duty Cycle register. When using this method, the PWM override must be disabled when the duty cycle is a non-zero value. If output override synchronization is configured to occur on CPU clock boundaries ($\text{IOCONx}\langle 0 \rangle = 0$), enabling and disabling the override must be timed to occur as closely as possible to the PWM period boundary.
2. Configure the module for Immediate Update ($\text{PWMCONx}\langle 0 \rangle = 1$) *before* enabling the module. In this mode, writes to the Duty Cycle register have an immediate effect on the output. As with the previous work around, writes to the Duty Cycle register must be timed to occur as close to the PWM period boundary as possible in order to avoid distortion of the output.

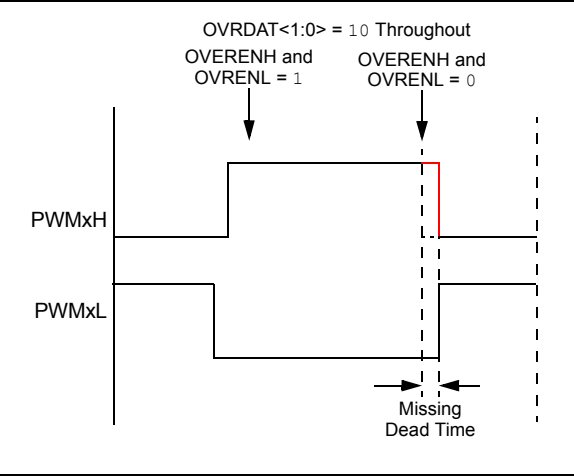
FIGURE 4:

In Complementary Output mode, the expected dead time between transitions of the PWMxH and PWMxL outputs may not be asserted when the following occurs:

- Output override synchronization is configured to occur on the CPU clock boundary ($\text{IOCONx}\langle 0 \rangle = 0$);
- Both PWMxH and PWMxL overrides are enabled prior to the event (OVRENH and OVRENH are both '1'), and
- Both overrides are disabled (OVRENH and OVRENH are both '0') at the instant the dead time should be asserted (Figure 4).

This has been observed in both Center-Aligned and Edge-Aligned modes.

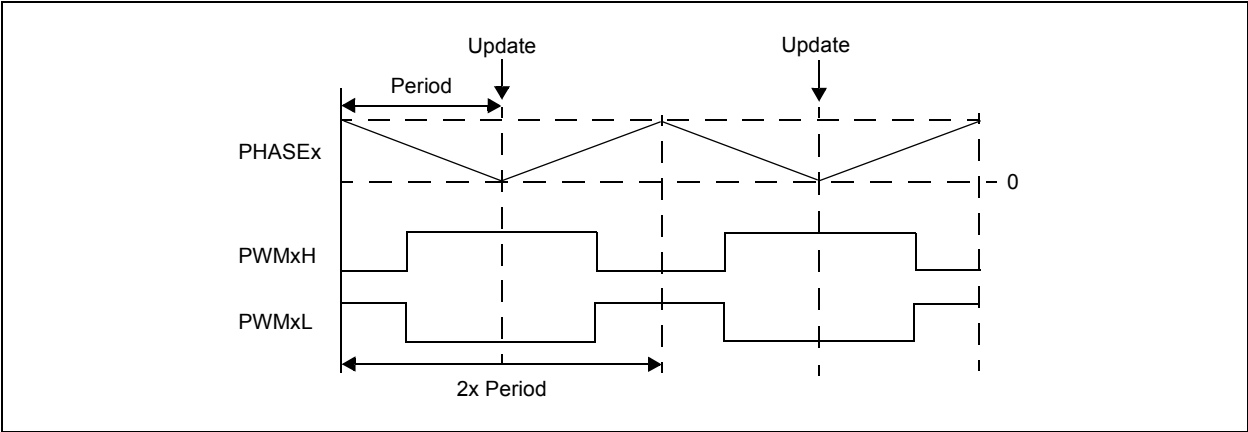
FIGURE 5:

Figure 5. This occurs only when the Immediate Update feature is disabled (IUE = 0). If Immediate Update is enabled (IUE = 1), the PHASEx register updates will take effect immediately.
